# SOUTH DAKOTA TANK PATHOLOGY STUDY

## EVALUATING THE INTEGRITY OF TANK SYSTEMS IN SOUTH DAKOTA

South Dakota  
Petroleum Release  
Compensation Fund

**June 15, 2005**

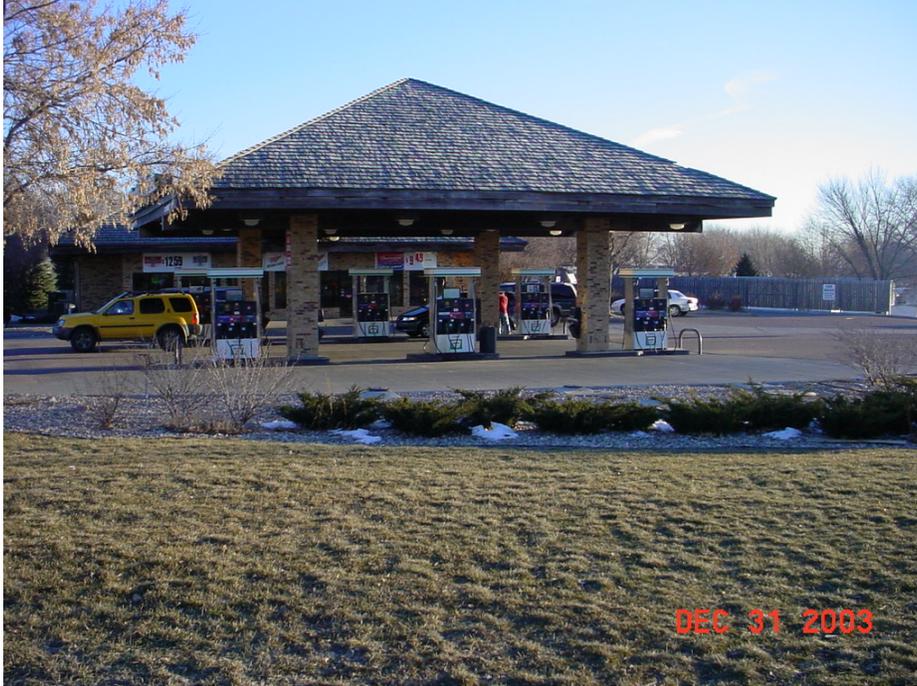
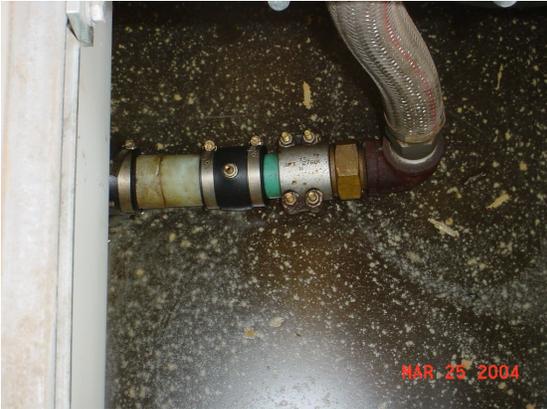
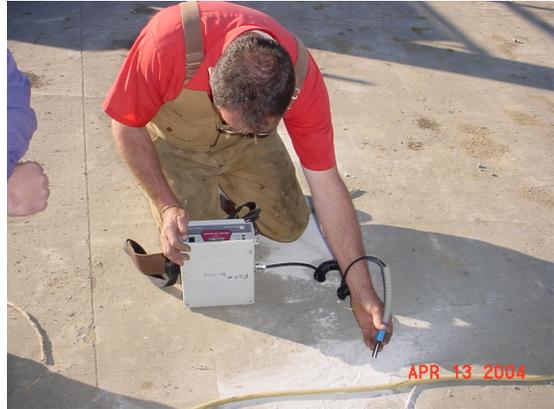
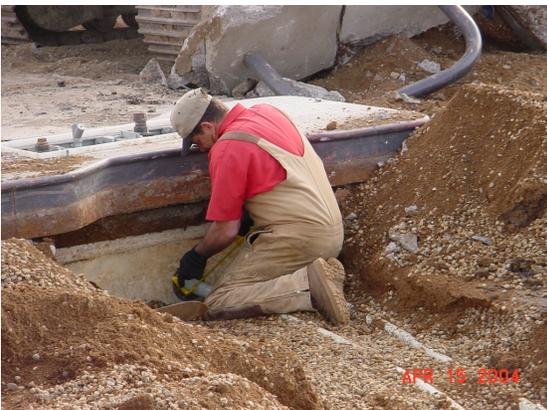
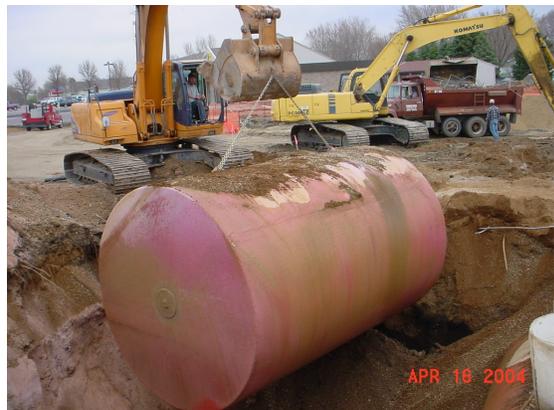
**Project Location #1  
Country Corner  
Sioux Falls, SD**

- This location has operated as a retail service station since 1985. A state-of-the-art UST system was installed in mid-2000. The station ceased operation in early 2004 to be razed and replaced by another commercial retail business.

- Some installation discrepancies were noted but none had yet contributed to a release. The interstitial spaces of the double wall piping were not connected in the dispenser sumps and there were no sensors in the sumps to detect any loss from the interstitial spaces.

- Records received from the site indicate checks performed during the short life of the system were spotty, inconsistent, and often incorrectly performed. Although the system had an automatic tank gauging (ATG) and checking capability, the operator continued intermittent recording of SIR information. The operator utilized the ATG to perform an inventory function.

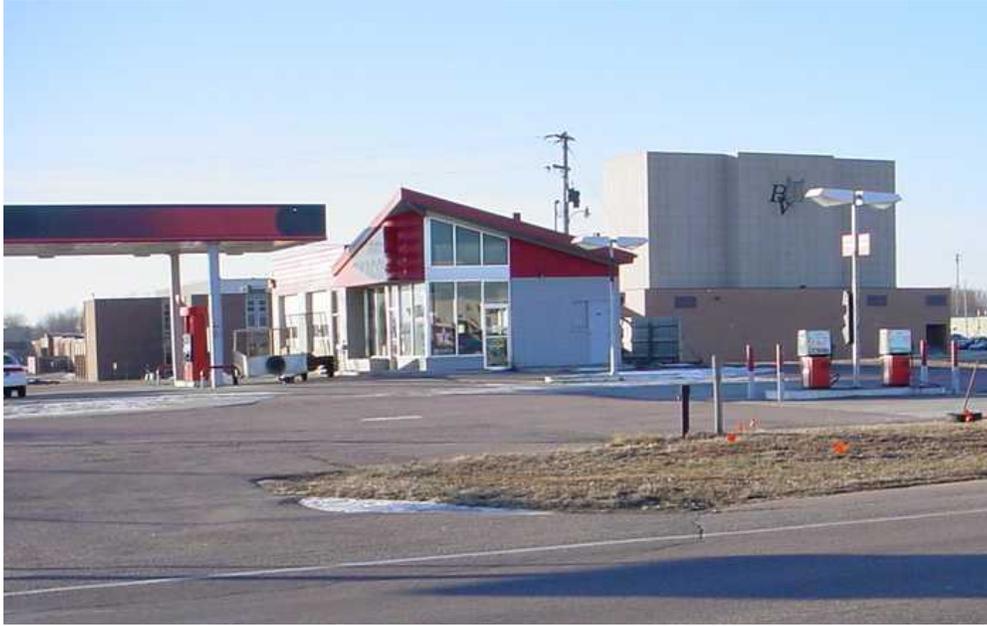
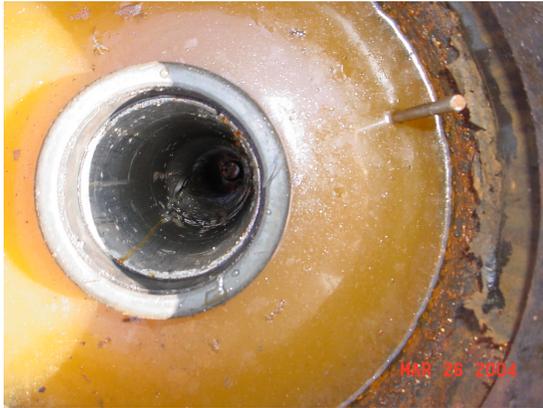
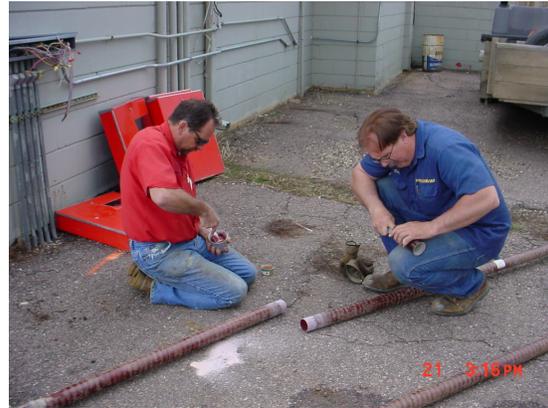
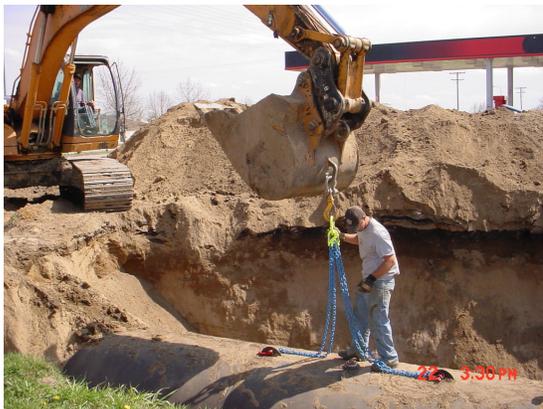
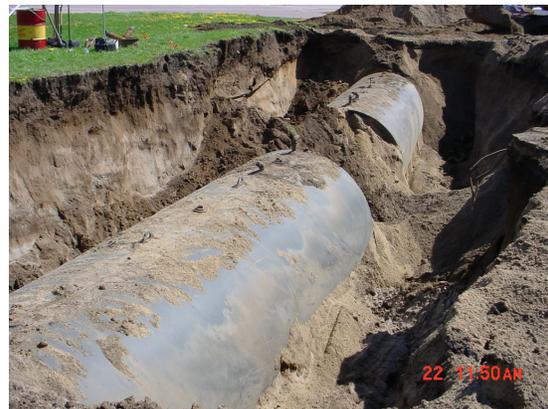
**Project Location #2**  
**Bill's Texaco**  
**Brandon, SD**

- This neat appearing location had two separate-second generation, UST systems; one gasoline and one diesel. The system studied was installed in 1992 and was a suction fed, diesel system.
- Some installation discrepancies were noted but none had yet contributed to a release. Shipping cover protectors were not removed from a few tank anodes prior to burial.
- No documentation (i.e., component installation, maintenance, operation manuals) was available.
- No as-built drawings, installation proposals, leak detection, inspection, or maintenance records were available.

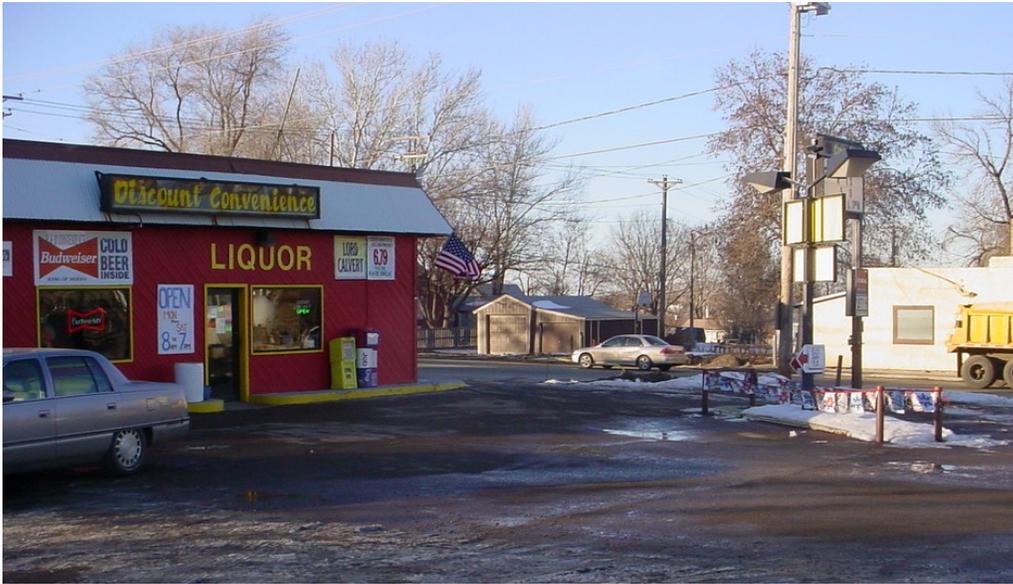
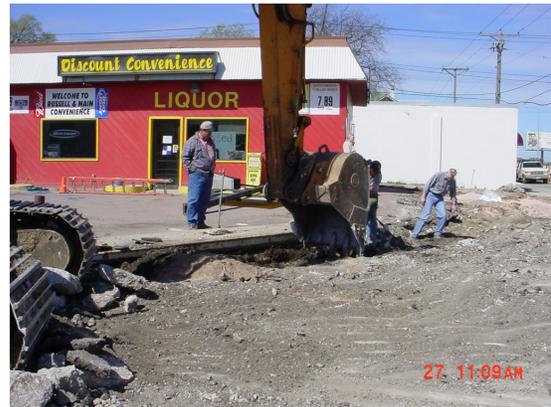
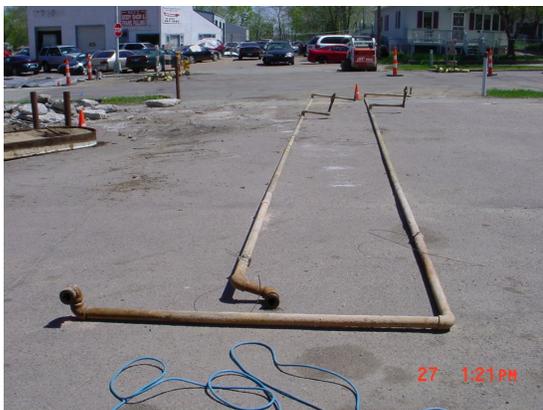
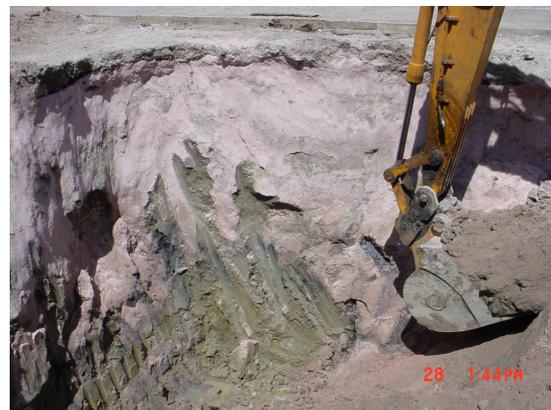
**Project Location #3**  
**R&M Convenience**  
**Sioux Falls, SD**

- This location, exhibiting an aged appearance, had a second generation, single-product gasoline UST system. The system was installed in 1982 and consisted of two 6,000 gallon, asphalt-coated steel USTs bedded in quartzite dust. The steel piping was also bedded in quartzite dust. Overfill valves, spill containment, electronic line leak detectors and cathodic protection were added seven years earlier to meet federal upgrade requirements.

- Installation discrepancies noted included the failure to anchor fire/shear valves to the island beneath the dispensers and underground vent lines that were unconnected.

- No documentation (i.e., as-built drawings, component installation, maintenance, operation manuals) was available.
- Consistent leak detection, inspection, or maintenance records were unavailable for the site.

- Upon removal of the USTs it was determined that a release had apparently occurred from a previously system installed at this location and that the current USTs were installed without remediating the previous release. Additional corrective action is required to assess the site and determine an appropriate corrective action for the earlier release.

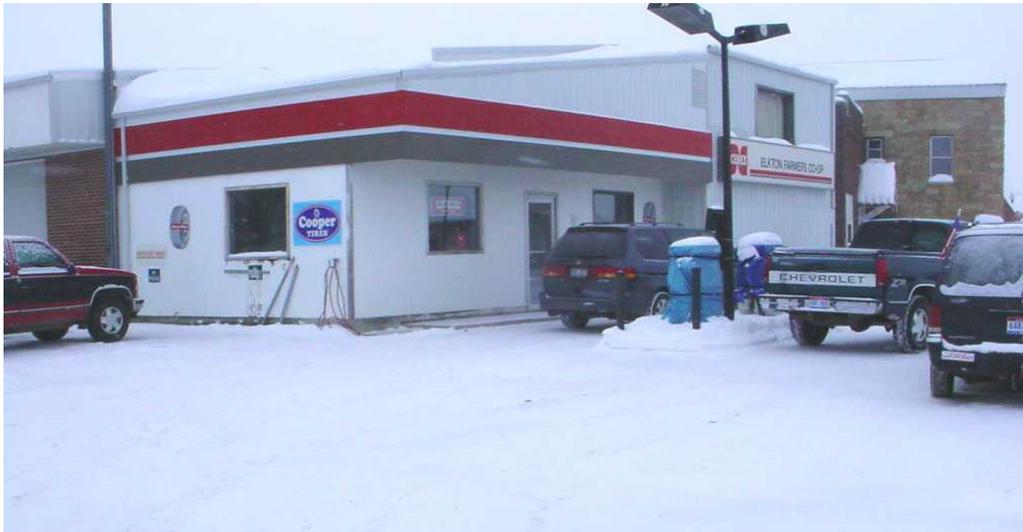
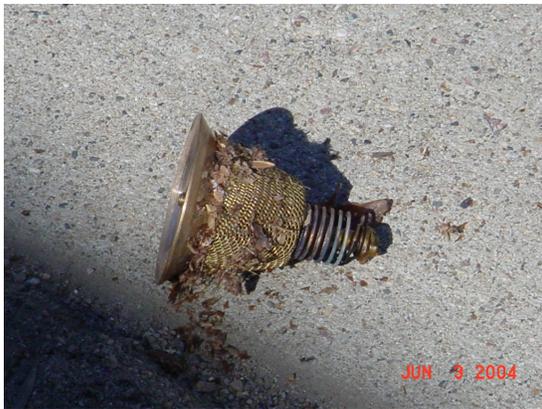
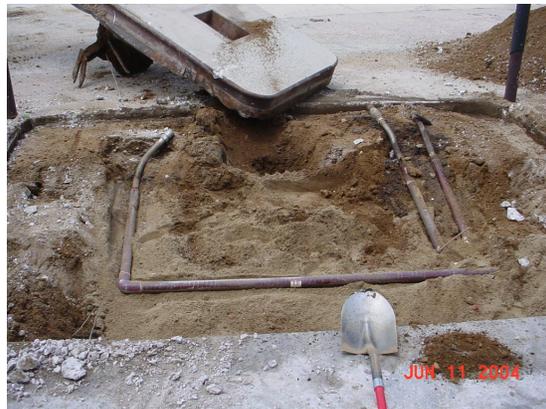
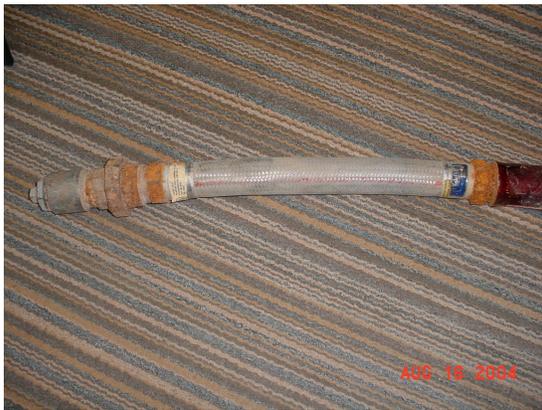
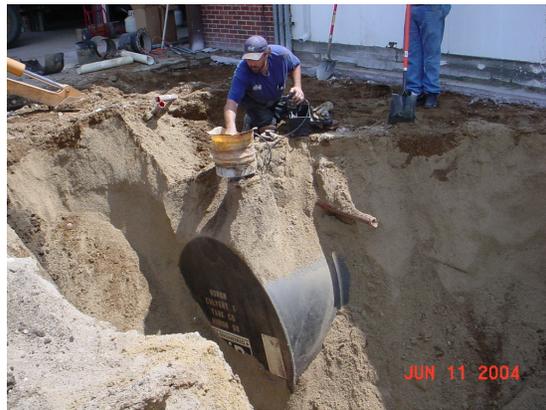
**Project Location #4  
Farmer's Union  
Elkton, SD**

Generally the system was in good shape. One dispenser was found to have a double check valve installed and the screen in the valve was clogged with debris. The only system documentation available was the original installation plans which included photos. Leak detection records included DENR inspections and a line tightness test. No monthly release detection or reconciliation records were available. No release was identified during the system removal.

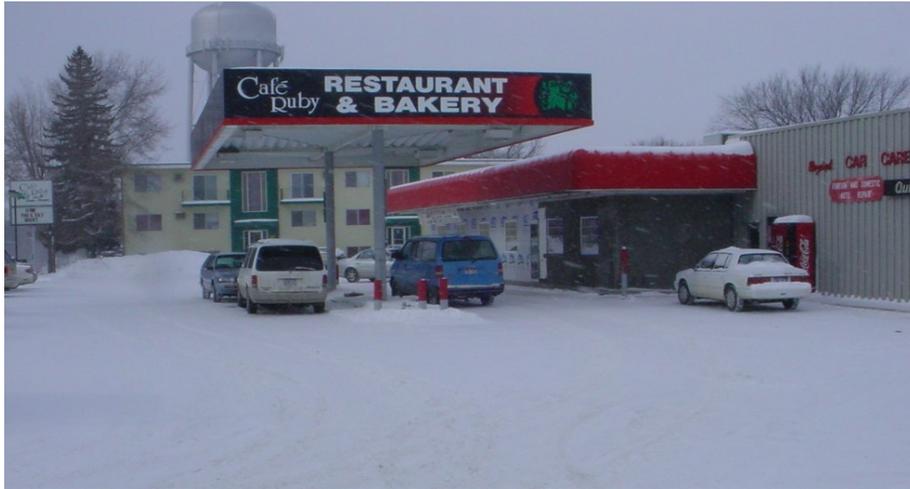
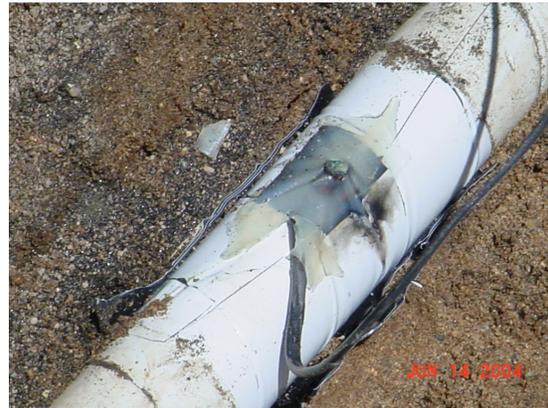
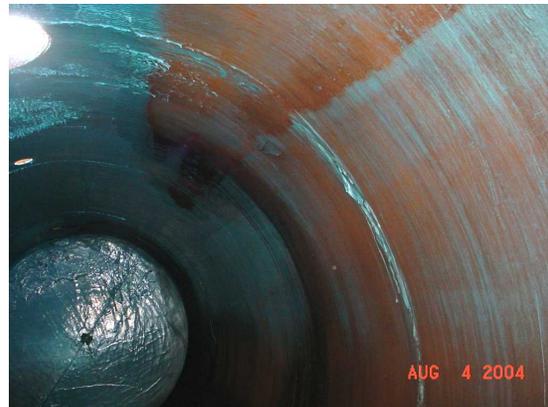
**Project Location #5  
Bozied Texaco  
Brookings, SD**

The original tank system was installed in 1969. In 1991 the tanks were upgraded by applying internal lining, adding spill / overfill protection, replacing the product lines, and adding cathodic protection to the tank system. The tank system was found to be in generally good condition. No visible holes were found in the tanks. The cause of the tightness test failure in the premium line was not able to be identified when the lines were removed. Leak detection records were not available. The site had been closed for approximately one year and the records were not retained. A set of blueprints from the 1969 installation were available. No other records of tightness tests or DENR inspections were available. A release was reported as the result of the system removal. Contamination was noted in the tank basin and near the dispenser island. The tank basin contamination is likely the result of historic spills / overfills and the island contamination may have resulted from dispenser maintenance or leaks. No piping leaks were identified during the course of the evaluation. The visibly contaminated soil was removed from the site. DENR has required that site assessment be done to determine if there are any potential pathways and impacted receptors.

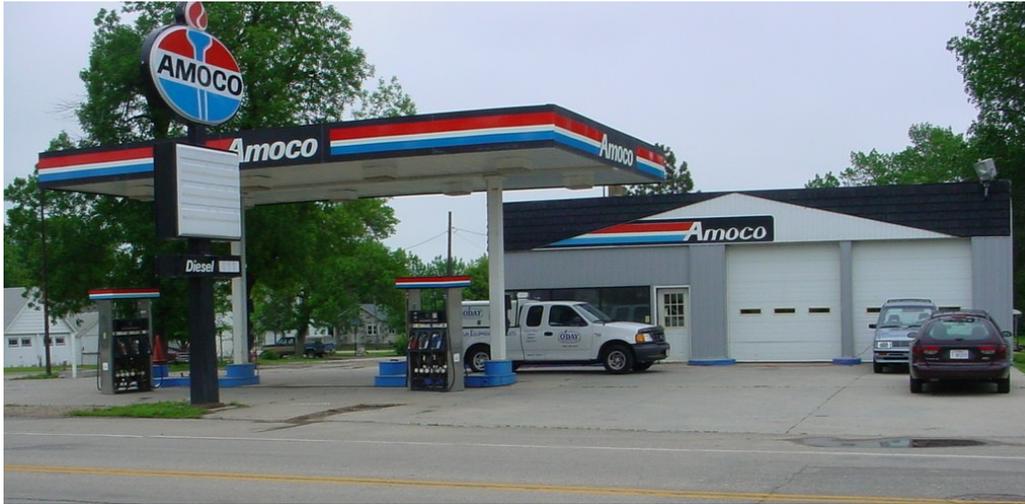
**Project Location #6  
Wayne's Amoco  
Clear Lake, SD**

The system was installed in 1993. It was found to be in generally good shape. One spill bucket had a damaged lid and the release valve was stuck. Documentation for the station was not available. The station was closed for nearly a year before the system removal, and the records were not retained. Leak detection and inspection records also were not retained. No release was identified during the system removal. Two other tanks were subsequently removed under the South Dakota Abandoned Tank Program and the contaminated soils associated with these tanks were removed and properly disposed.

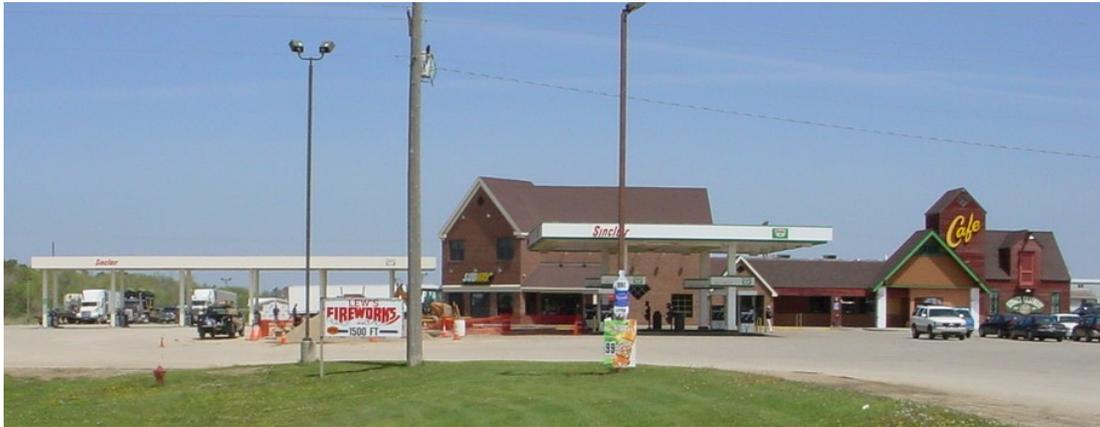
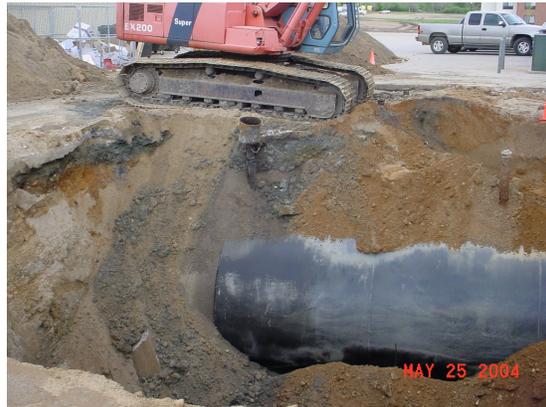
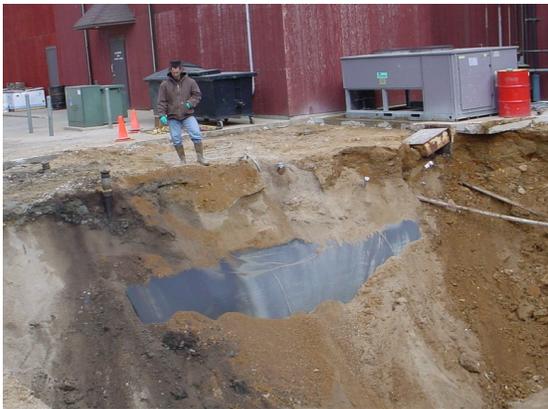
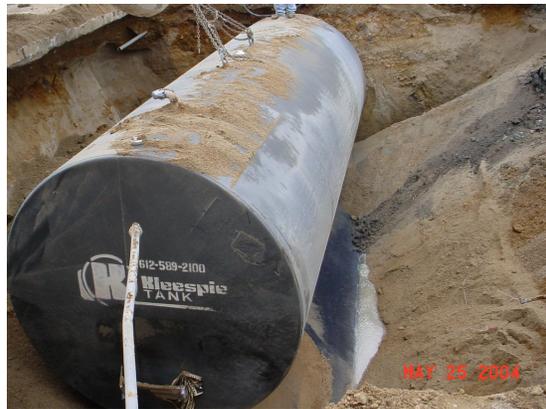
**Project Location #7  
Stone's Truck Stop  
Watertown, SD**

The condition of the system was generally good. The lines all passed the precision tightness test and the helium test. Contamination was found near the former location of the diesel islands and in the tank basin. The island contamination is believed to be the result of dispenser maintenance and/or dispenser leaks. The tank basin contamination is believed to result from spill buckets that were missing, not functioning properly or had leaked. The spill / overfill protection was added in 1994. The tanks were installed in 1985, so some of the release may have occurred before the protection was added.

DENR has required that site assessment be done to determine if there are any potential pathways and impacted receptors.

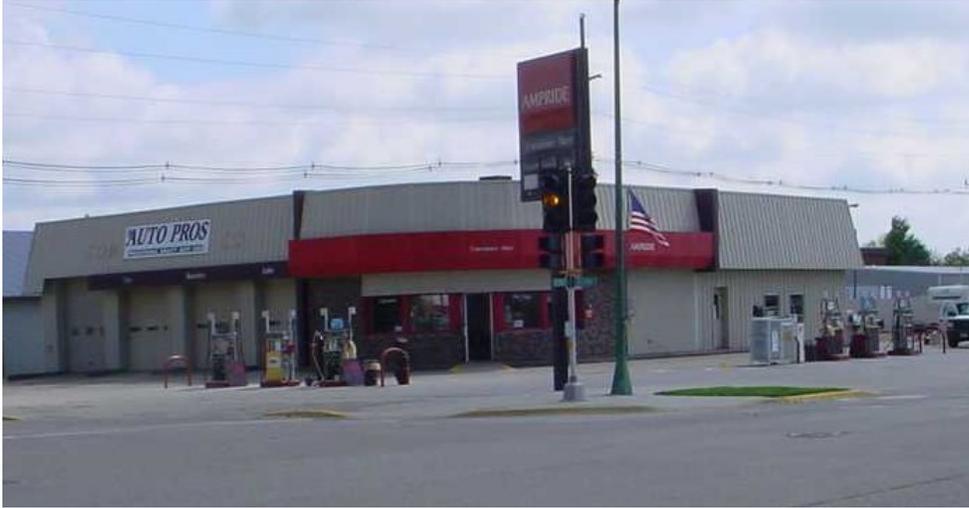
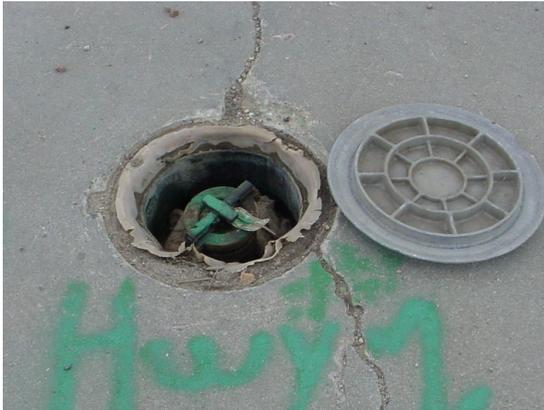
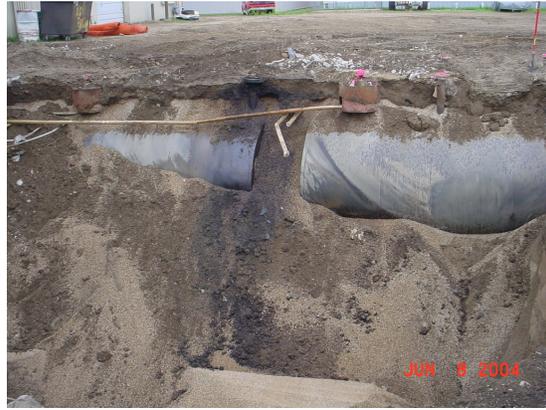
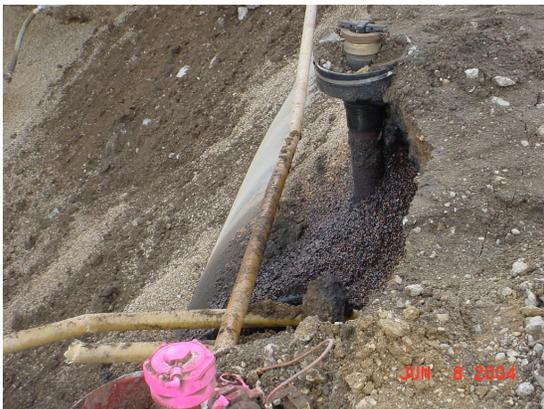
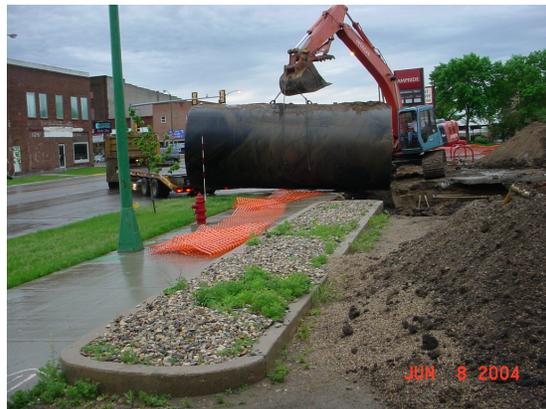
**Project Location #8  
Sioux Valley Coop  
Watertown, SD**

The tank system was installed in 1988 and consisted of StiP3 single walled steel tanks and fiberglass piping. The tank system was in good condition with the exception of one spill bucket that had malfunctioned / leaked. The system contained tanks for kerosene and E-85 (85% ethanol), as well as diesel, 10% ethanol blend, and regular unleaded.

The contamination from the leaking spill bucket was confined to the tank basin. A relatively small amount of contaminated soil was disposed and DENR is not requiring further work or assessment at the site.

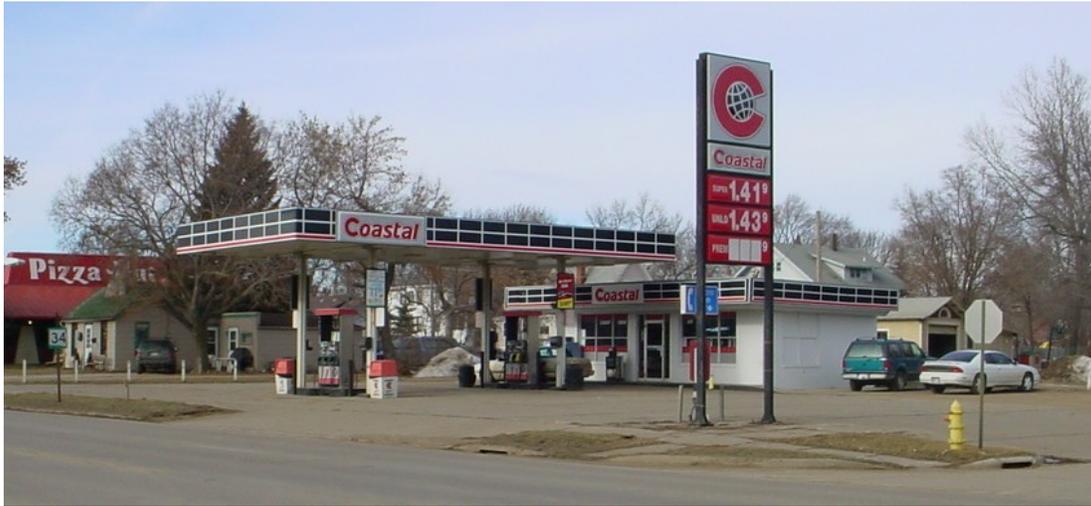
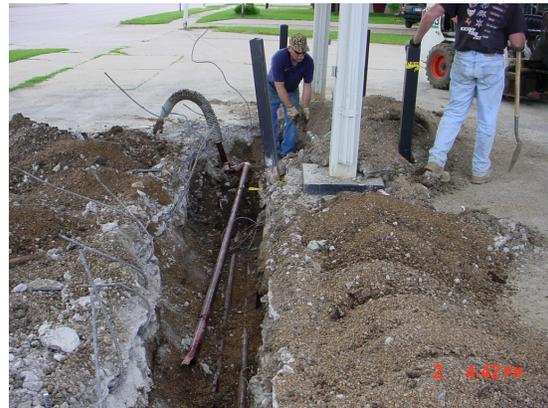
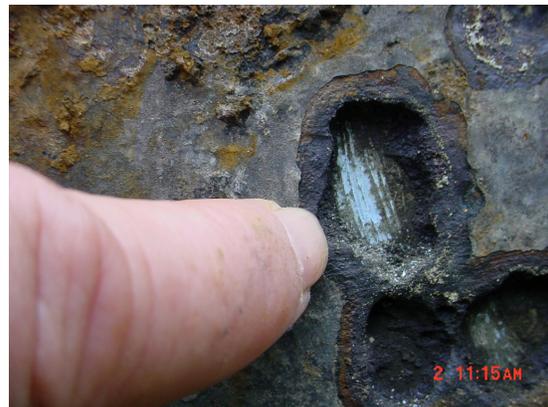
**Project Location #9  
Madison Coastal Mart  
Madison, SD**

- This location had a three-product gasoline UST system. The system was installed in 1961 and the USTs had been lined in 1992.
- A single installation discrepancy was noted. A potential greater problem was found when the UST's were excavated. In discrete areas, the steel tanks had
- No documentation (i.e., component installation, maintenance, operation manuals) was available.
- Consistent leak detection, inspection, or maintenance records were unavailable for the site.
- While removing the USTs it was determined that a release had apparently occurred. Additional assessment has been performed and no contamination above state standards was found.

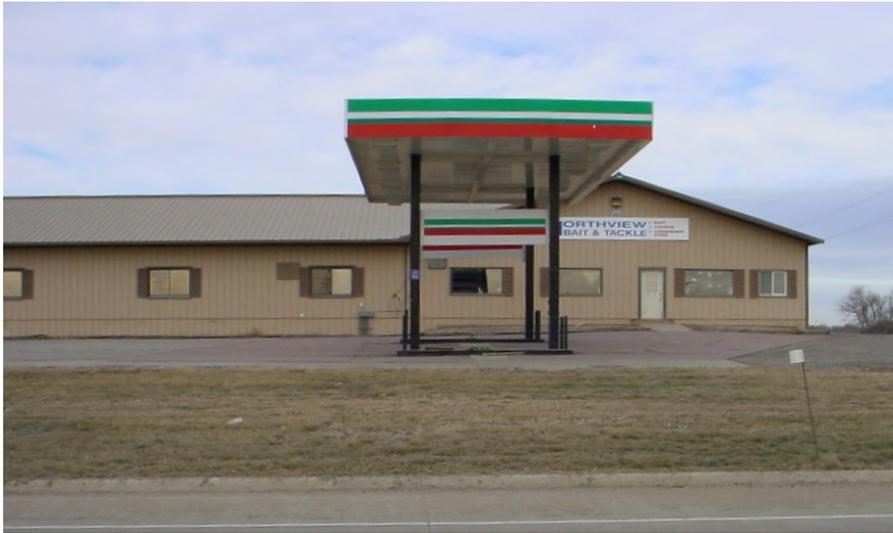
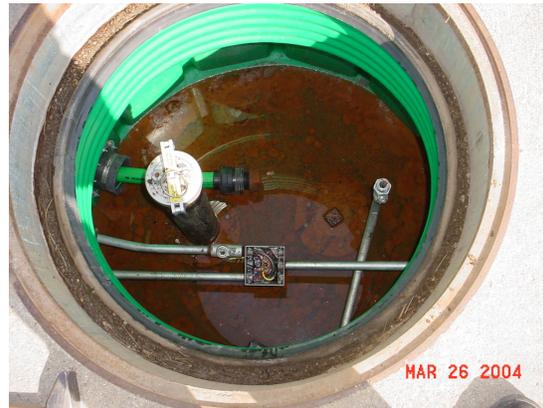
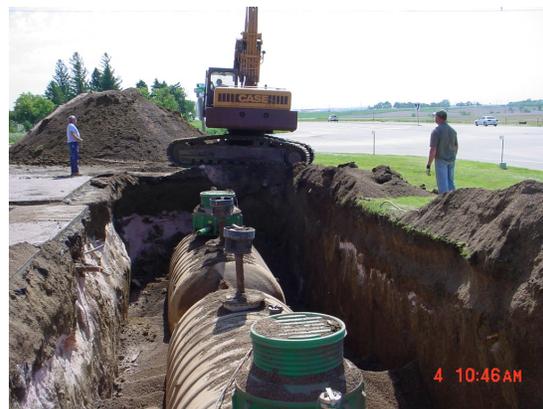
**Project Location #10  
Northview Bait & Tackle  
Sioux Falls, SD**

- This location had been a gas station prior to 1979. Contamination was found when the previous system was removed in 1999 and replaced with a two-product gasoline UST system in 1999. The station was closed in 2002 when purchased by the owner of surrounding property.
- No installation discrepancies were noted.
- No documentation (i.e., as-built drawings, maintenance, operation manuals) was available.
- Leak detection, inspection, or maintenance records were not available for the site.

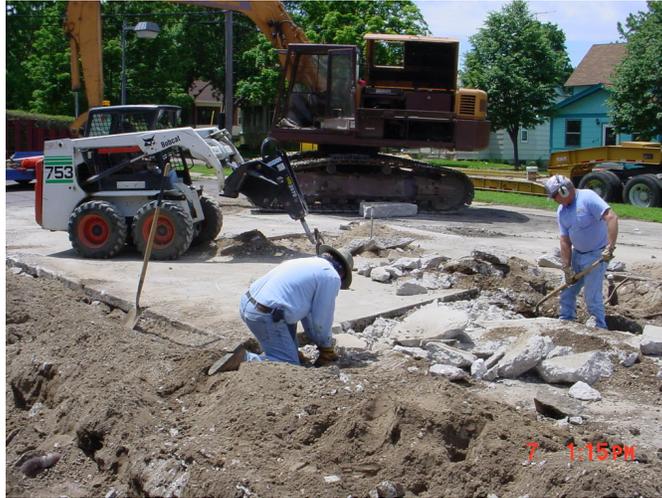
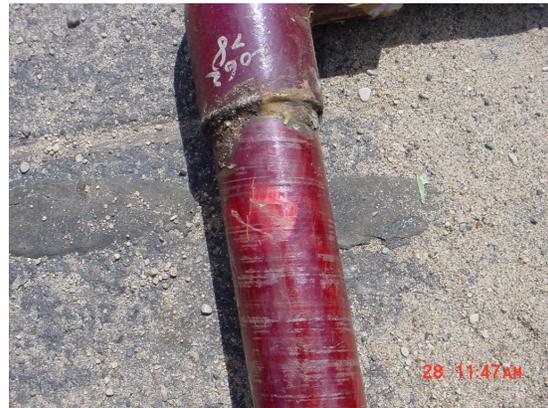
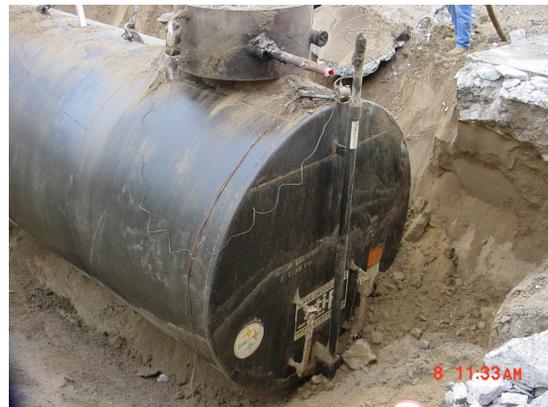
**Project Location #11  
12<sup>th</sup> Street Sinclair  
Sioux Falls, SD**

- This site had been a retail gas station since approximately 1954. The current system of three 8,000 gallon tanks was installed in 1992.
- Discrepancies noted include the mixing of piping components from different manufacturers, failure to follow recommended installation practices by component manufacturers, the use of rubber sleeves in locations where gasoline product was contained, and using inadequate slope in product return piping to containment sumps.
- No documentation (i.e., as-built drawings, maintenance, operation manuals) was available.
- Product inventory records were available but leak detection, inspection, or maintenance records were not available for the site.
- Piping for two products failed tightness testing. DENR has required that site assessment be done to determine if there are any potential pathways and impacted receptors..

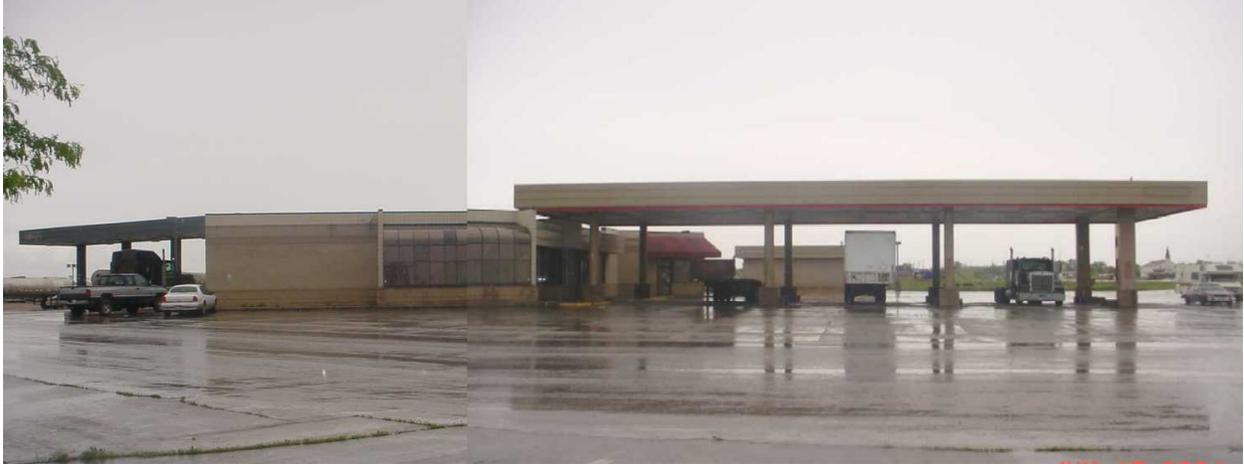
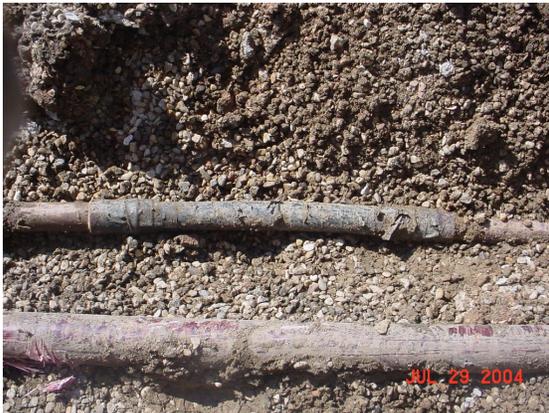
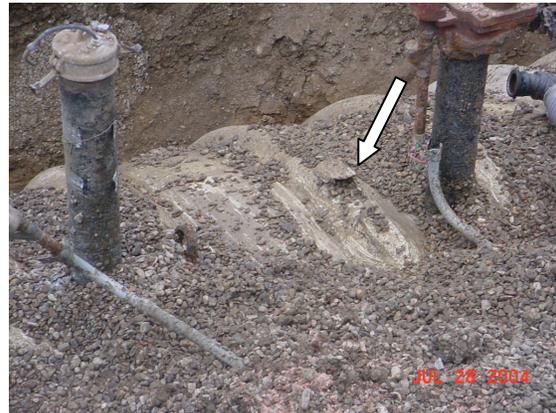
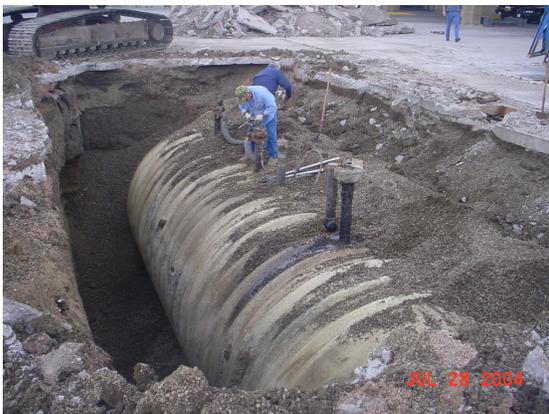
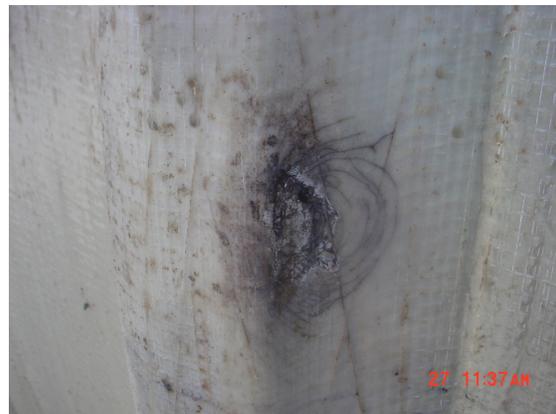
**Project Location #17**  
**Flying J Truck Stop**  
**Box Elder, SD**

- Configuration discrepancies were noted. For instance, three product lines had tape wrapped, stainless steel flexible connectors installed in straight, underground piping runs.

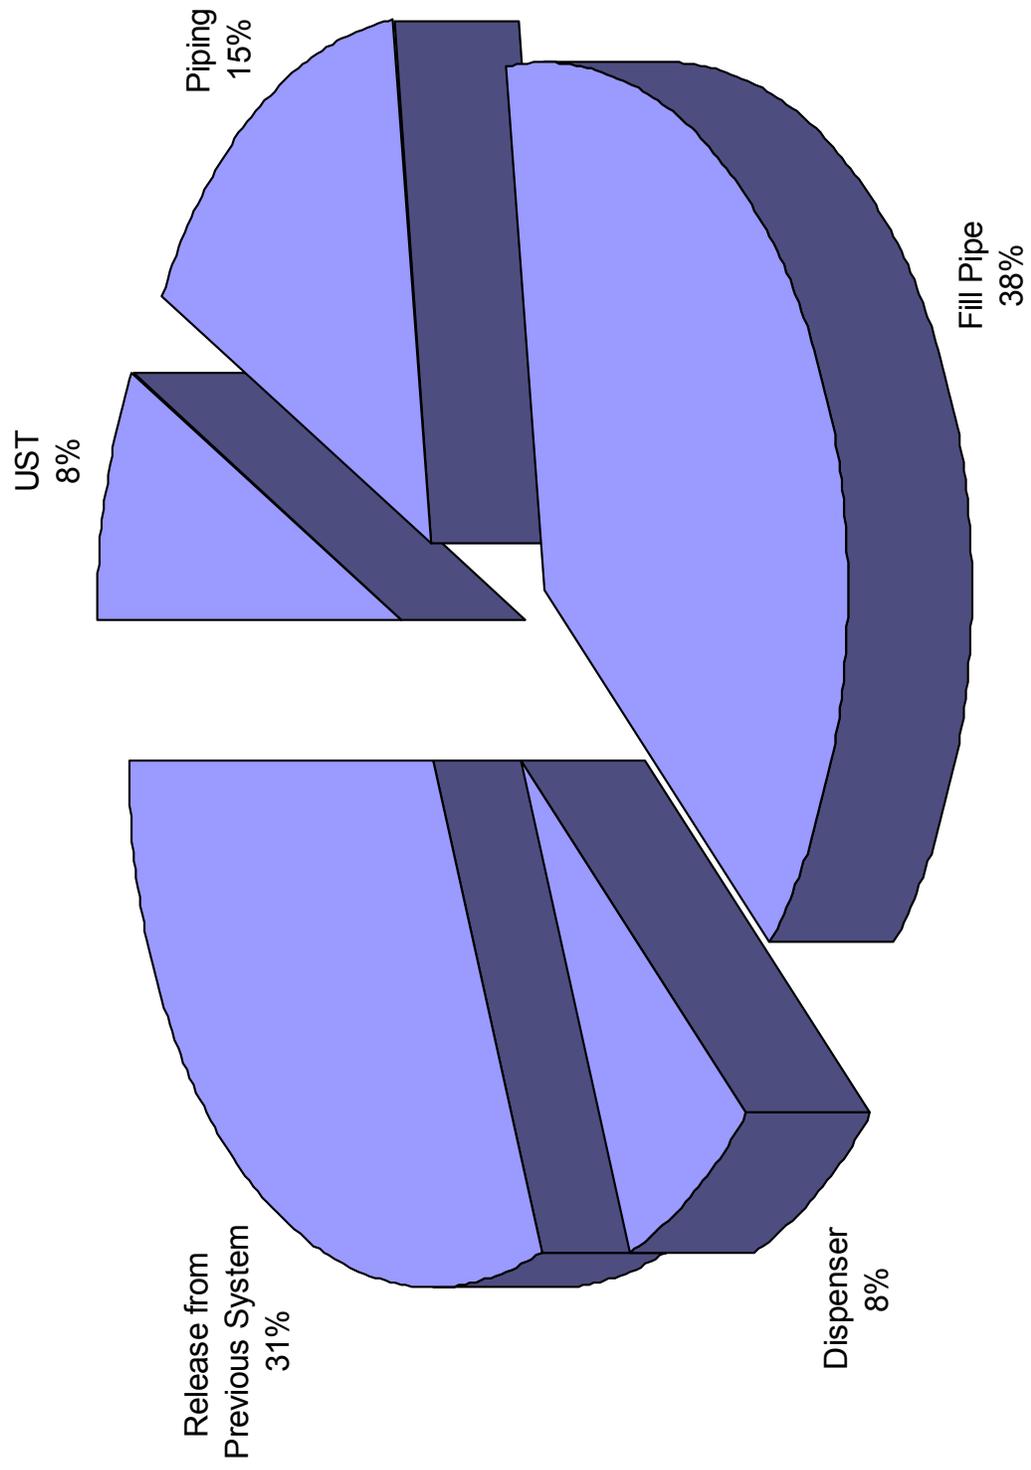
**Figure 3**  
**SOURCE OF DISCHARGE**  
South Dakota PRCF Tank Pathology Study

There were a total of 5 different sources from which contamination is believed to have originated. Majority of the releases are believed to have originated in part from the fill pipe or from a previous tank system. As previously mentioned the surface seals above the fill pipes were often damaged, or the spill containment bucket was cracked or missing.

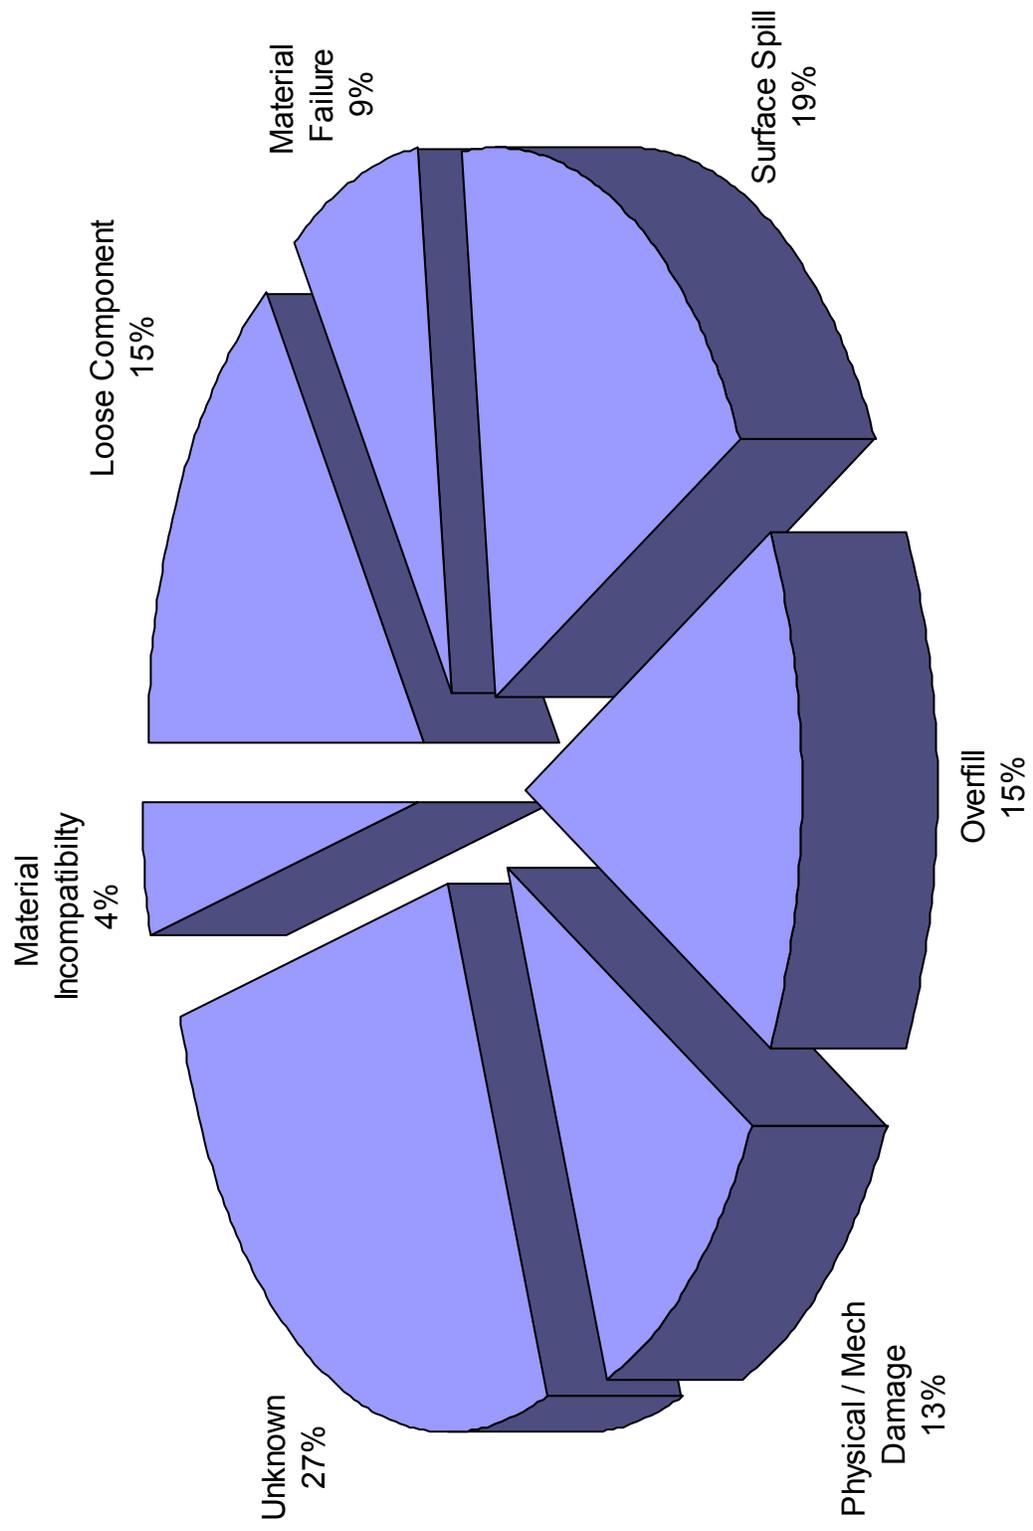
**Figure 4**  
**CAUSE OF DISCHARGE**  
South Dakota PRCF Tank Pathology Study

Of the 7 different areas where a release was found, a total of 16 different causes for the release were identified. Figure 5 summarizes the causes of discharge found during the evaluation. The causes found included loose components, material failures, surface spills, overfills, and physical and/or mechanical damage. However, there were installation errors, excessive corrosion, or material incompatibilities found, but none of these are believed to have resulted in a release of product from the fueling system.
