**LAC Minerals**  
**2014 Annual Environmental Audit and Inspection Report**

**Operator:** LAC Minerals (USA) LLC, Richmond Hill Mine  
**Project:** Annual Environmental Audit and Inspection  
**DENR Inspectors:** Mike Cepak, Eric Holm, Mark Keenihan, Roberta Hudson, Ryan Fitzpatrick, and Matt Hicks  
**Operators Present:** Todd Duex, Gene Fuller, and Mark Tieszen  
**Others Present:** Stan Michals, SD Game, Fish and Parks  
**Inspection Dates:** June 23 and 24, 2014  
**Time In/Out:** June 23, 2014: 11:20 am MDT to 12:45 pm MDT  
June 24, 2014: 10:30 am MDT to 2:30 pm MDT

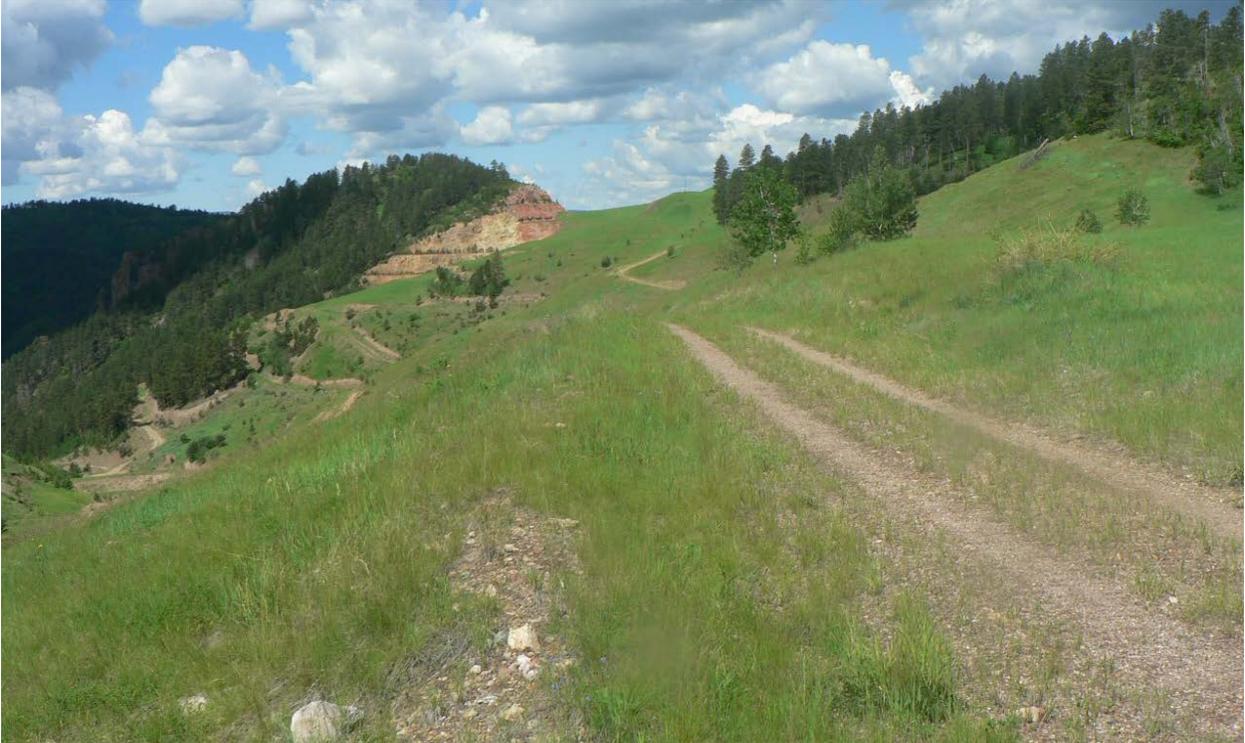
Vegetative cover in Spruce Gulch is now in its nineteenth growing season and continues to be very good to excellent. No new erosion was noted. LAC established four vegetation transects in Spruce Gulch (SG#1, SG#2, SG#3, and SG#4) and collected data in 1997, 1998, 1999, 2000, 2005, 2010, and 2013. Cedar Creek Associates also collected vegetation data in 2008. The overall average of 65 percent live cover for the monitoring period exceeds the 40 percent cover standard established for the mine site.

Average live vegetative cover in the area evaluated was estimated at 65 percent which is close to the overall average and above the 40 percent cover standard. Grasses and legumes present that are part of the approved seed mix include timothy, kentucky bluegrass, smooth brome grass, slender and western wheatgrass, hard fescue, white dutch clover, rocky mountain penstemon, and blue flax. Other species noted include black medic, goatsbeard, mushrooms, moss, and yarrow. Hard fescue and kentucky bluegrass were the dominant species. Noxious and other weeds noted include st. john's wort and houndstongue.

Photo 1. Looking west on reclamation on Spruce Gulch on old haul road.

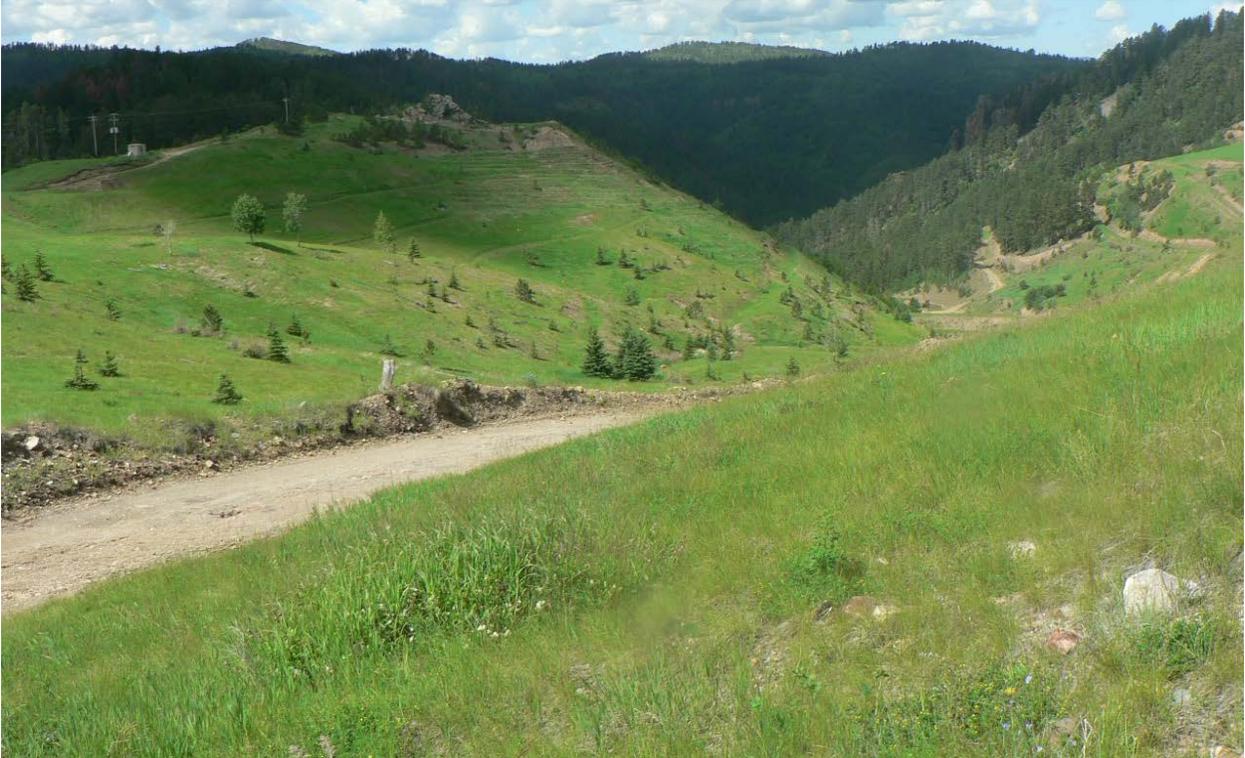
Trees and shrubs noted during the inspection include willows, ceanothus, serviceberry, aspen, birch, ponderosa pine, bur oak, black hills spruce, chokecherry, woods rose, snowberry, and oregon grape. All trees and shrubs appear to be healthy and well established. However, it appears woods rose and ceanothus were somewhat stressed from last October's blizzard. Most of the stressed shrubs appear to be recovering.

Photo 2. View to southwest from old haul road on across former waste rock facility in Spruce Gulch.

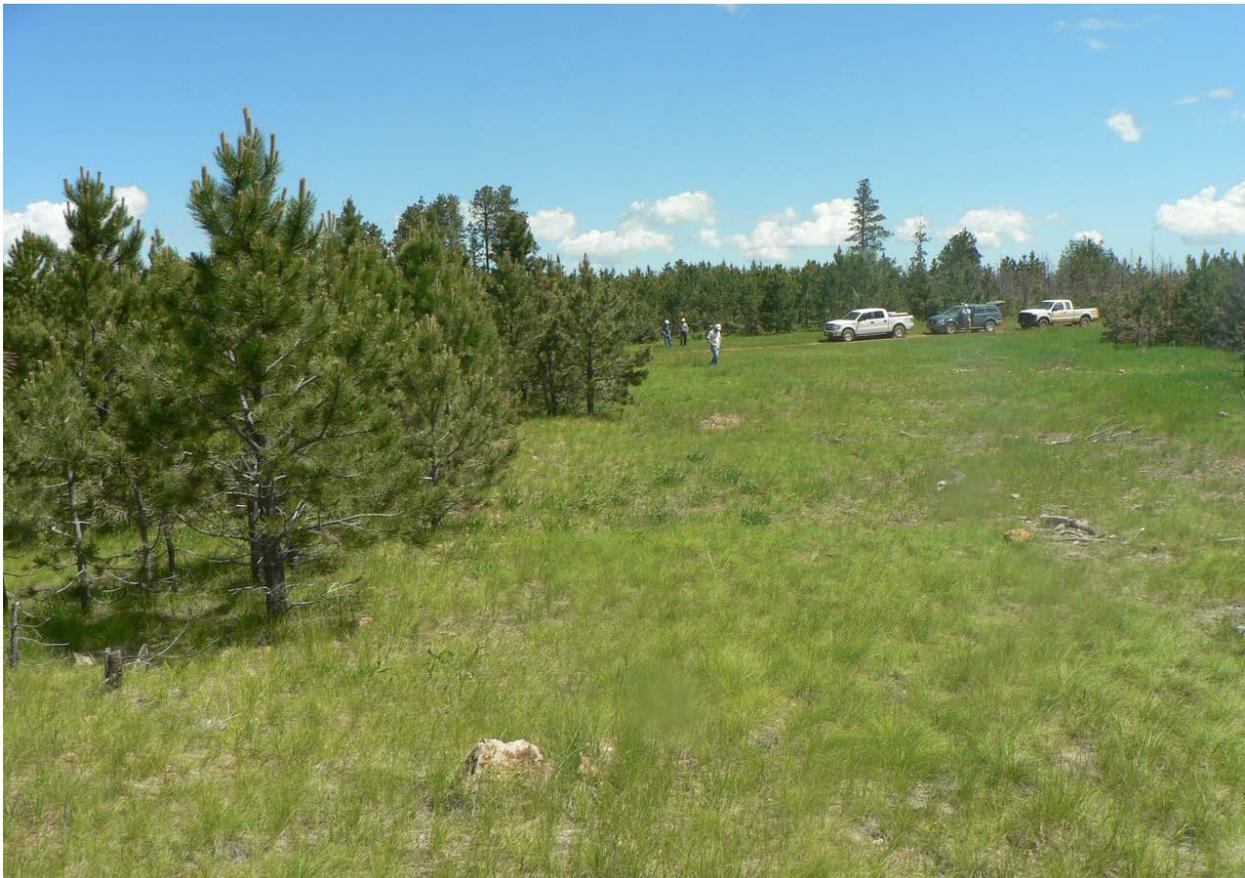
Average live vegetative cover in the area evaluated was estimated at 60 percent which is above the overall average and the 40 percent cover standard. Grasses and legumes present that are part of the approved seed mix include kentucky bluegrass, western wheatgrass, hard fescue, white dutch clover, and blue flax. Other species noted include black medic, oxeye daisy, bedstraw, moss, and yarrow. Hard fescue was the dominant species. Noxious and other weeds noted included st. johns wort.

Photo 3. Turnaround Pit Area view to north.

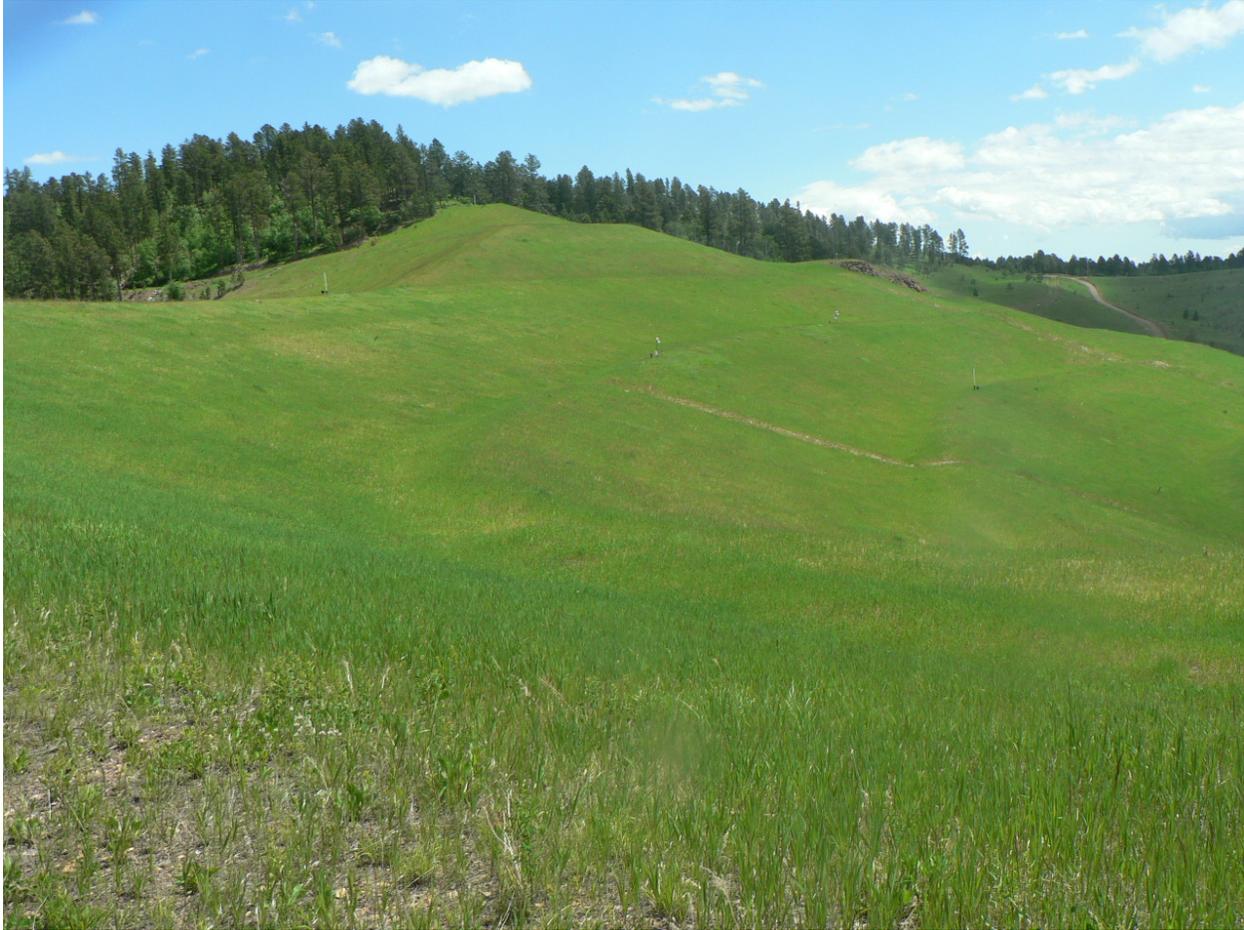
Pit Impoundment. The inspection group arrived at the top of the Pit Impoundment at 11:36 am MDT. Vegetative cover on the pit impoundment is now in its nineteenth growing season and continues to be very good to excellent. No new erosion was noted. LAC established four vegetation transects on the pit impoundment (PI#1, PI#2, PI#3, and PI#4) and collected data from 1997 through 2013. The overall live coverage average of 57 percent for the 17 year monitoring period exceeds the 40 percent cover standard established for the mine site.

Average live vegetative cover was estimated at 55 percent which is close to the overall average and above the 40 percent cover standard. Grasses and legumes present that are part of the approved seed mix include kentucky bluegrass, smooth brome, western wheatgrass, hard fescue, white dutch clover, blue flax, and rocky mountain penstemon. Other species present include black medic, goatsbeard, assorted vetches, and yarrow. Noxious and other weeds present include st. johns wort. The company needs to continue to remove pine trees from the impoundment and spray ceanothus.

Photo 5. Pit Impoundment.

1. LAC continues to do a very good job of reclamation and site-wide environmental management.
2. LAC needs to continue spraying st. john's wort, spotted knapweed, and other noxious weeds in areas covered by the mine permit.
3. LAC needs to continue removing pine trees, ceanothus, and other deep rooting vegetation from the pit impoundment and leach pad areas of the mine.

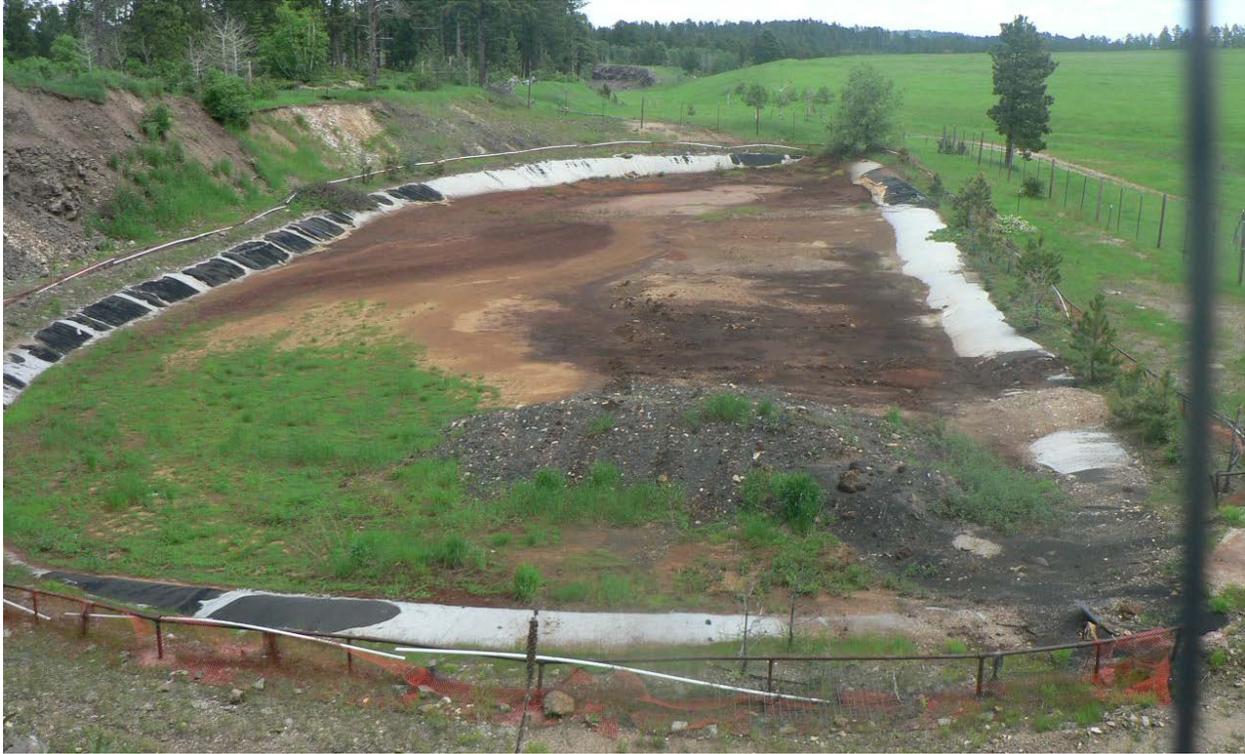
Old Sludge Pond. At 1:07 pm MDT we stopped at the Old Sludge Pond. LAC placed some spent carbon from the old Process Plant into the pond. Some grasses are growing on the sludge. LAC personnel said it is unlikely the sludge pond will be reclaimed this year. The company still plans to place a soil cover over the sludge during final reclamation.

Photo 6. Old Sludge Pond.

4. LAC will need to submit a technical revision if HDPE liner is used as part of the cover over the sludge in the old Sludge Pond during final reclamation.

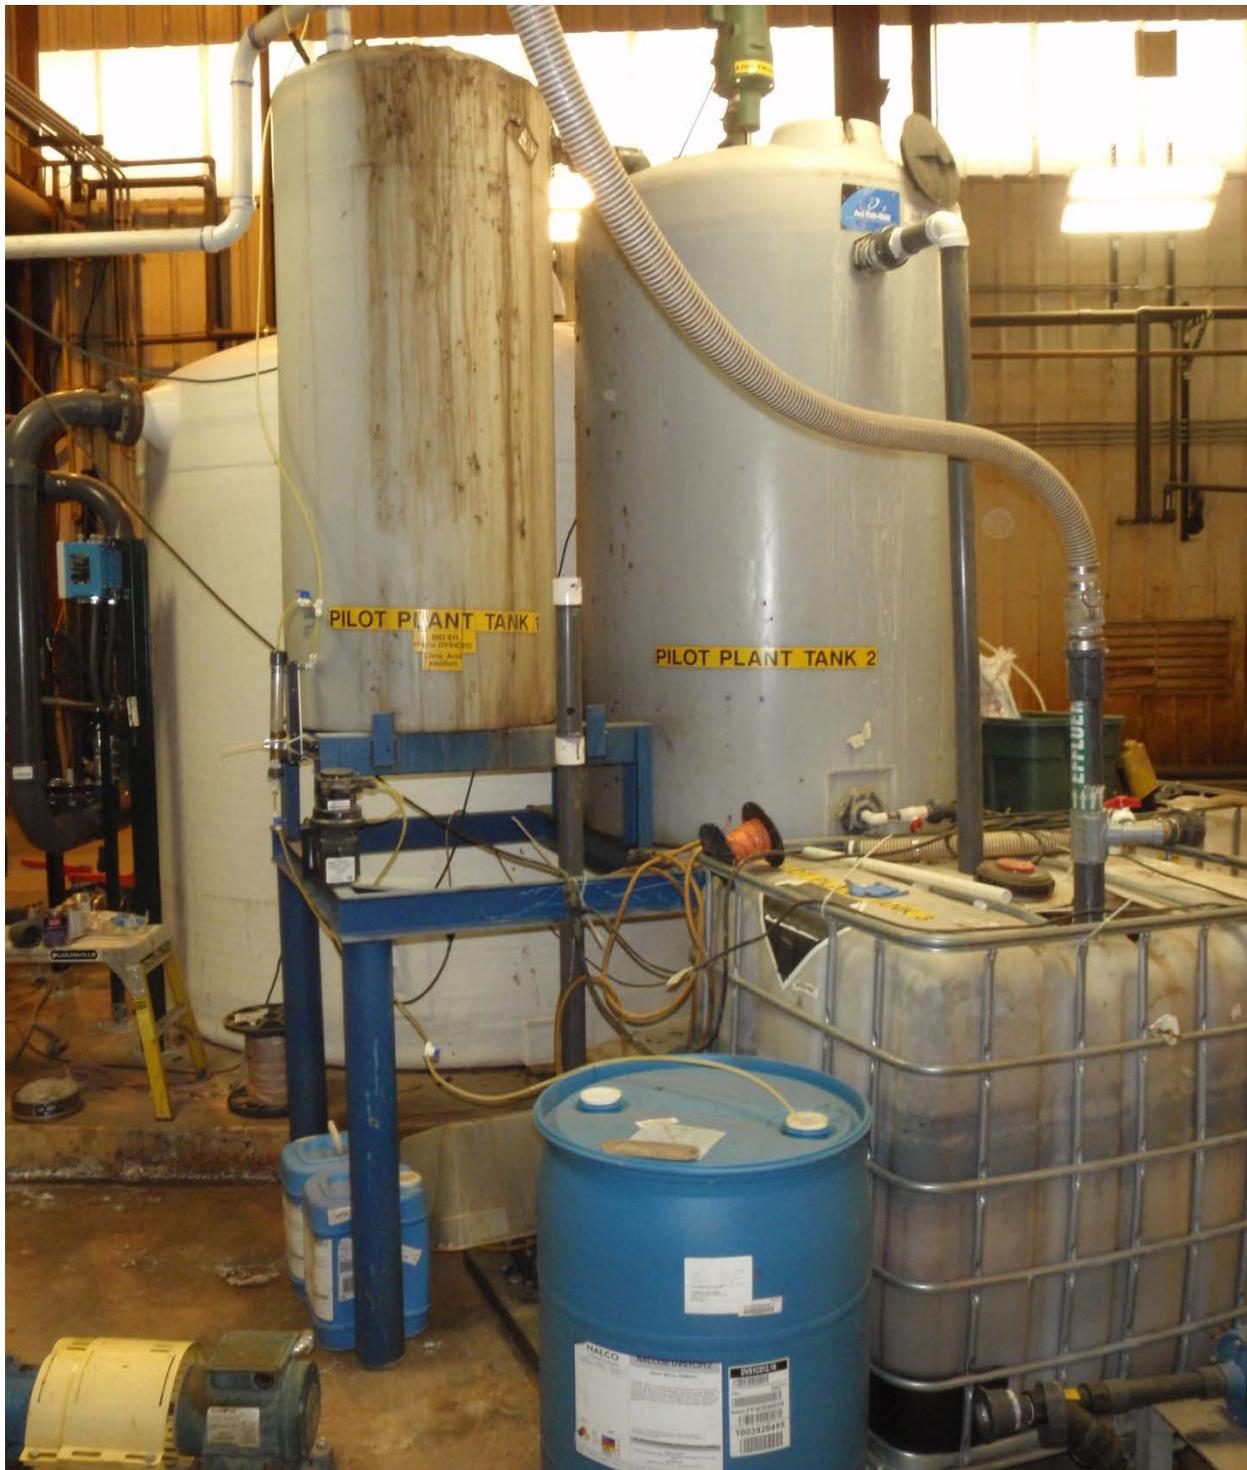
Water Treatment Plant (WTP). We entered the WTP at 1:22 pm MDT. The old carbon tanks (more recently used as water treatment tanks) have been removed. A small area near where the old carbon tanks had been located has been set up as the area where the Nalco additive will be used in assisting the removal of selenium from the water. The tanks were set up and ready for start-up. LAC personnel indicated the Nalco circuit will be up and running very soon. In the remainder of the treatment plant, parts of the main floor of the building are being remodeled, and a new lunch/meeting room (with a water treatment plant control panel), a laboratory and dry facilities have been constructed. As we left the plant, we noted the liner has been removed from the Blend Pond (old Chlorine Pond) which will be reclaimed later this year. We also noted some spotted knapweed around the Storm Water Pond which needs to be sprayed and controlled.

Photo 7. Nalco Water treatment pilot selenium removal tanks.

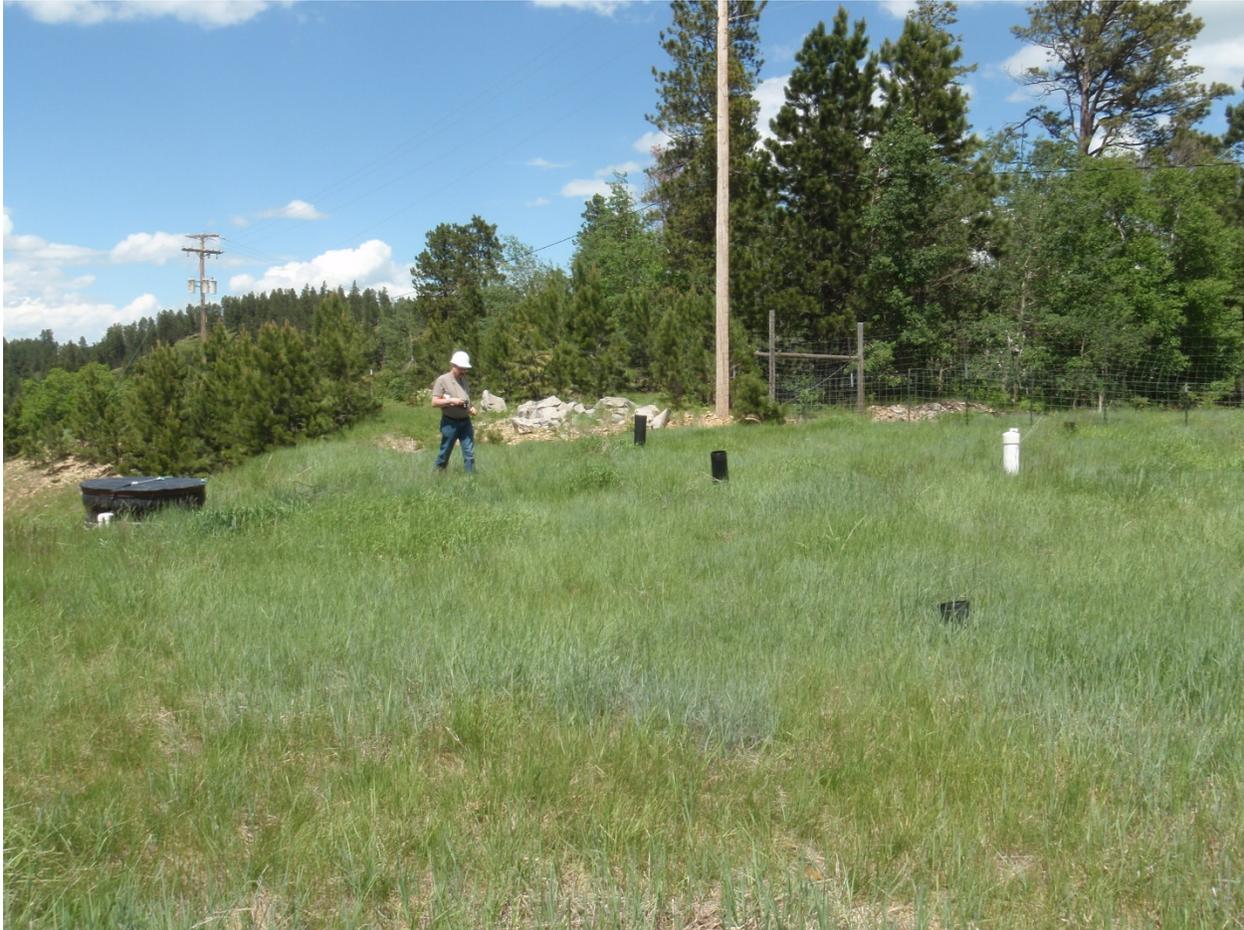
Passive Treatment Area. At 1:44 pm MDT we visited the Passive Treatment Area. Vegetative cover was excellent and meets the postmine land use criteria for wildlife habitat. The only work remaining prior to reclamation liability release was to cut off the PVC ventilation pipes and

remove distribution system piping. (NOTE: The pipes have been removed with no significant disturbance of the vegetation).

Photo 8. Selenium passive treatment circuit.

- c. Selenium Passive Treatment Cell. Todd Duex said LAC will complete reclamation of the old selenium passive treatment cell this summer. The cell is currently revegetated, but five ventilation pipes and the distribution system piping remain. LAC plans to remove the ventilation and distribution pipes by the end of summer. However, the lined spillway will remain until water treatment is no longer required in the postclosure period. At that point, the liner will be removed and the spillway will be revegetated. (NOTE: On November 3, 2014, LAC Minerals stated the removal of the pipes had been completed with no significant disturbance of the vegetation).

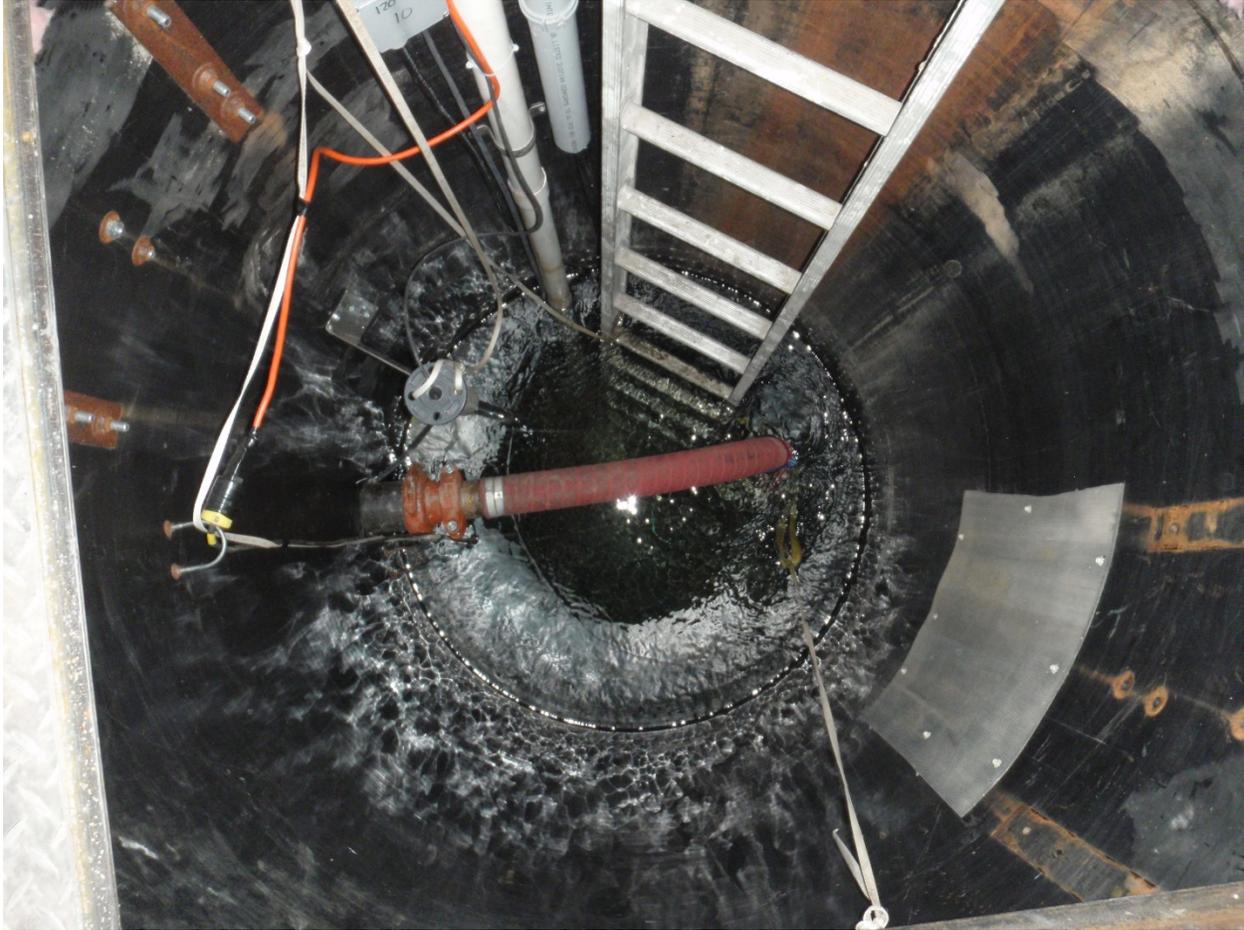
FD-1. We stopped by the FD-1 area at 1:51 pm MDT. A construction crew was at the FD-1 site and was in the process of finishing concrete on a manhole for a valve. Water from FD-1 flows into the FD-1 sump. The water then flows out of the sump top and is discharged to Outfall 004 and Rubicon Gulch, or it can be pumped from the sump to the water treatment plant feed pond if necessary. The FD-1 water sample point was moved to the area where the FD-1 sump normally discharges.

Photo 9. Sump at FD-1.
