OPERATOR: Wharf Resources (USA), Inc.
PERMIT NUMBER: Pending (Expansion Project Permit Application)
INSPECTION TYPE: Pre-Inspection and Meeting
DATE: June 29 and 30, 2011
TIME IN/OUT: June 29: 8:10 am to Noon MDT - Meeting
12:50 pm to 4:25 pm MDT – Inspection
June 30: 8:15 am to 3:20 pm MDT – Inspection
July 19: 10:00 am to 3:30 pm MDT – Water Sampling
July 20: 8:00 am to 8:20 am MDT – Water Sampling
July 21: 8:00 am to 11:30 pm MDT – Water Sampling
DENR INSPECTORS: Eric Holm, Roberta Hudson, Mike Lees, Mark Keenihan, Matt Hicks, Janile Lewis, Jon Epp, and Doug Baldwin
OTHER INSPECTORS: Stan Michals, Game, Fish, and Parks
ACCOMPANIED BY: Bill Shand, Ken Nelson, Ron Waterland, and Lynne Blackman (Wharf Resources)

In accordance with SDCL 45-6B-20, a pre-inspection of Wharf’s proposed mine expansion area was conducted as part of the annual mine permit for Wharf’s existing mining operation on June 29 and 30, 2011. The legal location of the proposed mine expansion is portions of Sections 1, 2, 3, and 12; T4N-R2E, Sections 6 and 7; T4N-R3E, and Sections 33 and 36; T5N-R2E, Lawrence County. The pre-inspection meeting and inspection was conducted on June 29 and 30, 2011 by the above menti

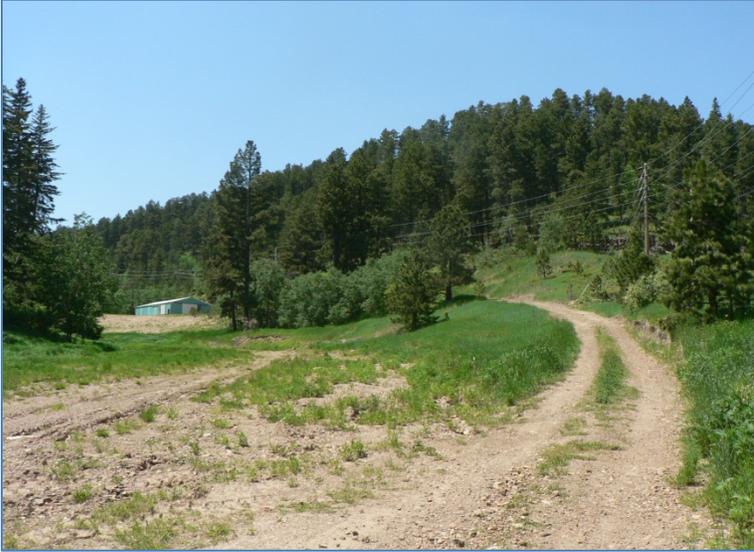
Photo 1 – Current access road from parking lot.

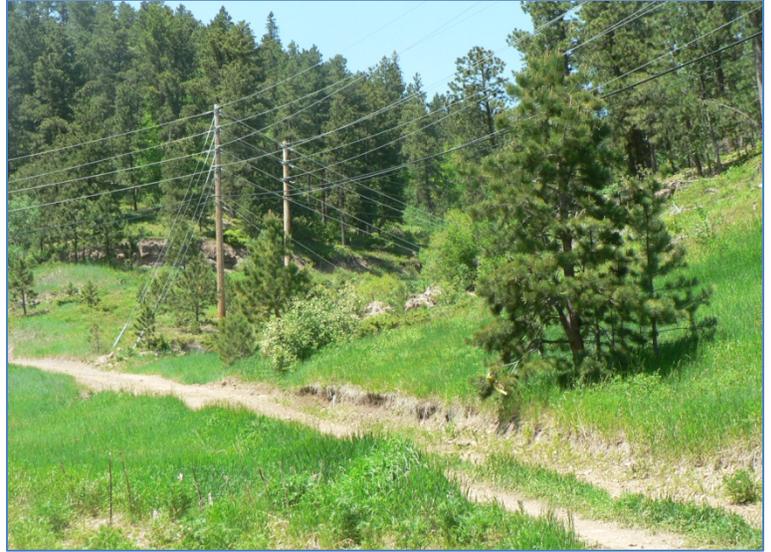
Wharf also pointed the route of the relocated portion of Highway 473 (Photo 2). The highway will be rerouted along a slope on the north side of the gulch about half way down the slope. The rerouted highway will be constructed over the haul road tunnel. Several utility lines will need to be moved during construction of the rerouted highway and haul road.

Photo 2 – New highway and tunnel in middle of photo.

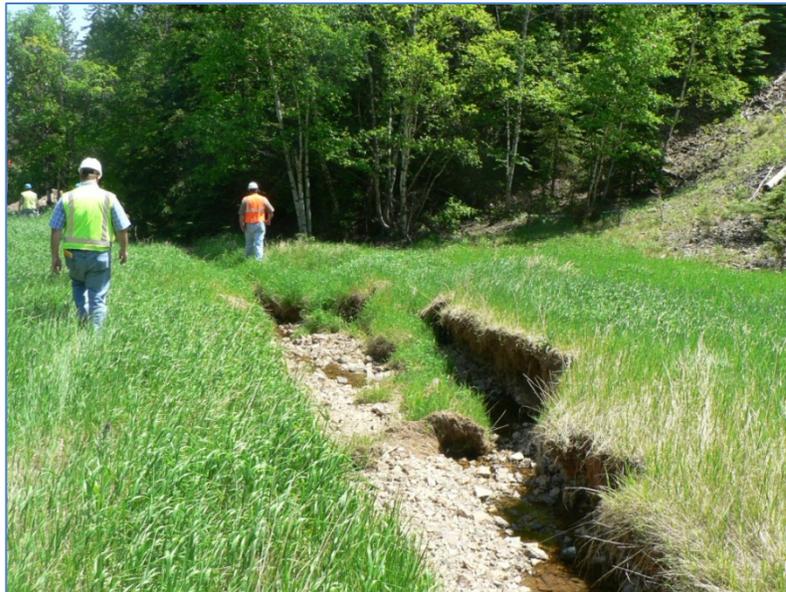
Photo 3 – Nevada Gulch Creek channel.

The department asked Wharf about the Nevada Gulch Creek drainage in this area. Wharf personnel said the creek starts at the lower end of the Blue Chair parking lot as unconfined flow is routed under the parking lot. The unconfined flow is routed through a culvert into the existing drainage below the parking lot. The flow in the creek is seasonal as it flows only during spring runoff and thunderstorms. Any runoff from the ski area disappears at the Horseshoe well and reappears as a seep in the parking lot.

The department said topographic maps show the creek begins further to the north and west of the parking lot. After walking around the area, department personnel found the Nevada Gulch Creek channel upstream from the parking lot to the south of the existing gravel road (Photo 3). The creek was flowing at the time of the inspection. No riparian vegetation was noted along the creek in this area. A portion of the original creek channel apparently was covered during construction of the ski area parking lot as the channel disappeared at the edge of the parking lot and flowed under the lot in several areas until it reappeared at the spot where Wharf said the creek started. The department told Wharf the entire Nevada Creek drainage needs to be shown on the maps in the mine permit application.

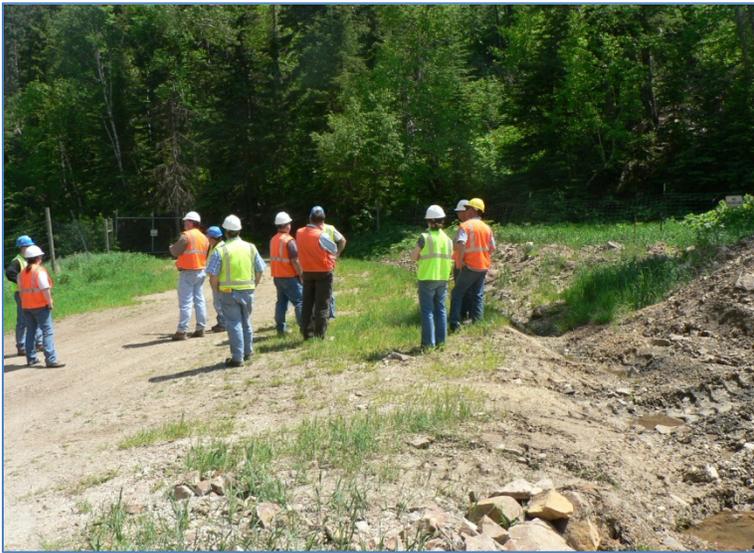
We then discussed sediment control along the new haul road. Wharf plans to construct drainage ditches on both sides of the haul road and install a series of sediment traps in the ditches. The goal is to keep any drainage from the haul road away from Nevada Gulch Creek. There are no plans to divert the creek. However, culverts will be placed in areas where the haul road crosses the creek. Any existing culverts will be replaced. A sediment pond will also be constructed just to the southeast of the parking lot near well SM-01A. We looked at the area where the pond will be constructed (Photo 4). Department staff has some concerns over the limited area where the pond will be constructed and whether it would be large enough to contain runoff from the haul road. Wharf will be required to provide plans and specs for the sediment pond for department approval prior to construction.

Photo 4 – Proposed haul road sediment pond.

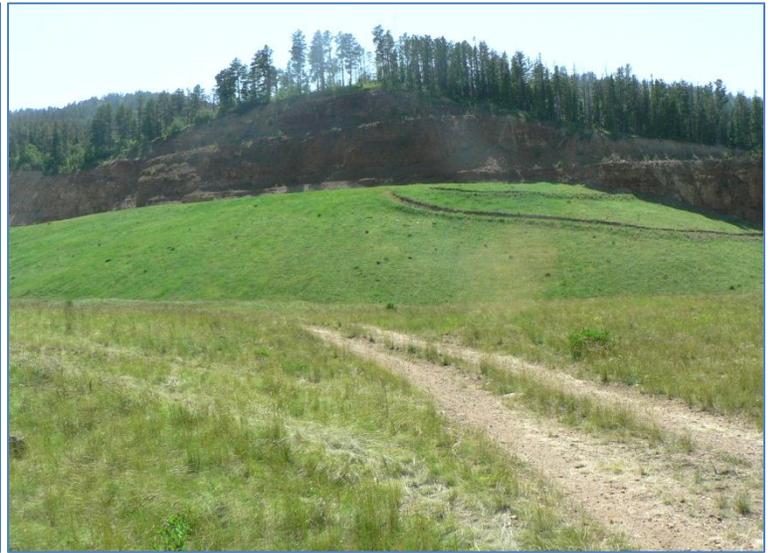
Photo 5 – Current Harmony Pit Highwall.

We then proceeded to the Golden Reward mine. After resuming inspections of various areas related to the mine permit audit, we arrived at the Harmony Pit highwall at 3:29 pm MDT to continue the pre-inspection of the expansion area. The Harmony highwall will be part of the Golden Reward Pit that will be mined during Phase 3 of the expansion project (Photo 5). Wharf is currently conducting exploration drilling along the Harmony highwall. During mining, the highwall will be removed as mining proceeds to the base of the Terry Peak Red Chair Lift. The highwall is basically all ore. During final reclamation, this area will be backfilled with the final

slope at 15 to 8 percent grade (down slope). The area will be regraded to tie into the ski area. The existing ski runs will be extended down this slope.

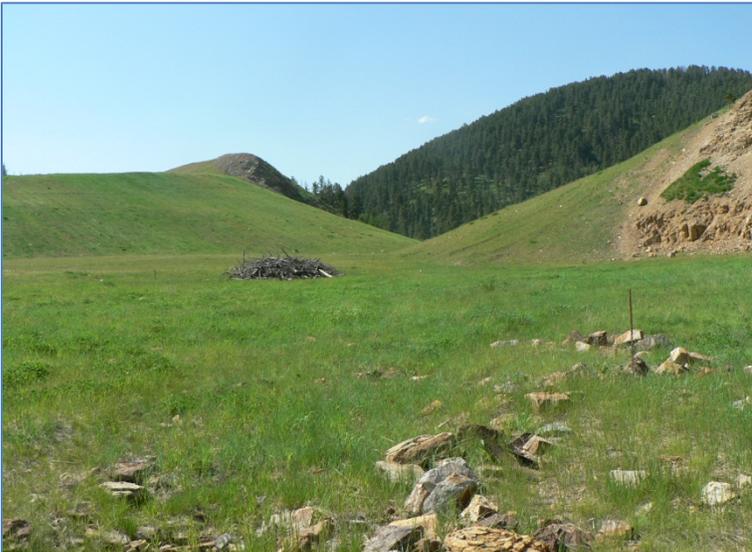
Photo 6– Proposed pit area near highwall.

In addition, we discussed the proposed pit near the southwestern corner of the Terry Cemetery (Photo 6). There is currently a remaining highwall form the previous Golden Reward Mine along the southern end of the cemetery. The department asked if there would be any stability issues with the highwall or cemetery since the pit is approximately 200 feet from the highwall. Wharf personnel said past studies show the highwall is stable and they do not expect mining activities to affect the stability of either the highwall or the cemetery. Wharf will monitor the stability of the highwall and cemetery during mining and will mitigate any stability problems should they arise as stated during the meeting. We asked if Wharf was considering buttressing

the highwall with backfill after mining. Since the highwall is stable, Wharf is not planning to do any buttressing. However, it will be backfilling the highwall just to the south of the Fantail drainage and south of the cemetery during final reclamation of the pit.

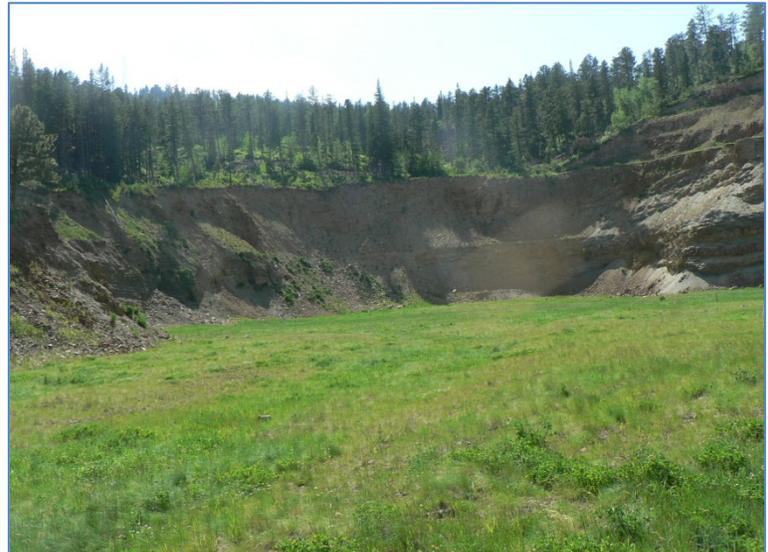
Photo 7 – Current Liberty Pit Highwall.

After we went to the area where the original Fantail drainage from the ski area meets the reconstructed drainage, we then proceeded to the Liberty Pit. The Liberty Pit will be part of the Golden Reward Pit that will be mined during Phase 3 of the expansion project. During mining, the existing highwall will be laid back to a 3:1 (H:V) slope (Photo 7). The current lined area in the Liberty Pit will be extended so it goes under the reclaimed slope to help prevent leakage at the liner/slope intersection. Wharf is looking at putting an additional ski run in this area after final reclamation.

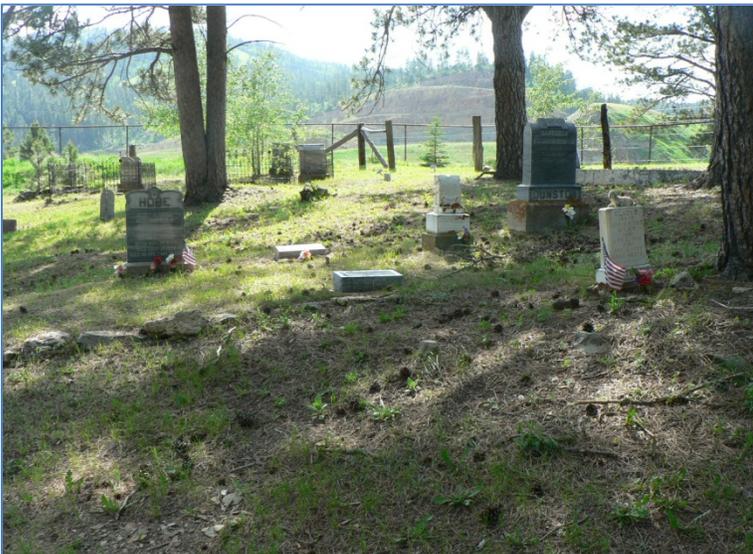
The final stop on the inspection for the day was the Terry Cemetery. We arrived at 4:11 pm MDT. The cemetery was placed on the Preliminary List of Special, Exceptional, Critical or Unique Lands during the department's special lands determination earlier this year. Wharf has no plans to mine the cemetery or the ridge to the east at this time. However, Wharf will be required to ensure that any impacts to the cemetery during mining such as blasting and subsidence are prevented. We took some general photographs of the cemetery (Photos 8 and 9). There is a berm and fence between the cemetery and the south highwall.

Photo 8 – Terry Cemetery looking southeast.

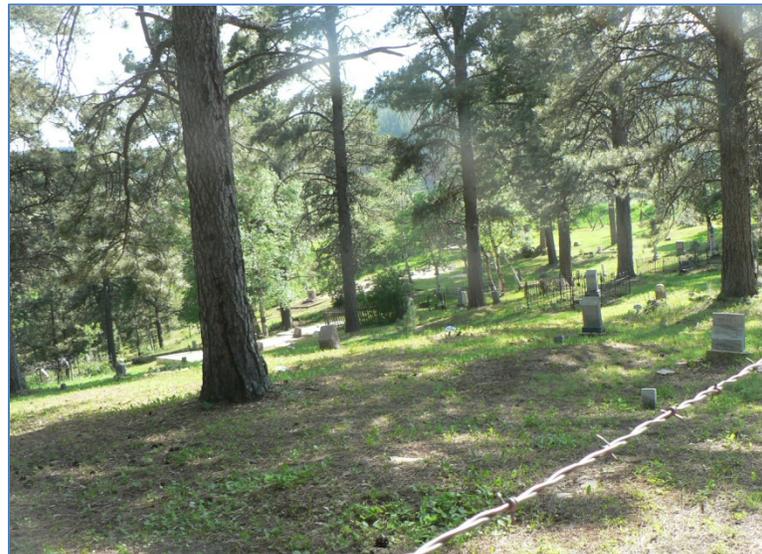
Photo 9 – Terry Cemetery looking east.

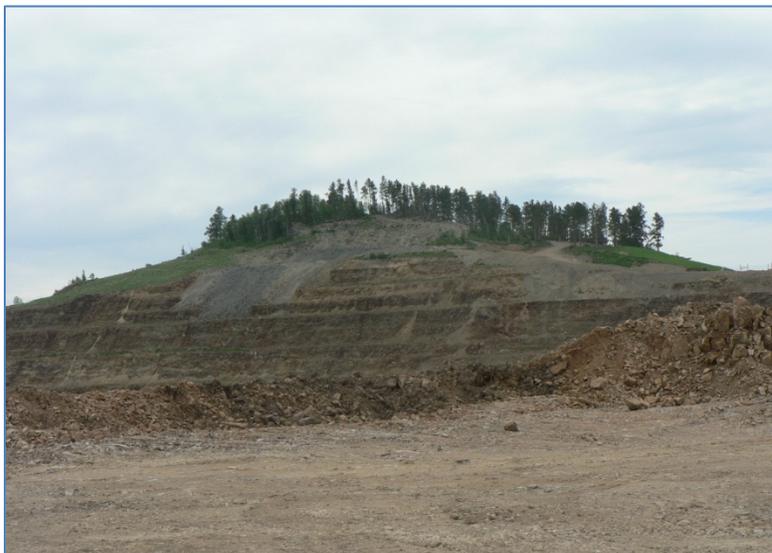
Photo 10 – View of Green Mountain from Trojan Pit.

The inspection resumed at 8:15 am MDT. We met at the Wharf Mine office before proceeding to the American Eagle Pit as part of the audit inspection. We then resumed the pre-inspection of the expansion area by walking over to the proposed Green Mountain Pit (Photo 10). We arrived at 8:58 am MDT. The Green Mountain Pit will be mined during Phases 1, 2, and 3 of the expansion project. The pit will be mined to a final elevation of 5,720 feet. During final

reclamation, the pit will be totally backfilled with no remaining highwalls. Wharf plans to move power and other utilities in the area prior to mining.

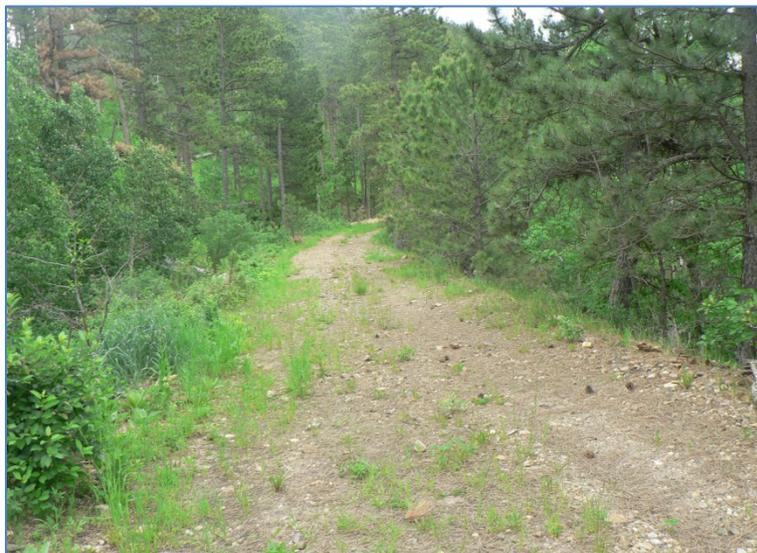
We walked along the old Fremont, Elkhorn, and Missouri Valley railroad grade that was determined to be eligible for the National Register of Historic Places in the cultural survey in the mine permit application (Photo 11). Mike Fosha of the State Archaeological Research Center asked Wharf to collect additional data and photos of the railroad grade. After Wharf submitted the additional information to Mr. Fosha, he was satisfied and told Wharf they could disturb the railroad grade with the standard conditions on artifact and bone found during mining. Wharf said the haul road would be constructed over a portion of the railroad grade.

Photo 11 – Old railroad grade.

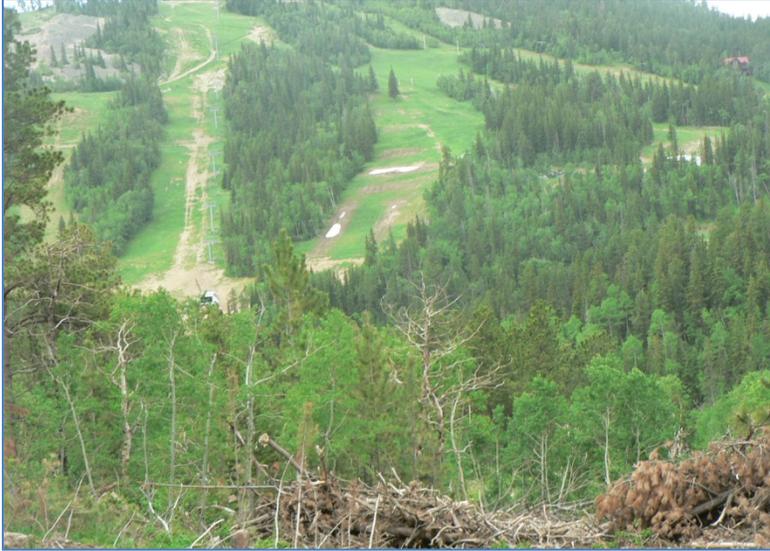
Photo 12 – View of Terry Peak from Green Mountain

We then walked south on the railroad grade toward Highway 473 and the Terry Peak ski area. Portions of the Green Mountain Pit will be visible from the ski area during mining (Photo 12). Wharf showed the route of the haul road in this area (Photo 13). As mining progresses and the elevation drops to the level of the exiting highway, the haul road will be extended into the pit and will tie in with the portion of the haul road from the Golden Reward Mine.

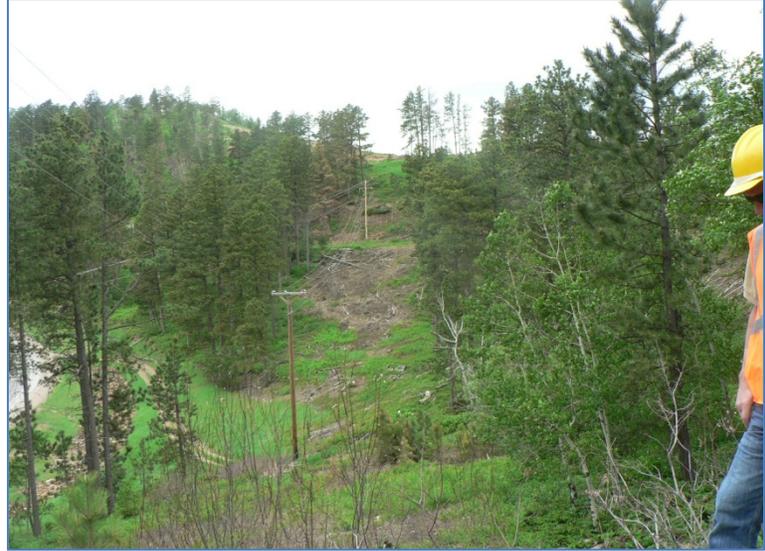
Photo 13 – Location of proposed haul road.

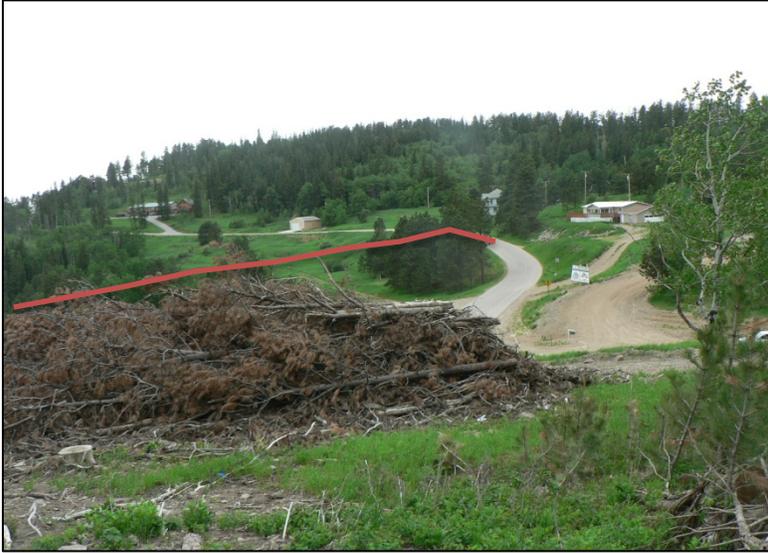
As we walked back across Green Mountain, we discussed the reroute of Highway 473 and access to residential areas and the Richmond Hill Mine located north of the Wharf Mine. The new highway will tie into the paved road to the Lost Camp development by the bed and breakfast (Photo 14). The existing access road from the bed and breakfast into the Wharf Mine will be used until 2017 when it will be rerouted over backfilled portions of Green Mountain.

Photo 14 – Red line shows path of new highway.

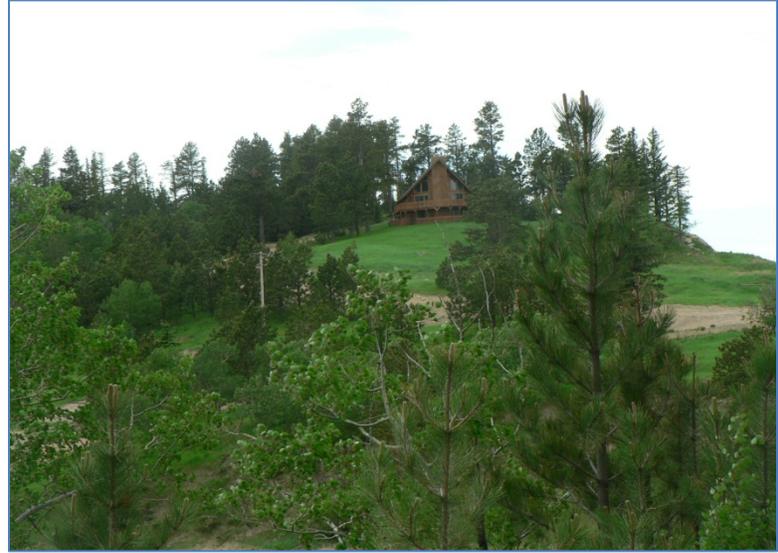
Photo 15 – A-frame home.

The department asked about the Terry Fire Department garage and two houses to the north of the bed and breakfast that will be close to the Green Mountain Pit. The Terry Fire Department garage will remain and will be used by the fire department. The two houses are owned by Wharf. One house is currently vacant and the other house will be vacant in the next year. Once mining ends, Wharf will sell the houses. The department also asked about the A-frame home where Mine Manager Bill Shand lived (Photo 15). Wharf said the home is now vacant and may be sold at auction and removed from the area by the buyer.

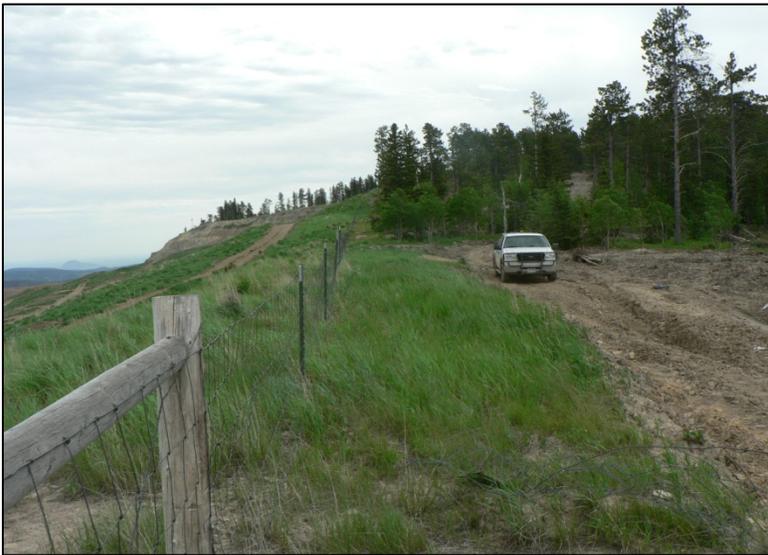
We then proceeded to the proposed Portland Ridgeline Pit (Photo 16). We arrived at 10:00 am MDT. Wharf conducted recent exploration on the reclaimed Portland Pit backfill. The exploration trails will be seeded this year.

Photo 16 – Proposed Portland Ridgeline Pit.

The Portland Ridgeline Pit will be the only pit within the proposed expansion area backfilled with spent ore. Since this pit will be mined during the fourth and final phase of the project, there will be no waste rock to backfill the pit. As a result, about 10 million tons of spent ore from the leach pads will be used to backfill the pit. Two small highwalls will remain after backfilling along the southern portion of the pit, one 400 feet long by 30 feet high and the other 500 feet long by 20 feet high.

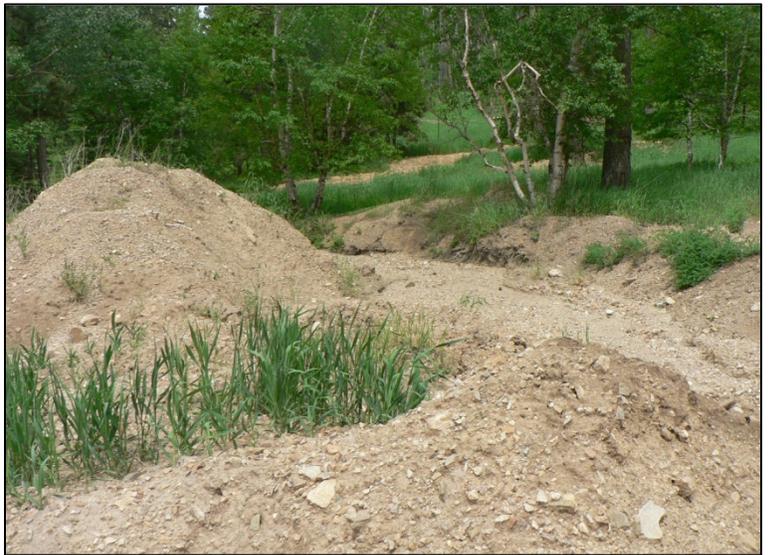
Photo 17 – Expansion area north of Pad 4.

After we left the Portland Ridgeline area, we resumed the permit audit inspection and took a short lunch break. After lunch, we proceeded to the expansion area north of Pad 4 and arrived at 12:54 pm MDT. There are currently sediment control structures in this area for the Pad 4 and the office area that need to be cleaned out (Photo 17). Wharf is planning to construct a parking area, new access road to the Process area, and possibly a new warehouse. Wharf said the new access road will be an improvement in that it will be able to easily handle two-way traffic, including liquid cyanide and other delivery trucks. It will also allow Wharf to better control sediment in the process and office areas.

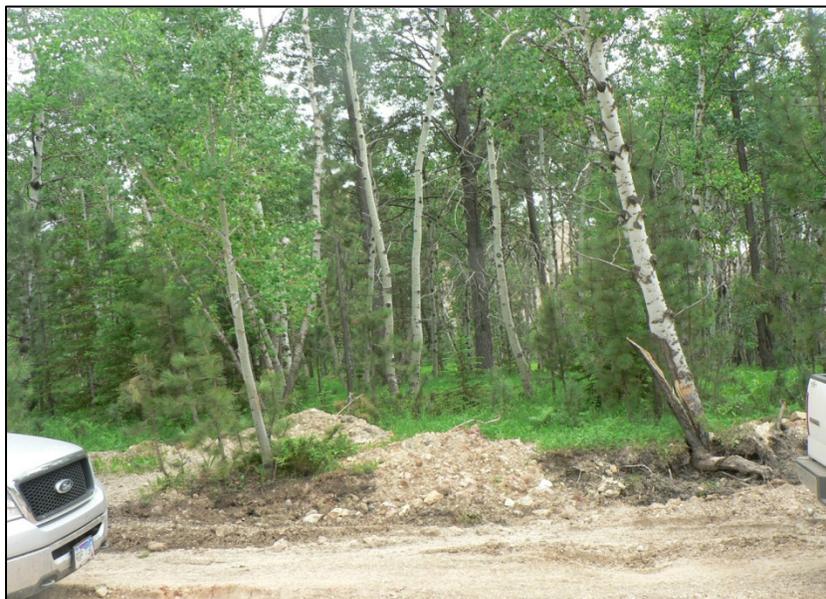
Photo 18 – Expansion area north of Pad 4.

After inspecting the process area as part of the permit audit, we completed the pre-inspection of the expansion area by going to the northern end of the area north of pad 4 (Photo 18). Wharf installed Well PW-2 in this area last year as a potable water source for the mine (Photo 19). The well has been enclosed with a fence. Wharf personnel showed us the route of the new access road.
