**WOODRUFF LAKE,
HUGHES COUNTY**

**BEDASHOSHA LAKE,
BUFFALO COUNTY,**

JANUARY 2009

**South Dakota
Department of Environment and Natural Resources
Division of Environmental Services
Pierre, South Dakota**

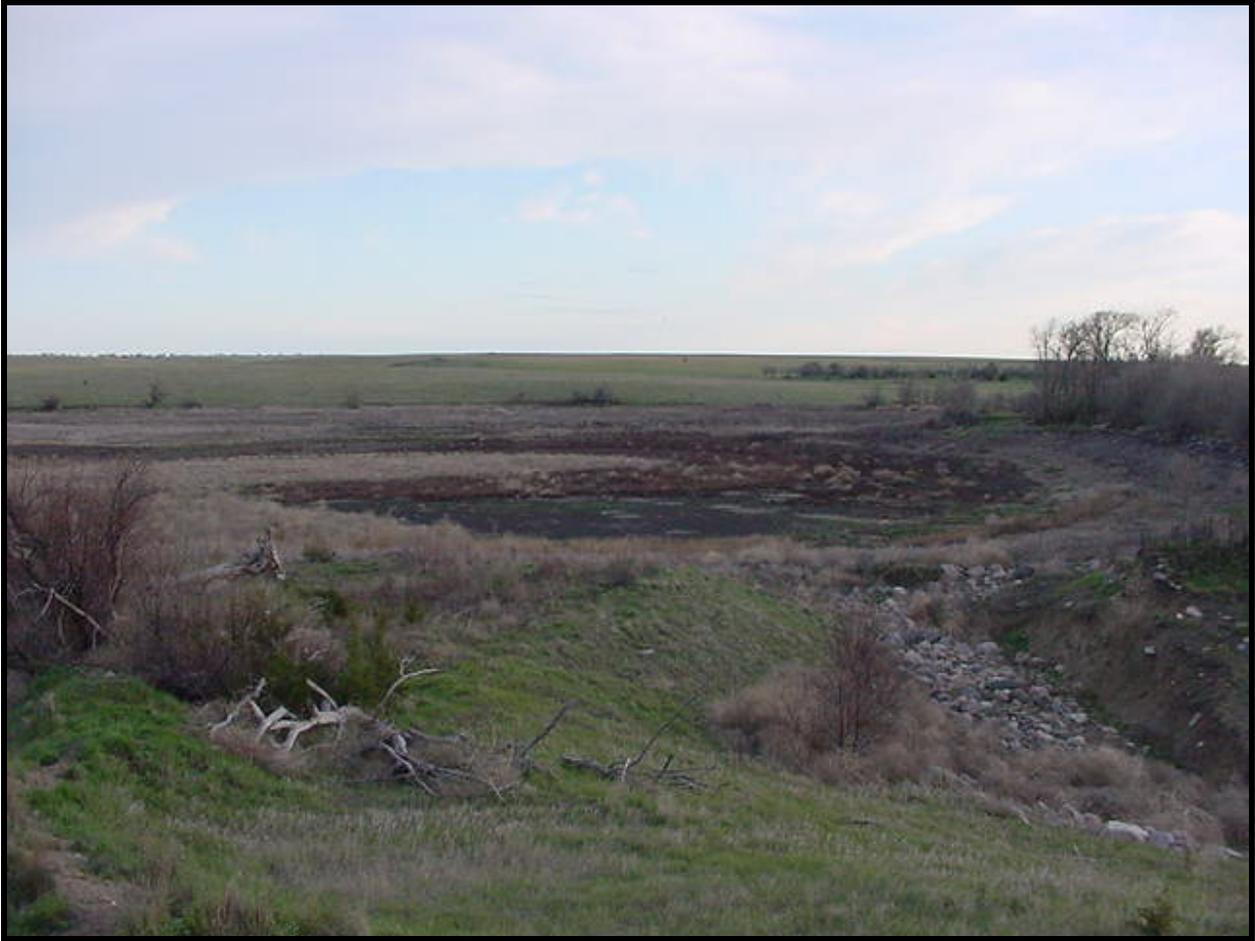
ATTACHMENT 3

Woodruff Lake near breached overflow structure.

This photograph was taken April 25, 2007. The photographer was standing on the north side of the lake near the breached holding structure facing southwest.

Woodruff Lake was a man-made reservoir constructed on South Fork Medicine Knoll Creek southwest of Harrold, SD. In March 1997, an abundance of spring melt water flowing over the spillway caused the spillway to fail. Concrete material and debris were removed from the area after the breach. Earth fill was not removed but is expected to naturally weather and degrade overtime. As a result, South Fork Medicine Knoll Creek still occasionally ponds in the lake bed and is still capable of holding small quantities of water. Woodruff Lake is not capable of supporting fishery or immersion recreation uses due to the reservoir breach and low quantity or absence of water. South Dakota Department of Game, Fish, & Parks (GF&P) plans to manage the lake basin as a waterfowl production area (personal communication with John Lott, GF&P).

DENR personnel visited Woodruff Lake in April 2007. The lake basin was completely dry and South Fork Medicine Creek was not flowing. South Fork Medicine Creek has the beneficial uses (6) Warmwater marginal fish life propagation waters and (8) Limited contact recreation waters. In removing Woodruff Lake from Chapter 74:51:02, the water body will still be protected by the beneficial use classifications of South Fork Medicine Knoll Creek. Attachment 1 is a site map; Attachments 3 and 4 are photographs of Woodruff Lake.

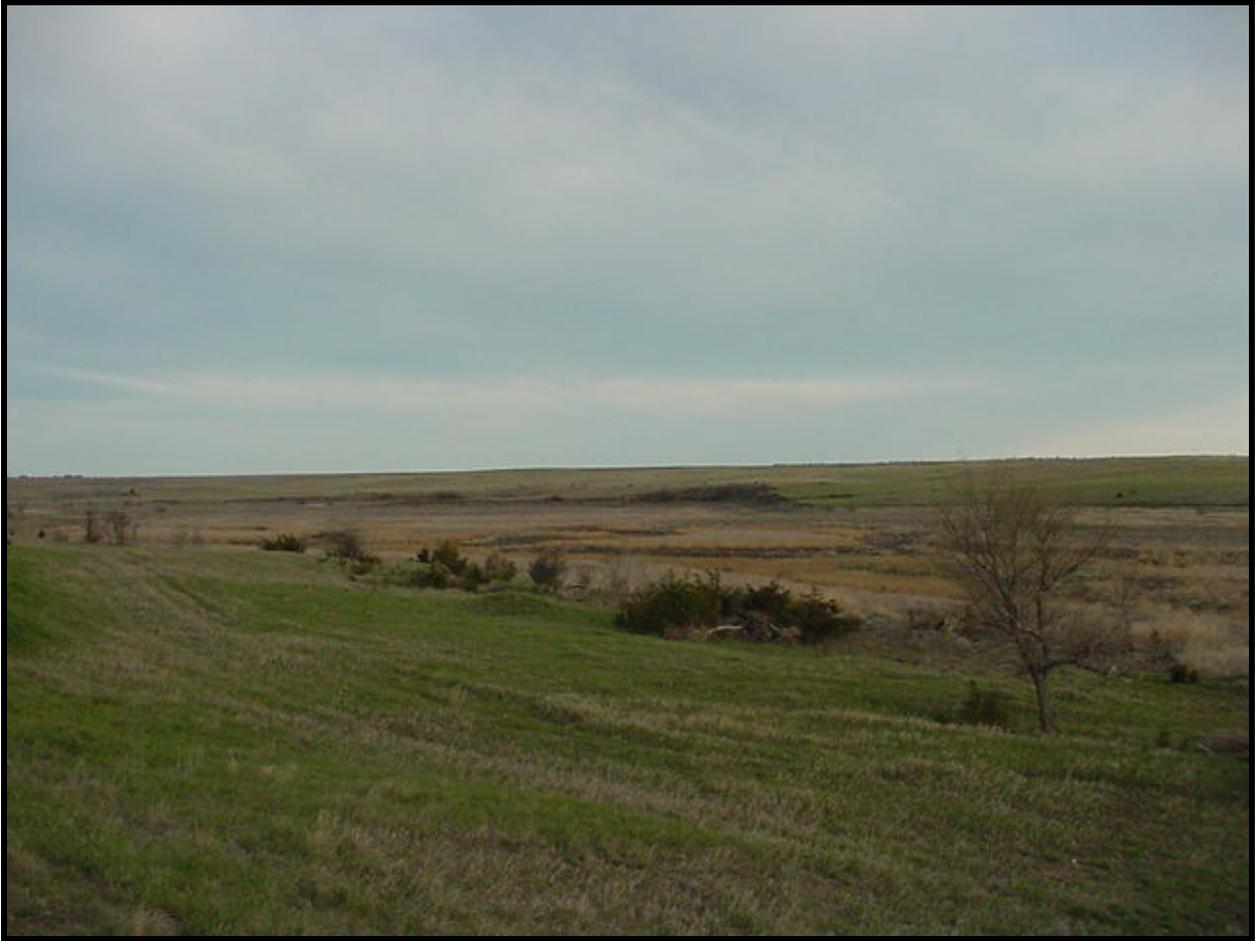
ATTACHMENT 4

Woodruff Lake.

This photograph was taken April 25, 2007. The photographer was standing on the north side of the lake facing south.

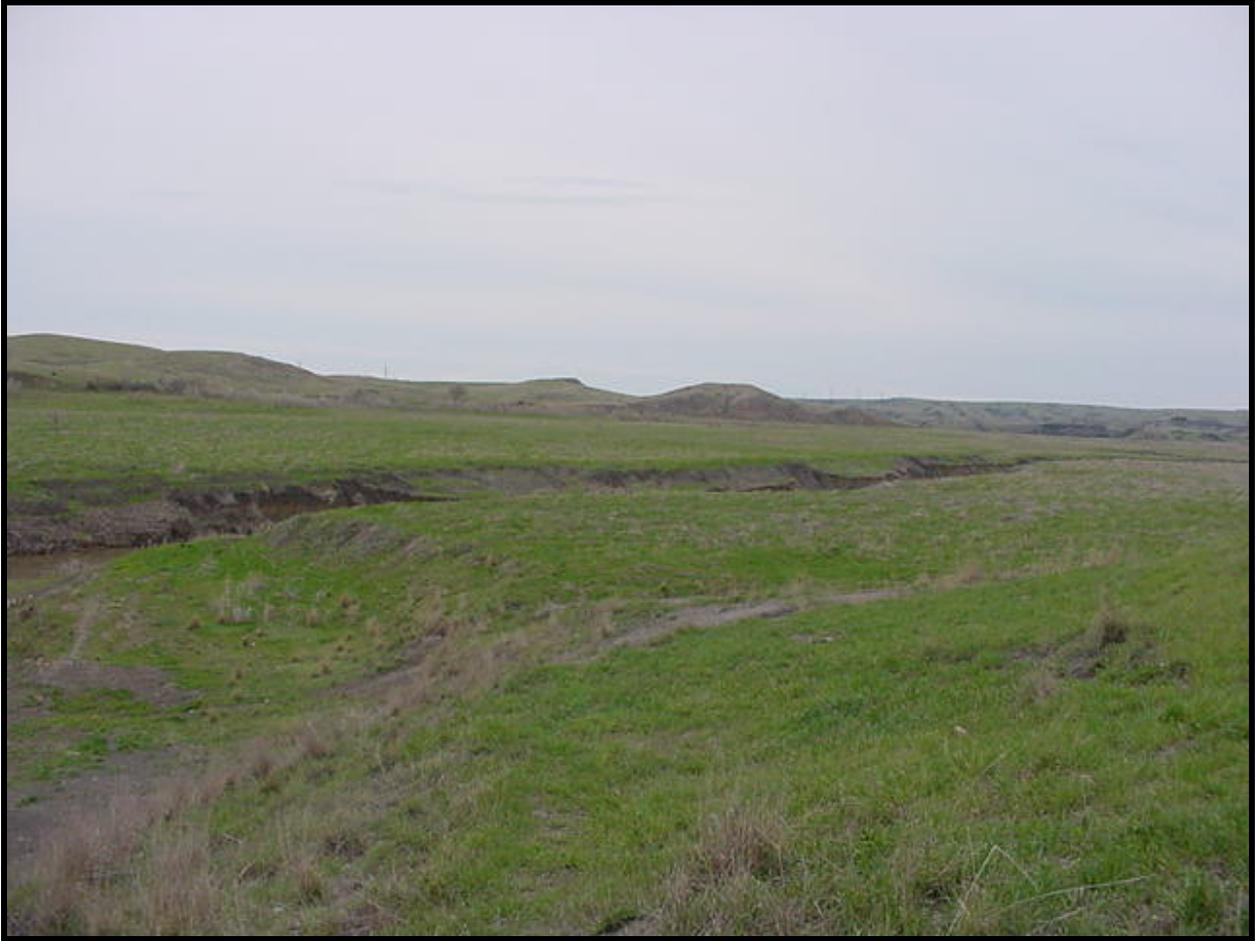
ATTACHMENT 5

Bedashosha Lake.

This photograph was taken on April 25, 2007. The photographer was standing on the northwest side of the lake basin facing southeast. Upland grasses now grow on the lake bed. Crow Creek is seen in the foreground cutting through the landscape.

DENR personnel visited Bedashosha Lake in April 2007. Due to the excavation of fill material and abutment walls, the old reservoir area is not capable of holding water. Crow Creek flows through the lake bed and discharges to the Missouri River. Crow Creek is classified with the beneficial uses (5) Warmwater semipermanent fish life propagation waters, and (8) Limited contact recreation waters. In removing Bedashosha Lake from Chapter 74:51:02, the lake classification will be removed; however, Crow Creek will still be protected by its existing beneficial uses. Attachment 2 is a site map of Bedashosha Lake. Attachments 5 & 6 are photographs of the breached reservoir.

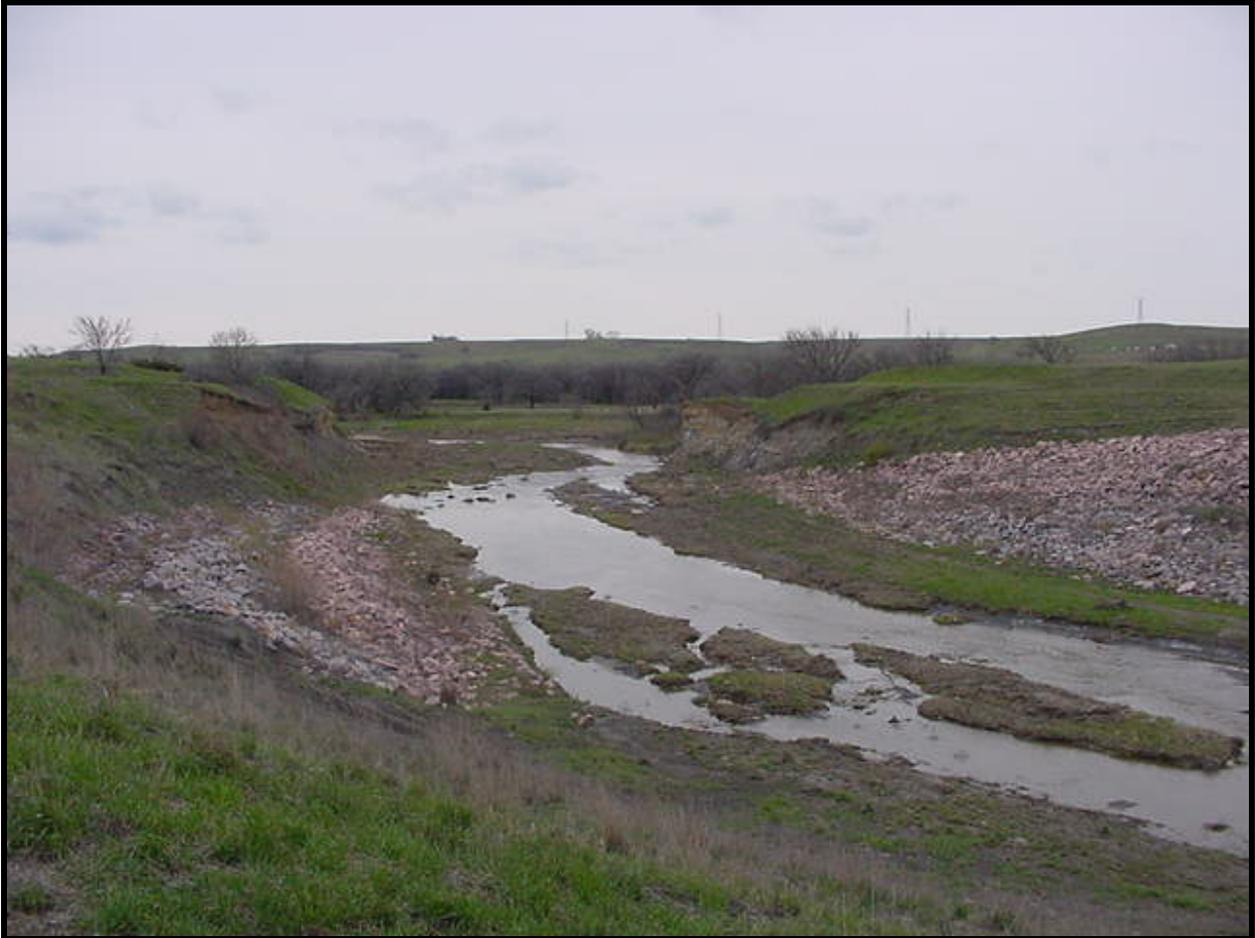
ATTACHMENT 6

Bedashosha Lake.

This photograph was taken on April 25, 2007. The photographer was standing near the northwest corner of the lake facing north at the location of the reservoir breach. Due to the failure of the holding structure, Crow Creek now flows freely to the Missouri River.

Bedashosha Lake was a man-made reservoir constructed on Crow Creek west of Shelby, SD. The dam was inspected and given a high hazard classification based on United States Bureau of Reclamation criteria. Water was drained from the dam, the spillway and abutment walls were removed, and over a five year period beginning in 1995, Crow Creek was restored to its natural elevation.
