ANALYSIS OF
GRINDSTONE CREEK
(FROM WAGGONER LAKE TO THE CONFLUENCE WITH THE
BAD RIVER)

NORTH OF PHILIP
HAAKON COUNTY, SOUTH DAKOTA

March 2006

South Dakota
Department of Environment and Natural Resources
Division of Environmental Services
Pierre, South Dakota

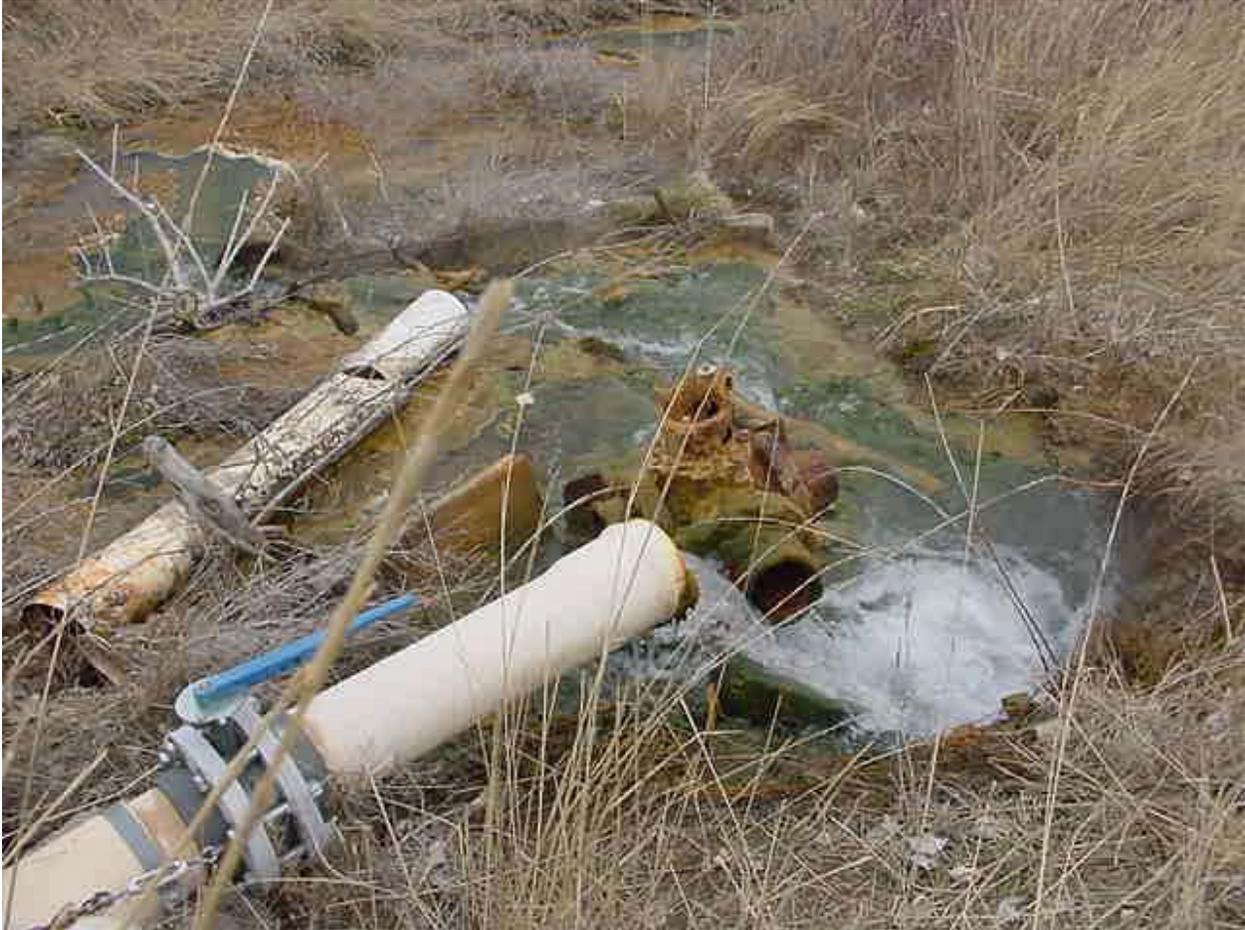
ATTACHMENT 1

Outfall #001:

This picture was taken on March 9, 2006. The photograph shows water being discharged from Min-kota Fisheries to Grindstone Creek below Lake Waggoner. The photographer was facing north.

Attachments 1 through 3 are pictures of Min-kota's discharge locations. Attachment 9 is a map that shows the outfall locations. Attachment 1 shows Outfall #001 discharging into Grindstone Creek. This water flow was included in the assessment of Grindstone Creek. Attachment 2 is a picture of Outfall #001 and a bypass T-valve that allows the fishery to bypass water from the discharge location to an irrigation pond in the nearby golf course. Attachment 3 is a photo of Outfall #002 discharging into Lake Waggoner. Discharge from Outfall #002 into Lake Waggoner was not sampled or included in the assessment of Grindstone Creek.

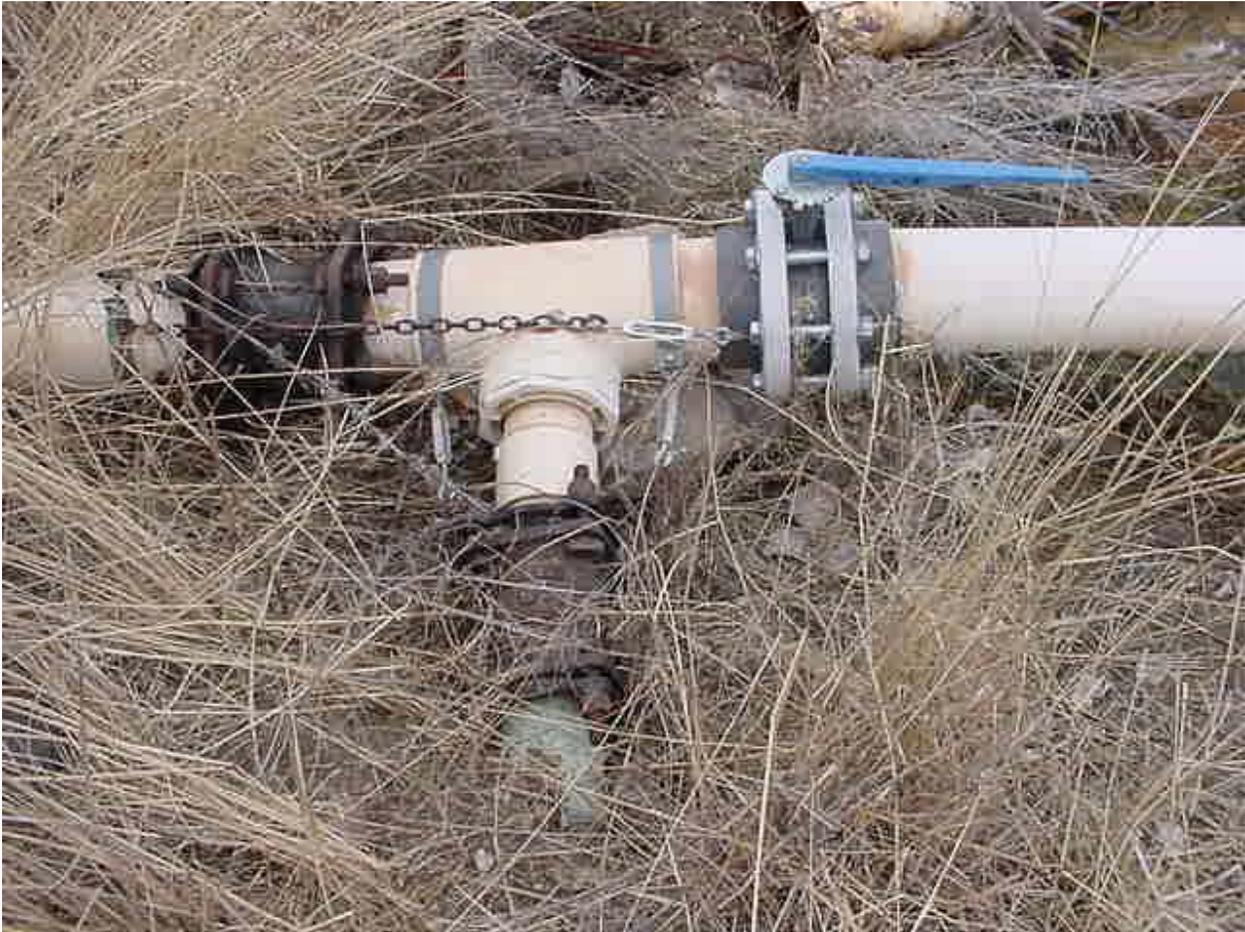
ATTACHMENT 2

Outfall #001:

Outfall #001 has a T in the plumbing which allows Min-kota Fisheries to divert the water from Outfall #001 to an irrigation pond at the Municipal Golf Course. The photograph was taken on March 9, 2006, the photographer was facing north.

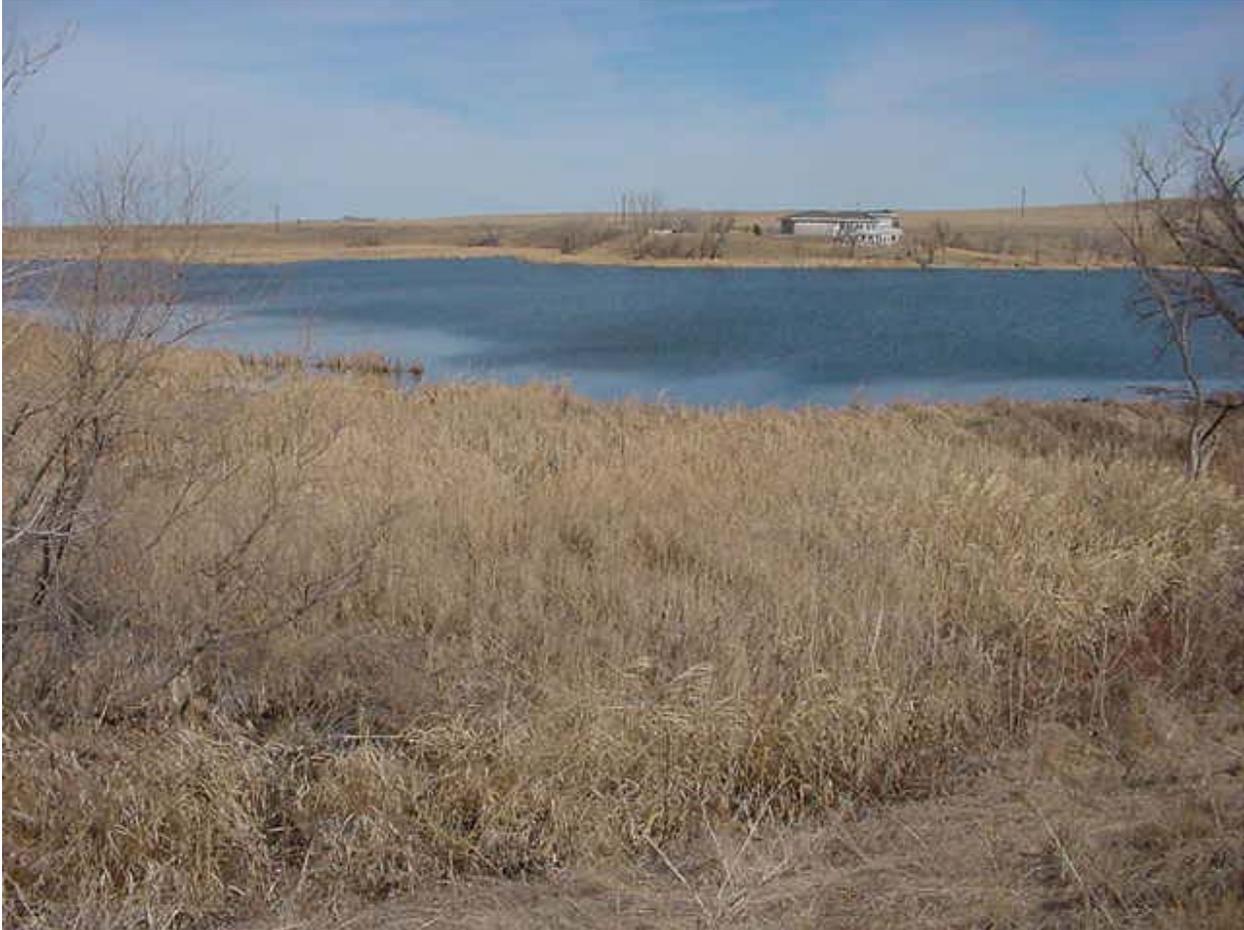
ATTACHMENT 3

Outfall #002:

This photograph was taken March 9, 2006. Min-kota Fisheries discharges water from Outfall #002 (bottom left hand corner of photo) into Lake Waggoner. The photographer was facing north.

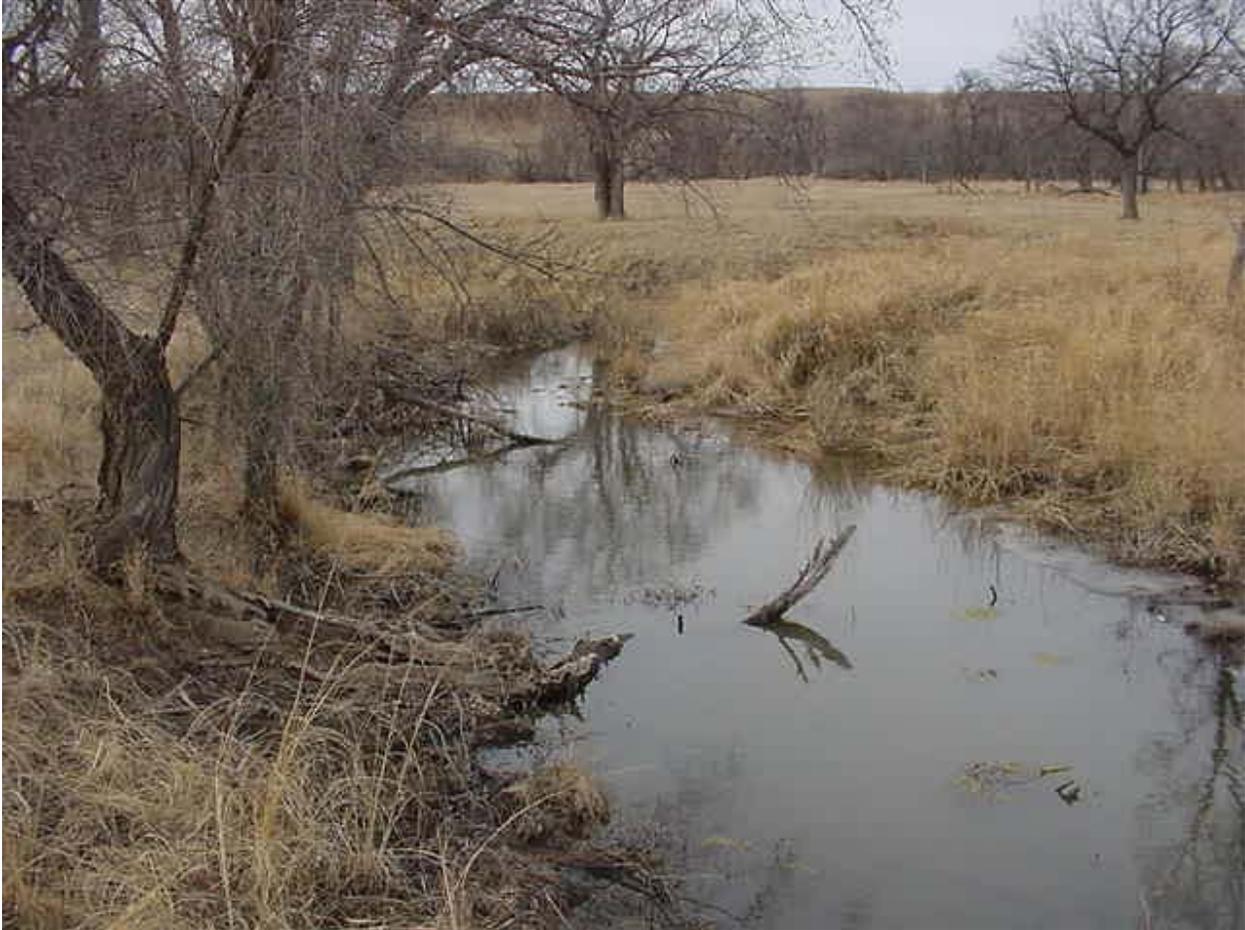
ATTACHMENT 4

Site # 1:

Picture was taken on March 9, 2006. The water at the site was flowing, however no fish were found. The photograph was taken near a culvert where Grindstone Creek intersects with the Darryl Peterson Ranch road south of US Route 14. The photographer was facing west.

Site #1 is on Grindstone Creek approximately one half mile south of US Route 14 and about one half mile northwest from the confluence with the Bad River. Attachment 9 is a map showing the sample site location. Attachment 4 is a photograph of the sample site.

Grindstone Creek measured about 7 feet in width and had flow of about 0.76 cubic feet per second. Water quality met standards for a 9, 10 waterbody, and for the proposed reclassification to a 6, 8, 9, and 10 waterbody. Laboratory analysis and field analysis results are summarized in Attachment 13. Flow measurement data is available in Attachment 11.

Using an Engineering Technical Services (ET) Model APB-3 electroshocker, DENR personnel attempted fish collection in Grindstone Creek for approximately 100 feet. No fish species were collected or observed. The landowner of Site #1, Darryl Peterson, stated that fish are typically present in this creek segment later in the year.

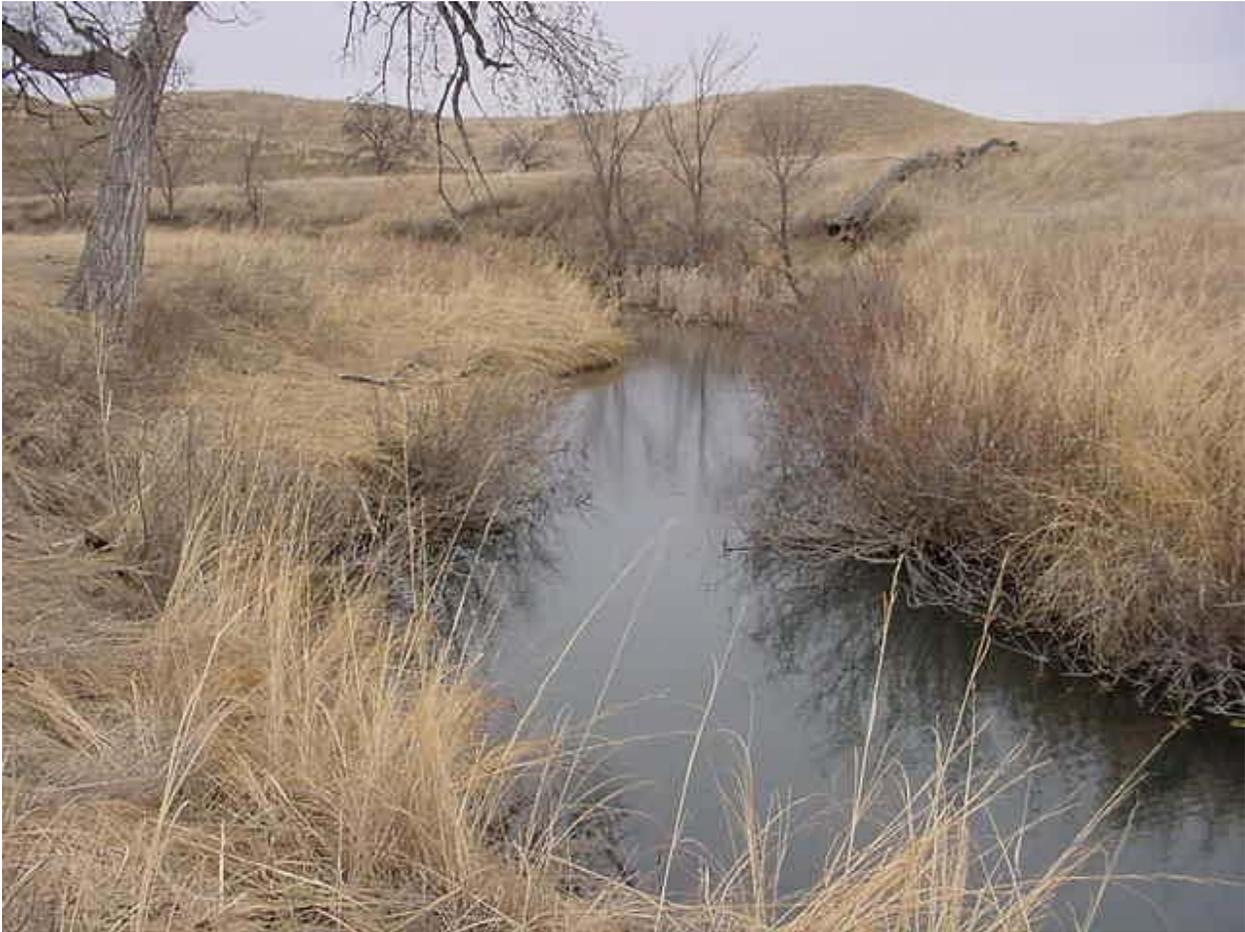
ATTACHMENT 5

Site # 2:

Picture was taken on March 9, 2006. The water at the site was flowing and several fish species were found. The photographer is facing northeast looking upstream. The site location is approximately ¼ mile downstream from Lake Waggoner on Grindstone Creek.

Site #2 is on Grindstone Creek, approximately one quarter mile downstream from Lake Waggoner. Attachment 9 is a map showing the sample site location. Attachments 5 through 8 are photographs of the sample site.

At this location on March 9, 2006, Grindstone Creek had a flow rate of 0.24 cubic feet per second. At the site where flow was measured, the creek was 14 feet wide and had a maximum depth of 1.95 feet. The creek bottom had a thick layer of fine silt-like mud that may have affected the calculated water flow.

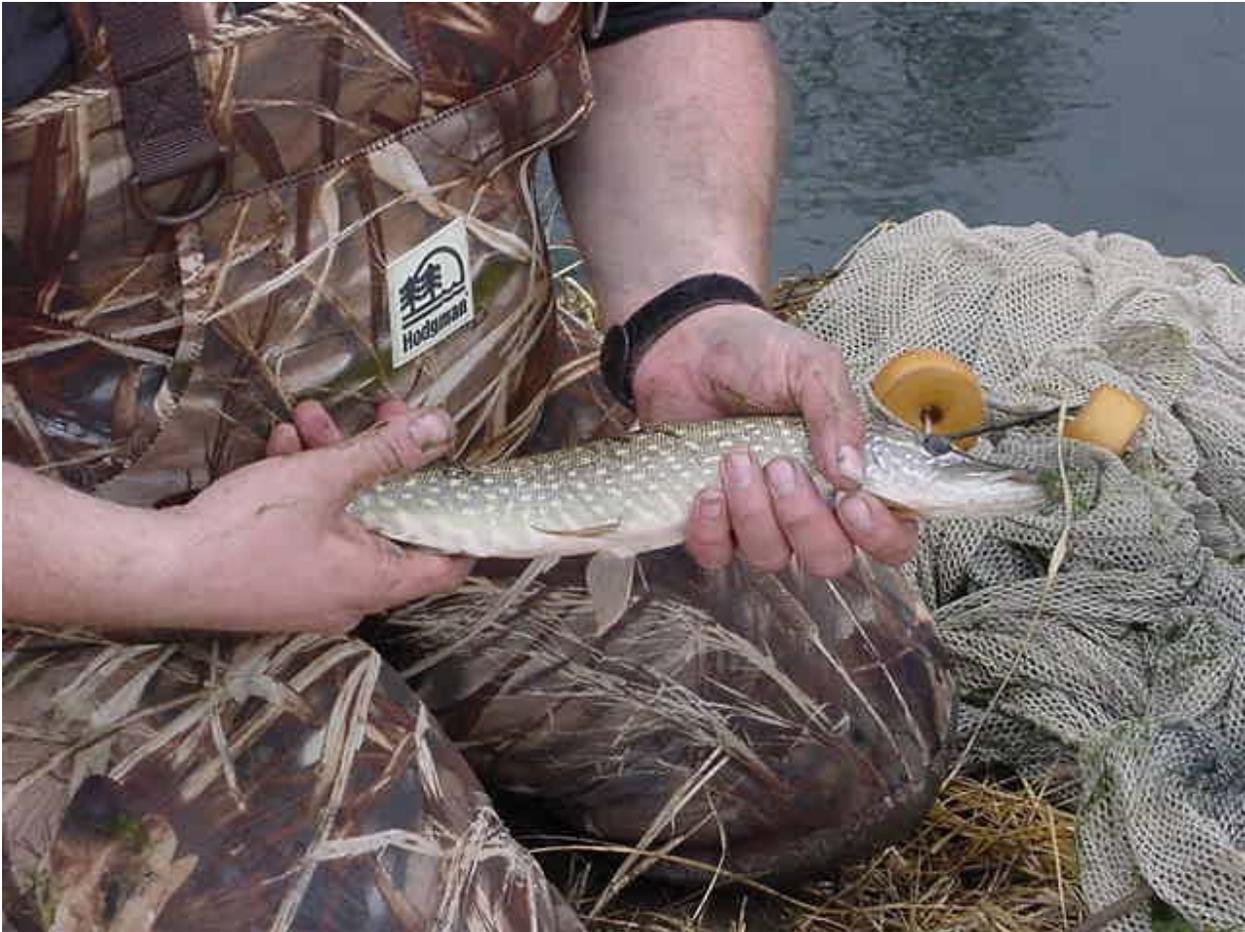
ATTACHMENT 6

Site # 2:

Picture was taken on March 9, 2006 of a Northern Pike.

Fish collected include common carp, black bullhead, black crappie, bluegill, largemouth bass, northern pike and green sunfish. Of the fish collected, bluegill, black crappie, and black bullhead appear to be representative of more than one age class. A list of fish collected by DENR personnel is available in Attachment 10.

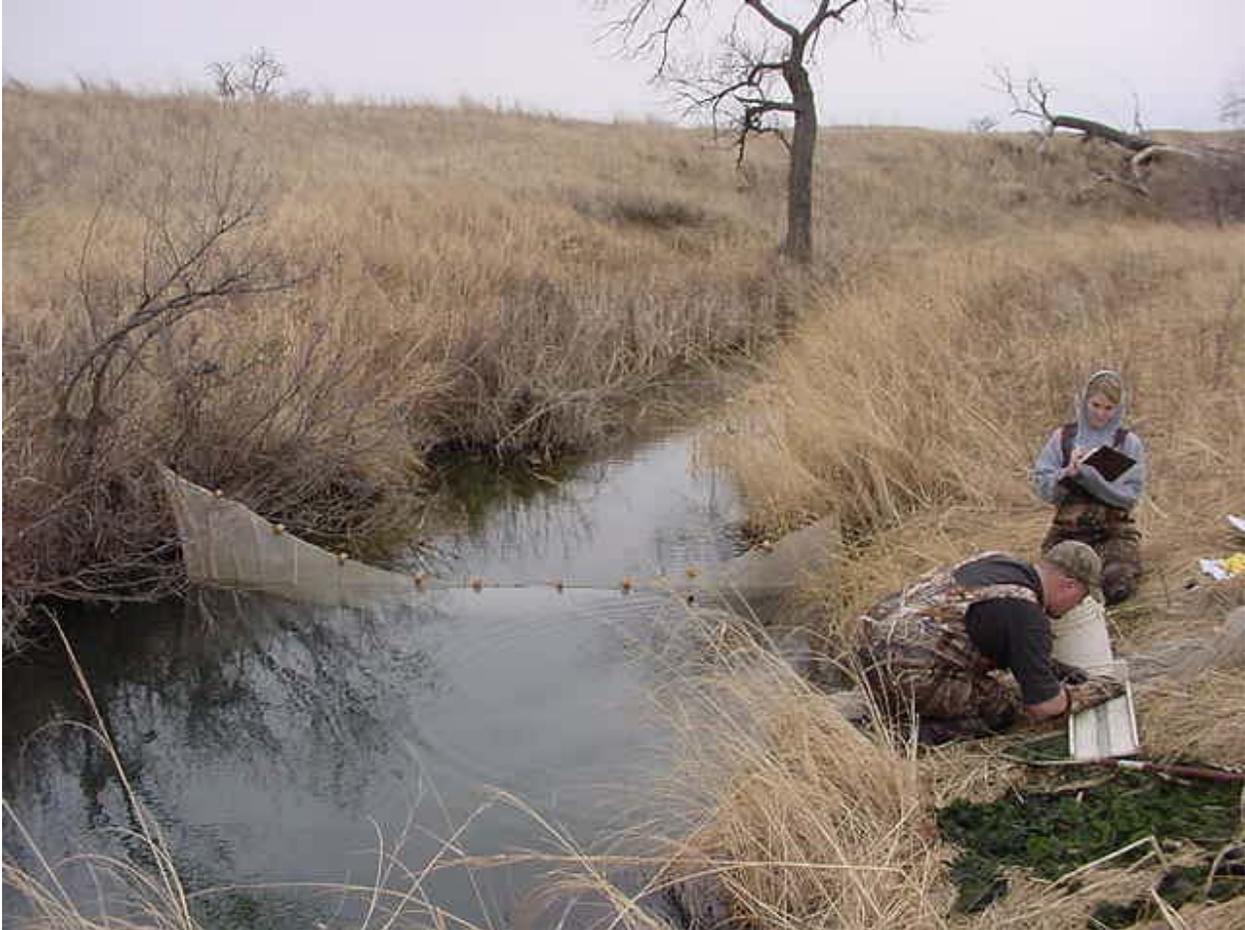
ATTACHMENT 7

Site # 2:

Picture was taken on March 9, 2006. The photograph was taken approximately ¼ mile downstream from Lake Waggoner on Grindstone Creek. The photographer was facing west.

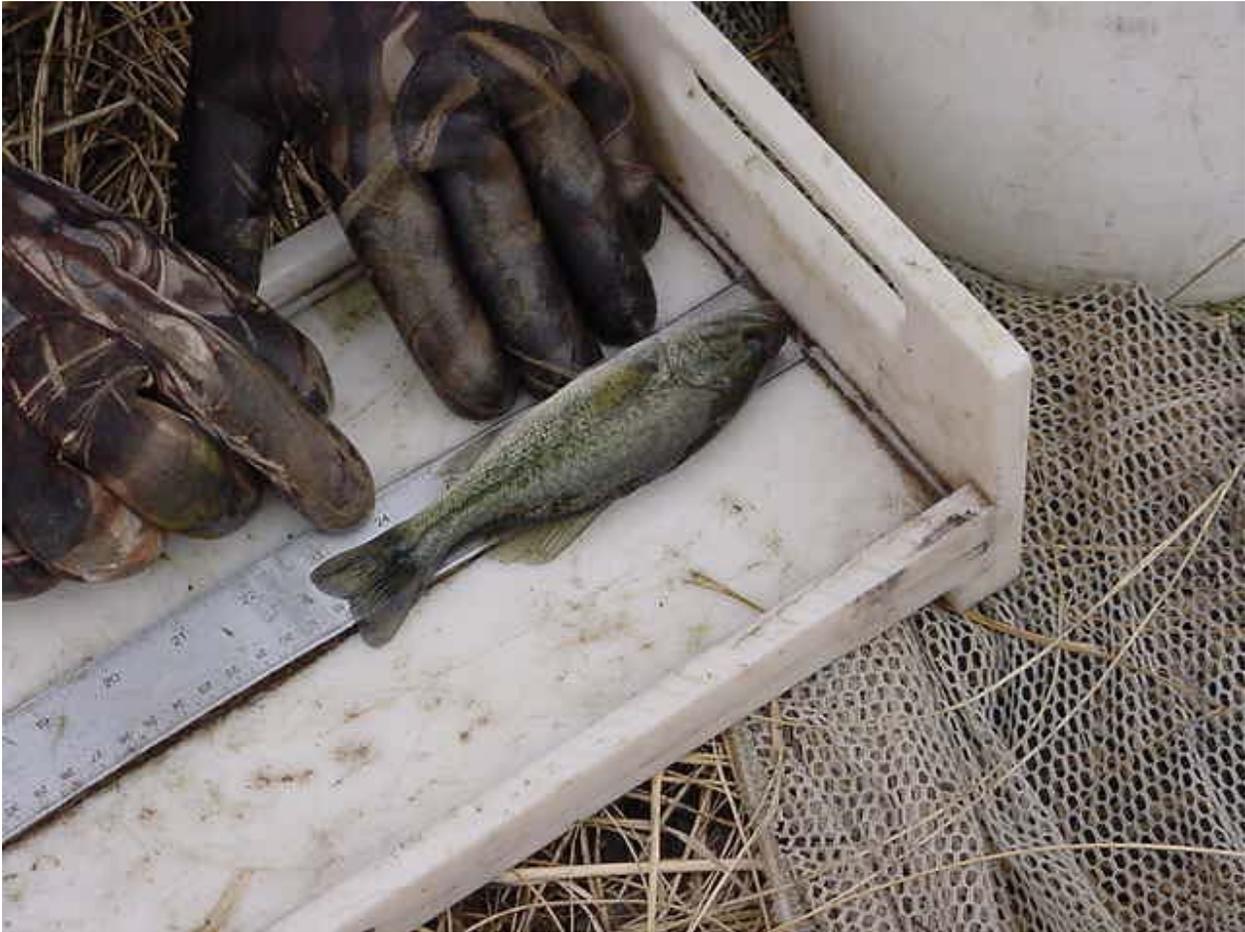
ATTACHMENT 8

Site # 2:

Picture was taken on March 9, 2006 of a Largemouth Bass.
