# SOUTH DAKOTA TANK PATHOLOGY STUDY

## EVALUATING THE INTEGRITY OF TANK SYSTEMS IN SOUTH DAKOTA

South Dakota  
Petroleum Release  
Compensation Fund

**June 15, 2005**

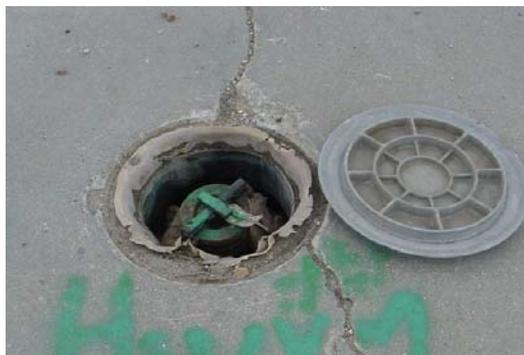
Many of the sites contained spill buckets that were damaged, which could result in a release to the environment during filling operations. The damages consisted of deteriorated or missing surface seals, cracked containment sumps, or the absence of the spill bucket all together.

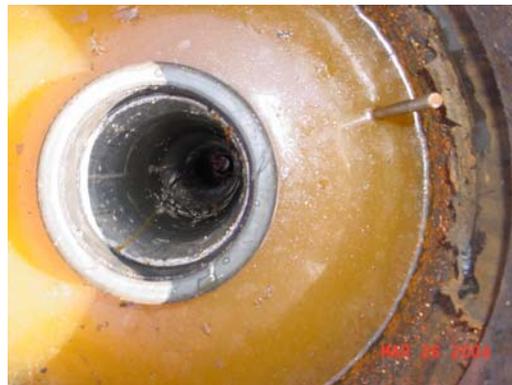
Majority of the sites evaluated had some type of overfill protection, which included spill containment buckets and overfill prevention valves. However, many of the spill containment buckets were either cracked, full of water, or the surface seals were damaged or missing. In some instances, it appeared the lack of maintaining this component resulted in a release to the tank basin.

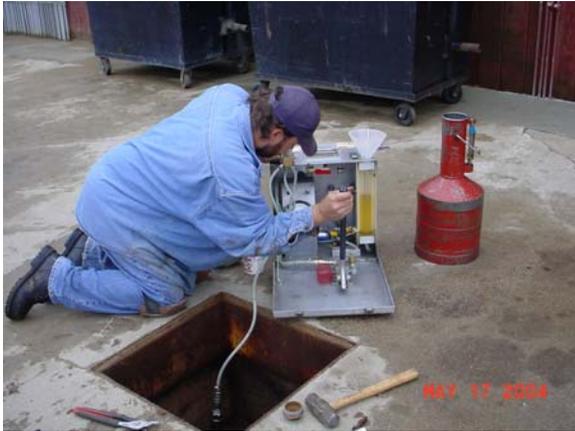
Pressure Testing

Prior to the removal of the product lines, two different types of line testing were conducted. First, each line was capped and hydrostatically tested to determine if any portion of the product lines were prone to leaks. This test was designed to detect a .1 gallon per hour leak rate using one and a half times the operating pressure of the lines.

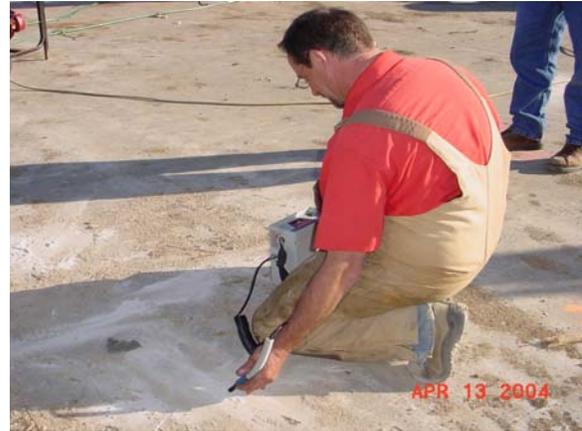
Helium Testing

Following the pressure test, holes were drilled through the surfacing along the piping trenches. The product lines were then purged, and again tested using helium gas. A specific instrument was then used to detect any trace amounts of helium venting from the holes in the surfacing. This method of leak detection attempts to pinpoint the exact location of a line leak. However, because the potential exists that the interior pipe in a double wall pipe has failed, and the outer piping remains tight, helium gases have the ability to travel

through the interstitial space and present itself some distance away from the actual failure. Therefore, it was concluded that pinpointing a leak in a product line using this type of method may not be most appropriate for double-wall piping.

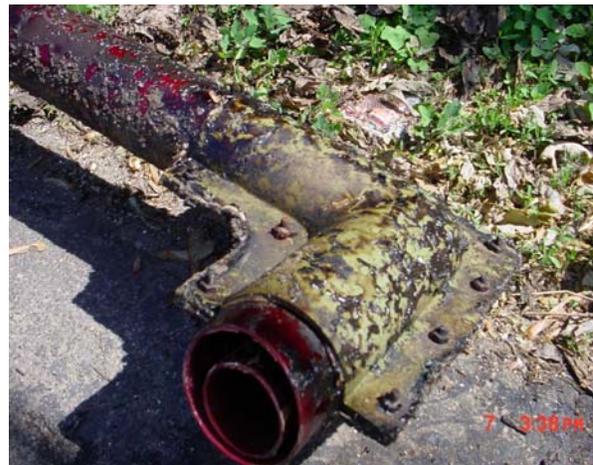
Once testing was completed on the product lines, the surface above the tanks and lines were carefully removed and each component inspected. The purpose of this examination was to identify any material defects, incompatibilities, installation errors, etc. Overall, the installation of the tank system at most project locations was considered satisfactory. However, a few minor errors were identified. For example, at one location, the manufacturer wrapping on a sacrificial anode had not been removed, as was instructed on the wrapping itself, prior to tank installation. Although the tank did not appear to be grossly corroded, this oversight could have led to aggressive material decomposition in the future.

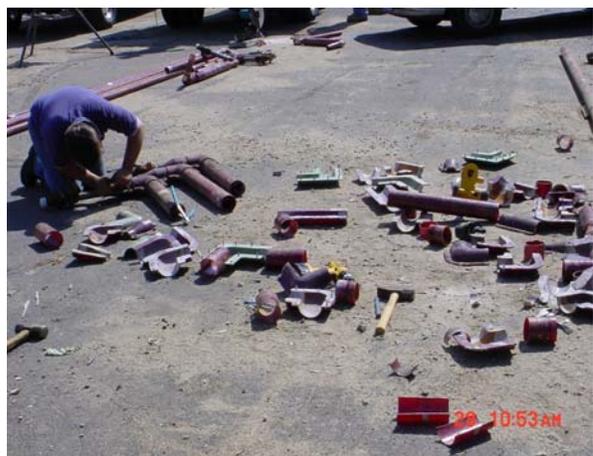
In other instances, material incompatibilities were discovered. For example, the piping at one of the sites included both A.O. Smith elbows installed with Ameron fiberglass piping. Excessive microbial growth was found on much of the piping system, indicating that a small release may have occurred within the piping galleries.

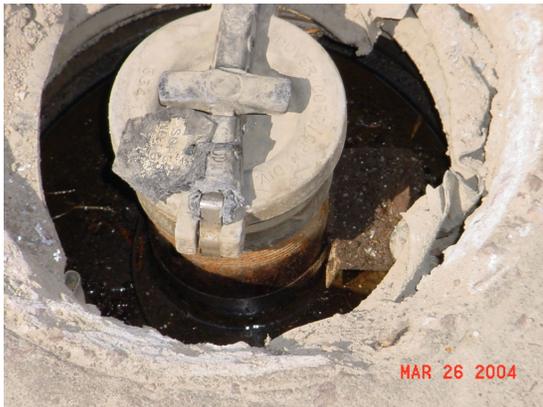
**Project Location #3**  
**R&M Convenience**  
**Sioux Falls, SD**

- Installation discrepancies noted included the failure to anchor fire/shear valves to the island beneath the dispensers and underground vent lines that were unconnected.

- Upon removal of the USTs it was determined that a release had apparently occurred from a previously system installed at this location and that the current USTs were installed without remediating the previous release. Additional corrective action is required to assess the site and determine an appropriate corrective action for the earlier release.

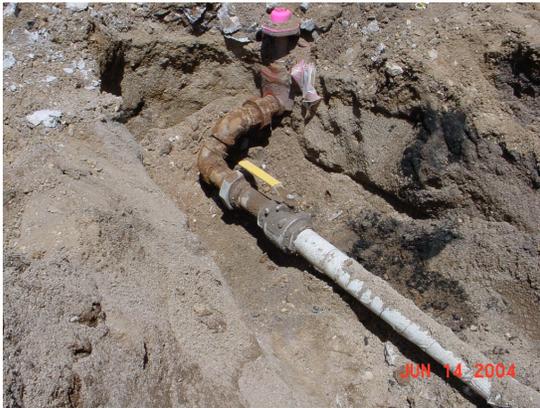
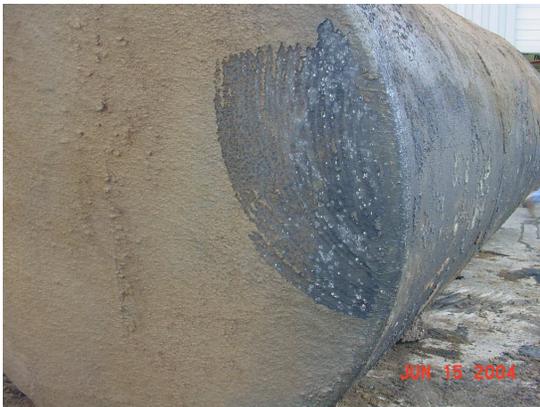
**Project Location #5  
Bozied Texaco  
Brookings, SD**

The original tank system was installed in 1969. In 1991 the tanks were upgraded by applying internal lining, adding spill / overfill protection, replacing the product lines, and adding cathodic protection to the tank system. The tank system was found to be in generally good condition. No visible holes were found in the tanks. The cause of the tightness test failure in the premium line was not able to be identified when the lines were removed. Leak detection records were not available. The site had been closed for approximately one year and the records were not retained. A set of blueprints from the 1969 installation were available. No other records of tightness tests or DENR inspections were available. A release was reported as the result of the system removal. Contamination was noted in the tank basin and near the dispenser island. The tank basin contamination is likely the result of historic spills / overfills and the island contamination may have resulted from dispenser maintenance or leaks. No piping leaks were identified during the course of the evaluation. The visibly contaminated soil was removed from the site. DENR has required that site assessment be done to determine if there are any potential pathways and impacted receptors.

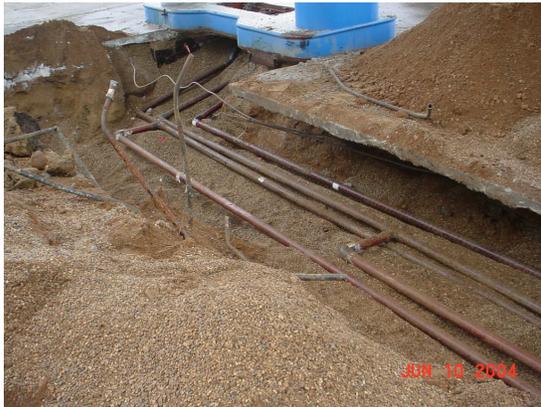
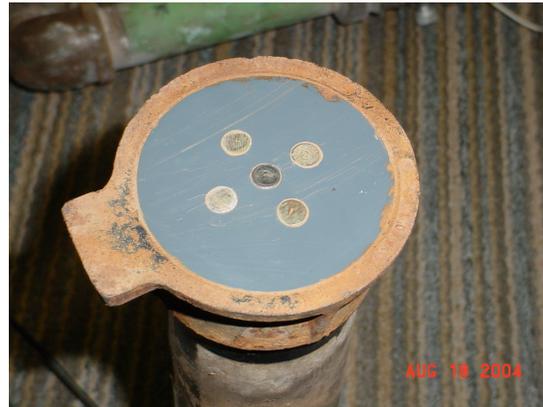
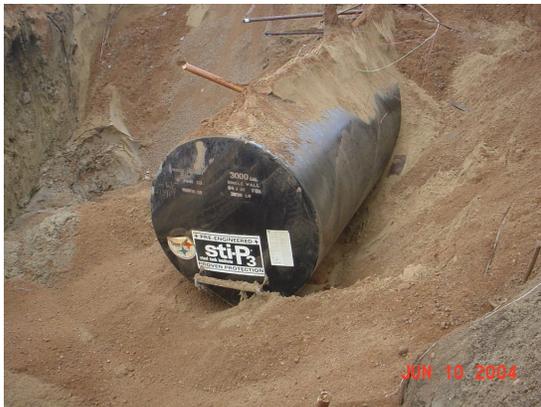
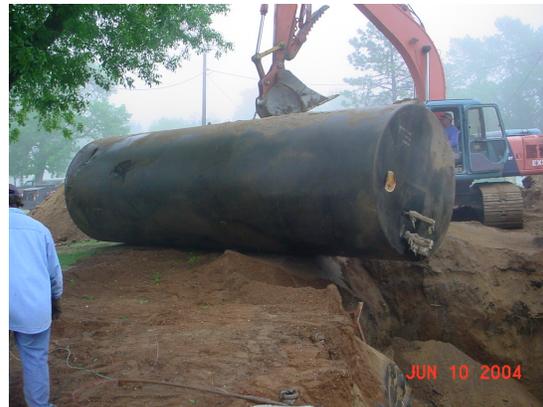
**Project Location #6  
Wayne's Amoco  
Clear Lake, SD**

The system was installed in 1993. It was found to be in generally good shape. One spill bucket had a damaged lid and the release valve was stuck. Documentation for the station was not available. The station was closed for nearly a year before the system removal, and the records were not retained. Leak detection and inspection records also were not retained. No release was identified during the system removal. Two other tanks were subsequently removed under the South Dakota Abandoned Tank Program and the contaminated soils associated with these tanks were removed and properly disposed.

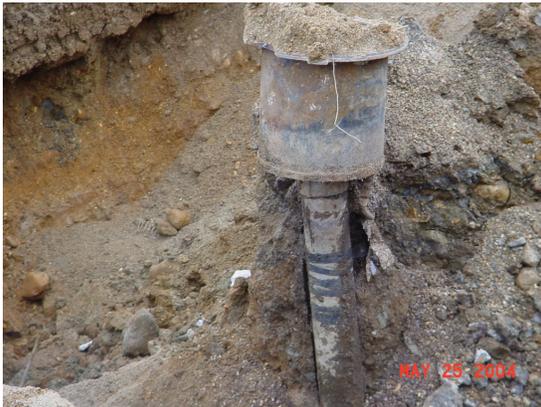
**Project Location #7  
Stone's Truck Stop  
Watertown, SD**

The condition of the system was generally good. The lines all passed the precision tightness test and the helium test. Contamination was found near the former location of the diesel islands and in the tank basin. The island contamination is believed to be the result of dispenser maintenance and/or dispenser leaks. The tank basin contamination is believed to result from spill buckets that were missing, not functioning properly or had leaked. The spill / overfill protection was added in 1994. The tanks were installed in 1985, so some of the release may have occurred before the protection was added.

DENR has required that site assessment be done to determine if there are any potential pathways and impacted receptors.

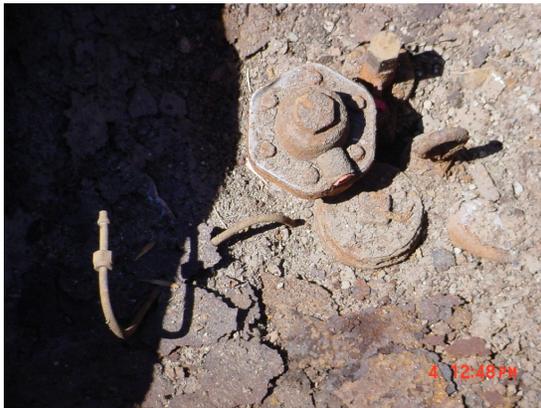
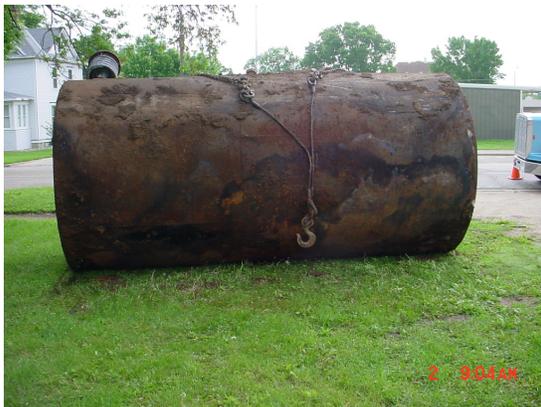
**Project Location #9  
Madison Coastal Mart  
Madison, SD**

- This location had a three-product gasoline UST system. The system was installed in 1961 and the USTs had been lined in 1992.
- A single installation discrepancy was noted. A potential greater problem was found when the UST's were excavated. In discrete areas, the steel tanks had
- No documentation (i.e., component installation, maintenance, operation manuals) was available.
- Consistent leak detection, inspection, or maintenance records were unavailable for the site.
- While removing the USTs it was determined that a release had apparently occurred. Additional assessment has been performed and no contamination above state standards was found.

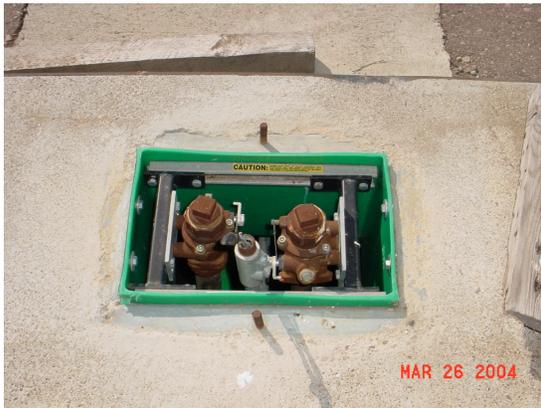
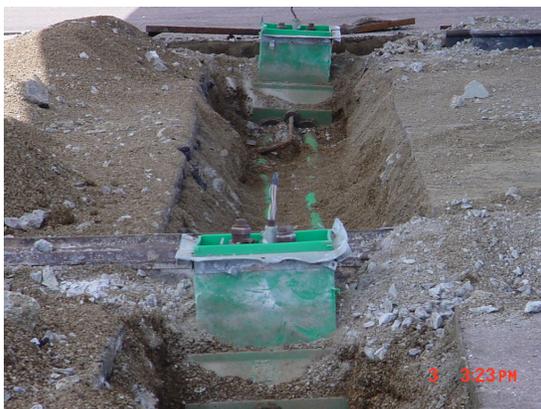
**Project Location #10  
Northview Bait & Tackle  
Sioux Falls, SD**

- This location had been a gas station prior to 1979. Contamination was found when the previous system was removed in 1999 and replaced with a two-product gasoline UST system in 1999. The station was closed in 2002 when purchased by the owner of surrounding property.
- No installation discrepancies were noted.
- No documentation (i.e., as-built drawings, maintenance, operation manuals) was available.
- Leak detection, inspection, or maintenance records were not available for the site.

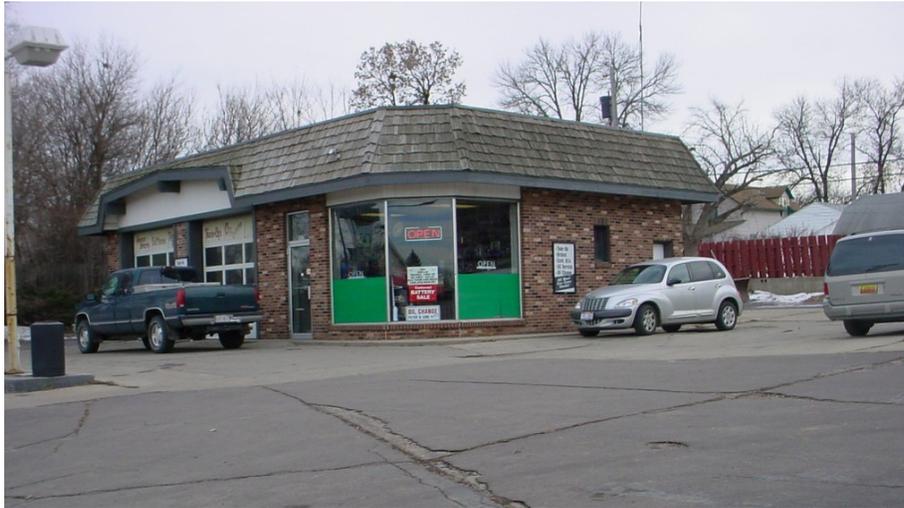
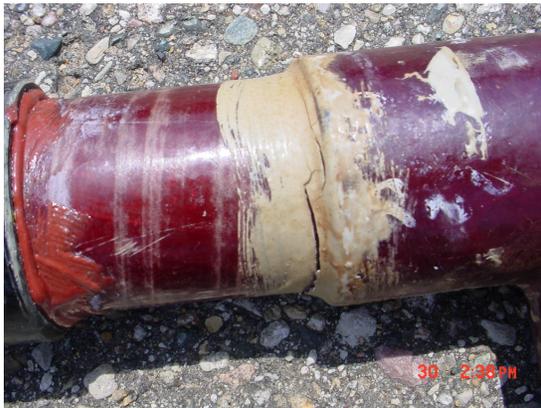
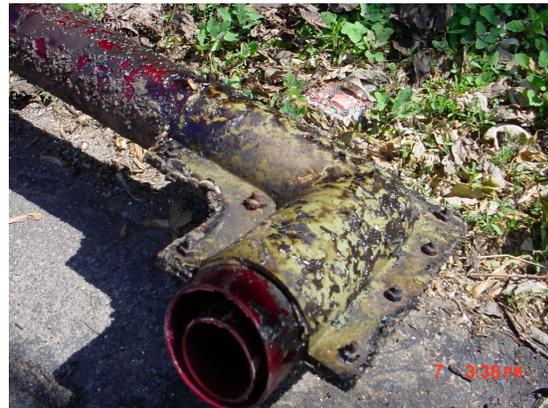
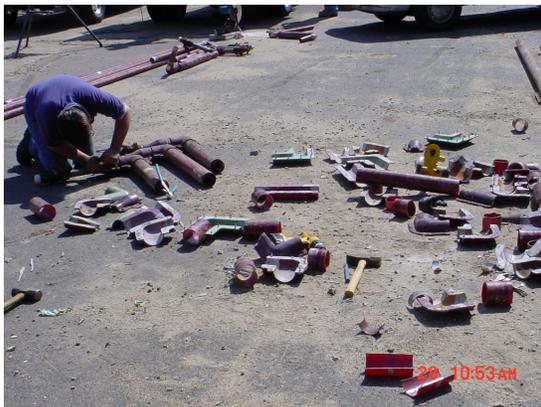
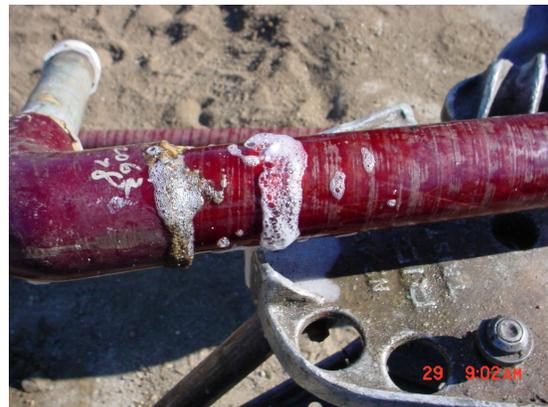
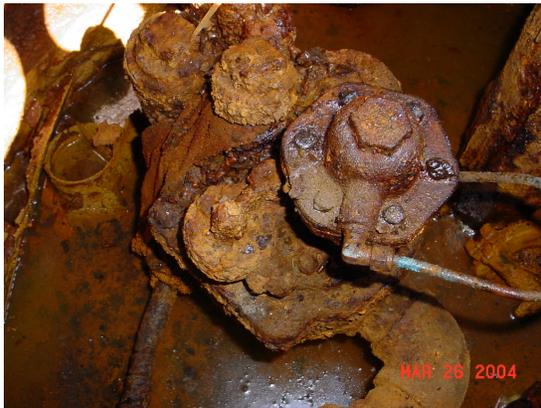
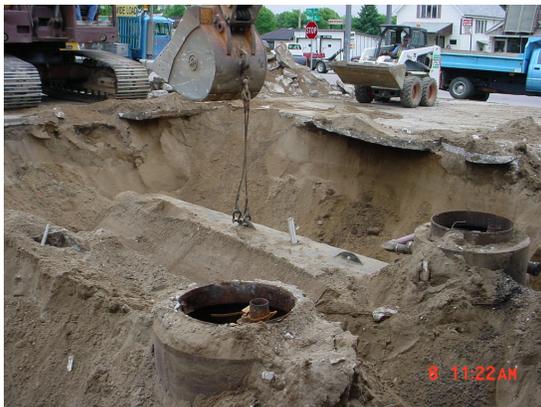
**Project Location #11  
12<sup>th</sup> Street Sinclair  
Sioux Falls, SD**

Release Identified at Site? (Yes/No)	Yes
Source(s) of Release (N/A if no release)	Tank fills and secondary piping
Assessment beyond backfill required? (Yes/No)	Yes
Number of Tanks	3
Type of Tanks	StiP3, Double wall steel
Type of Piping	Double wall fiberglass
Total Length of Piping	360'
Number of Dispensers	7
Type(s) of Dispensers (Pressure/Suction)	Pressure
Fill pipe Spill Bucket (Yes/No)/Condition	Yes / damaged
Dispenser Sump (Yes/No)/Condition	No
Overfill Protection (Yes/No)/Type	Yes / caged ball
Line Pressure Test (Pass/Fail)	Fail
System Documentation Adequate? (Yes/No)	No
Leak Detection Records Adequate? (Yes/No)	No

- This site had been a retail gas station since approximately 1954. The current system of three 8,000 gallon tanks was installed in 1992.
- Discrepancies noted include the mixing of piping components from different manufacturers, failure to follow recommended installation practices by component manufacturers, the use of rubber sleeves in locations where gasoline product was contained, and using inadequate slope in product return piping to containment sumps.
- No documentation (i.e., as-built drawings, maintenance, operation manuals) was available.
- Product inventory records were available but leak detection, inspection, or maintenance records were not available for the site.
- Piping for two products failed tightness testing. DENR has required that site assessment be done to determine if there are any potential pathways and impacted receptors..

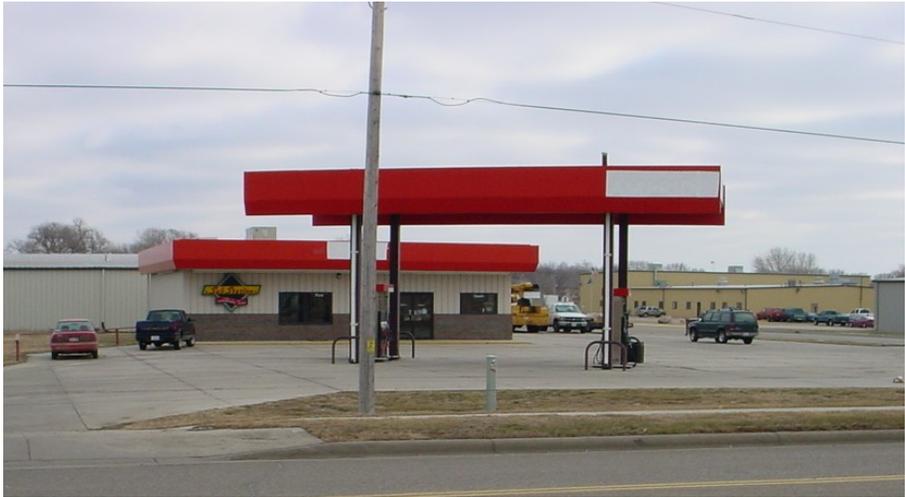
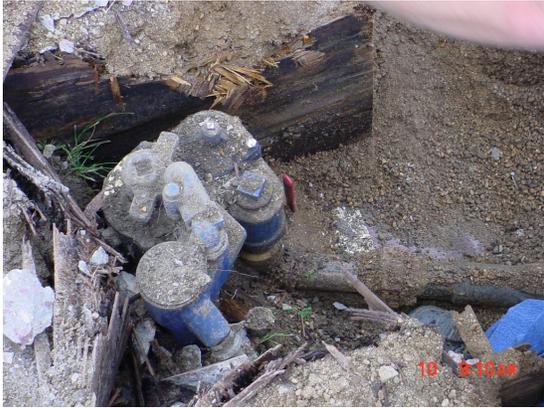
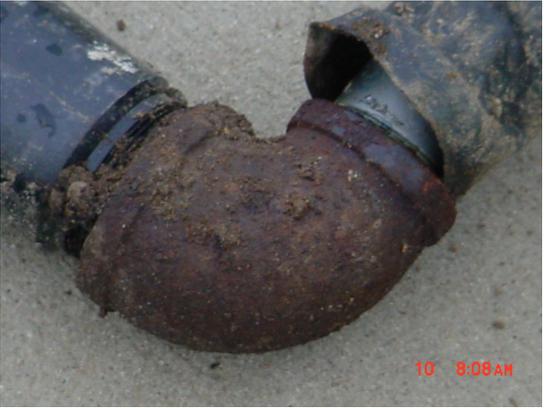
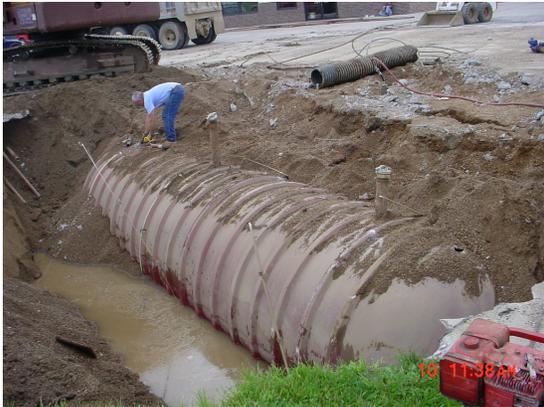
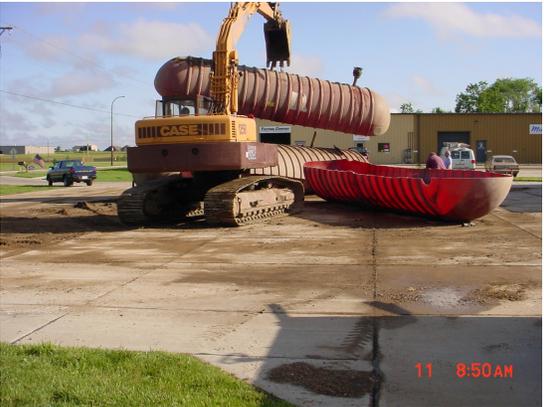
**Project Location #12  
Westside Convenience  
Yankton, SD**

Release Identified at Site? (Yes/No)	No
Source(s) of Release (N/A if no release)	N/A
Assessment beyond backfill required? (Yes/No)	No
Number of Tanks	3 (2-10,000 & one-4,000 gal.)
Type of Tanks	Single wall fiberglass
Type of Piping	Single wall fiberglass
Total Length of Piping	160'
Number of Dispensers	2
Type(s) of Dispensers (Pressure/Suction)	Pressure
Fill pipe Spill Bucket (Yes/No)/Condition	Yes / Good
Dispenser Sump (Yes/No)/Condition	No
Overfill Protection (Yes/No)/Type	Yes / Caged ball
Line Pressure Test (Pass/Fail)	Pass
System Documentation Adequate? (Yes/No)	Yes
Leak Detection Records Adequate? (Yes/No)	No

- This location had a first generation, three-product gasoline/diesel UST system. The system was installed in 1995.
- No installation discrepancies were noted.
- Documentation, including component installation diagrams, maintenance, and operation manuals was available.
- Product inventory records were not available, nor were leak detection, inspection, or maintenance records.

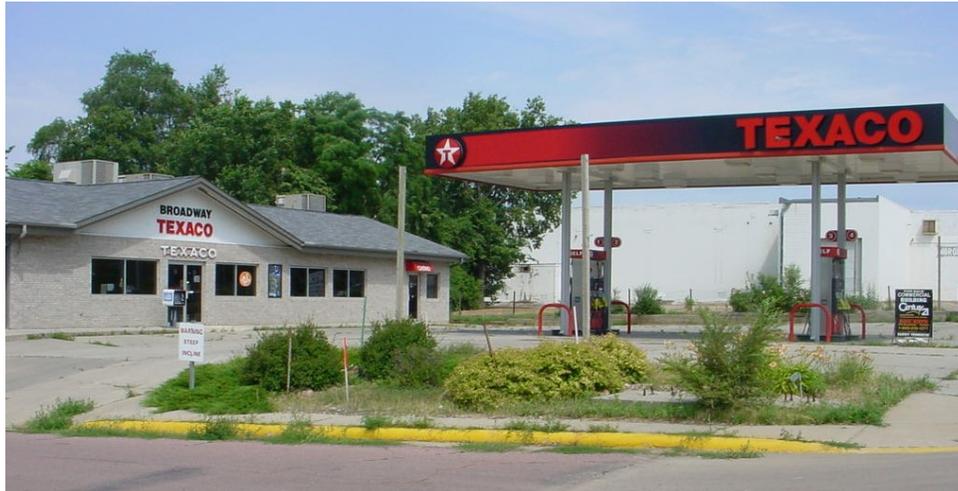
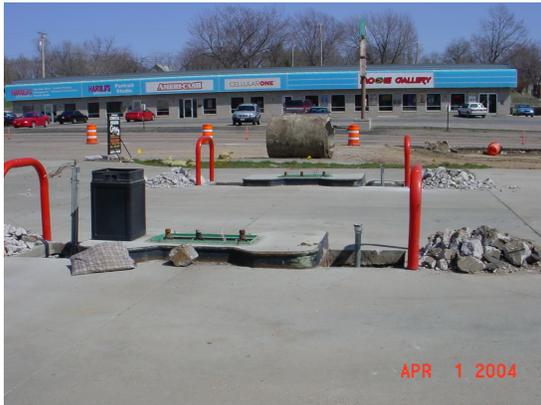
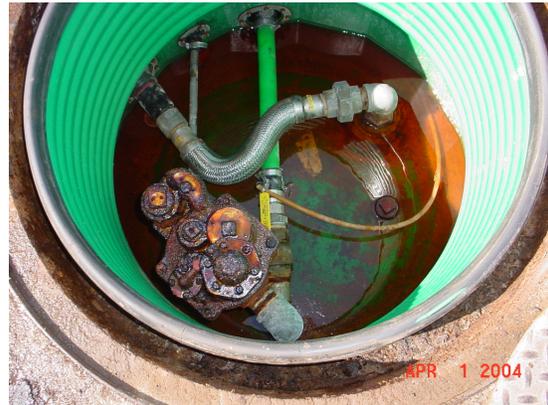
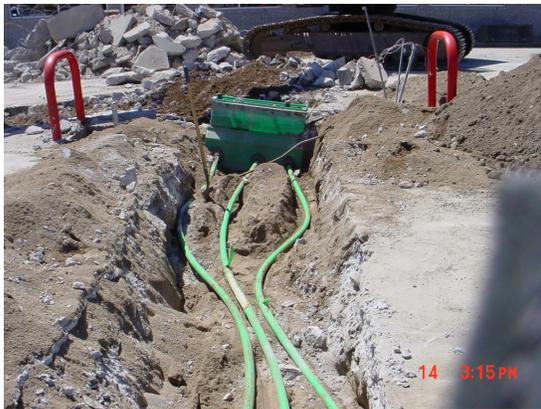
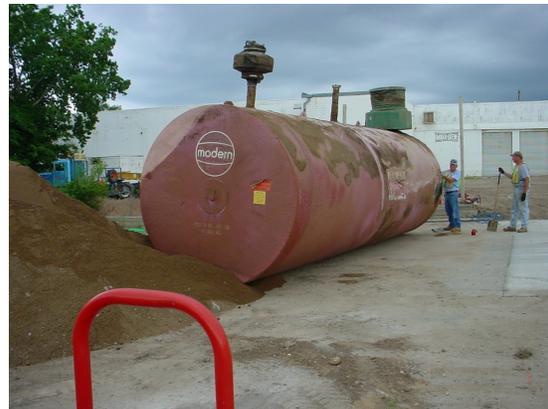
**Project Location #13  
Broadway Texaco  
Yankton, SD**

Release Identified at Site? (Yes/No)	No
Source(s) of Release (N/A if no release)	N/A
Assessment beyond backfill required? (Yes/No)	No
Number of Tanks	2 (one compartmented)
Type of Tanks	Double wall – steel with fiberglass secondary
Type of Piping	Double wall polymer
Total Length of Piping	153'
Number of Dispensers	2
Type(s) of Dispensers (Pressure/Suction)	Pressure
Fill pipe Spill Bucket (Yes/No)/Condition	Yes / Good
Dispenser Sump (Yes/No)/Condition	Yes / Good
Overfill Protection (Yes/No)/Type	Yes / Flow shutoff
Line Pressure Test (Pass/Fail)	Pass
System Documentation Adequate? (Yes/No)	No
Leak Detection Records Adequate? (Yes/No)	No

- This location had a second or third generation, three-product gasoline UST system. The system was installed in 1995.
- Some installation discrepancies were noted. For instance, the interstitial spaces for two of the product lines were properly routed to the tank sumps, which contained fluid sensors. However, the interstitial space for the third product line was routed to an island sump that did not contain a fluid sensor.
- No documentation (i.e., component installation, maintenance, operation manuals) was available.
- No product inventory records were available, nor were leak detection, inspection, or maintenance records.

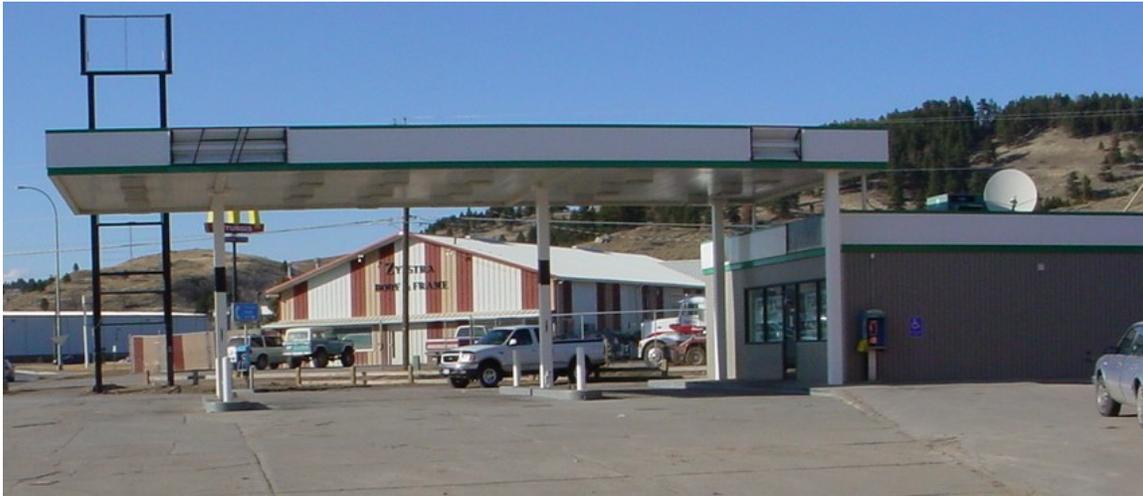
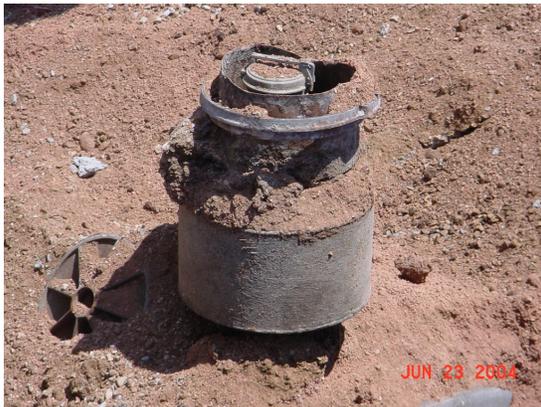
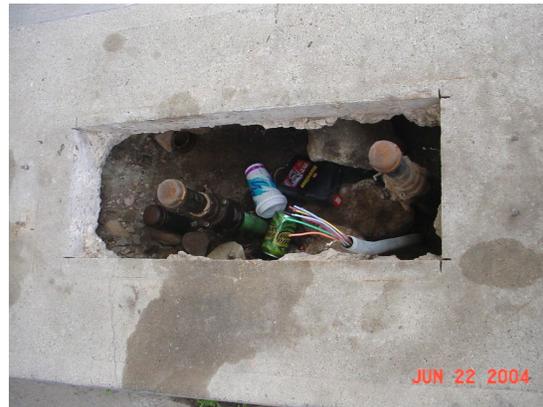
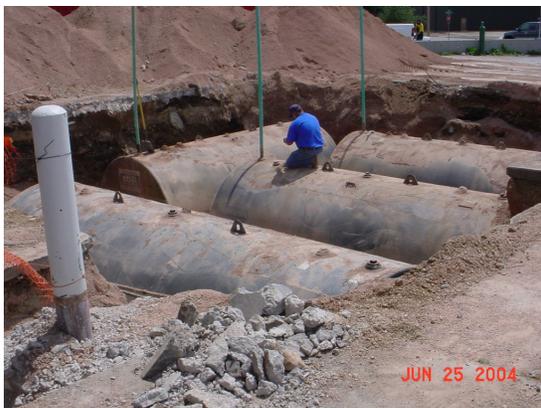
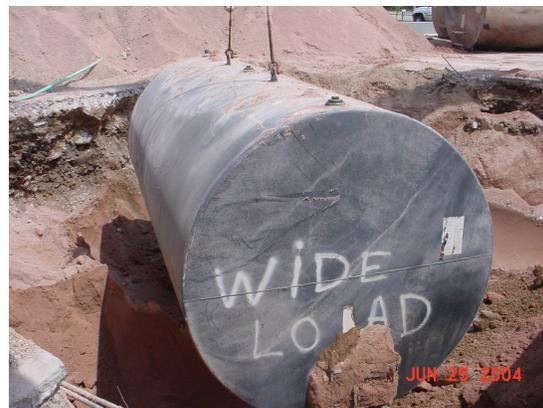
**Project Location #14**  
**Big D Oil**  
**Sturgis, SD**

Release Identified at Site? (Yes/No)	No
Source(s) of Release (N/A if no release)	N/A
Assessment beyond backfill required? (Yes/No)	No
Number of Tanks	4
Type of Tanks	Coated, cathodically protected single wall steel
Type of Piping	Coated steel
Total Length of Piping	70'
Number of Dispensers	4
Type(s) of Dispensers (Pressure/Suction)	Pressure
Fill pipe Spill Bucket (Yes/No)/Condition	Yes (shop made – no drains) good condition
Dispenser Sump (Yes/No)/Condition	N/A
Overfill Protection (Yes/No)/Type	Yes – ball check valve
Line Pressure Test (Pass/Fail)	Pass
System Documentation Adequate? (Yes/No)	Yes
Leak Detection Records Adequate? (Yes/No)	Yes

The tank system was in generally good condition. The station was originally constructed in mid-1960. New tanks were installed in 1994. The product lines from the original tank system were still in place and contained product. Approximately five gallons was recovered. Installation plans from the 1994 installation were available. No other tanks documents provided. Monthly leak detection records and a cathodic protection / tightness test from 4-18-02 were provided. No release was identified as a result of the tank system removal.

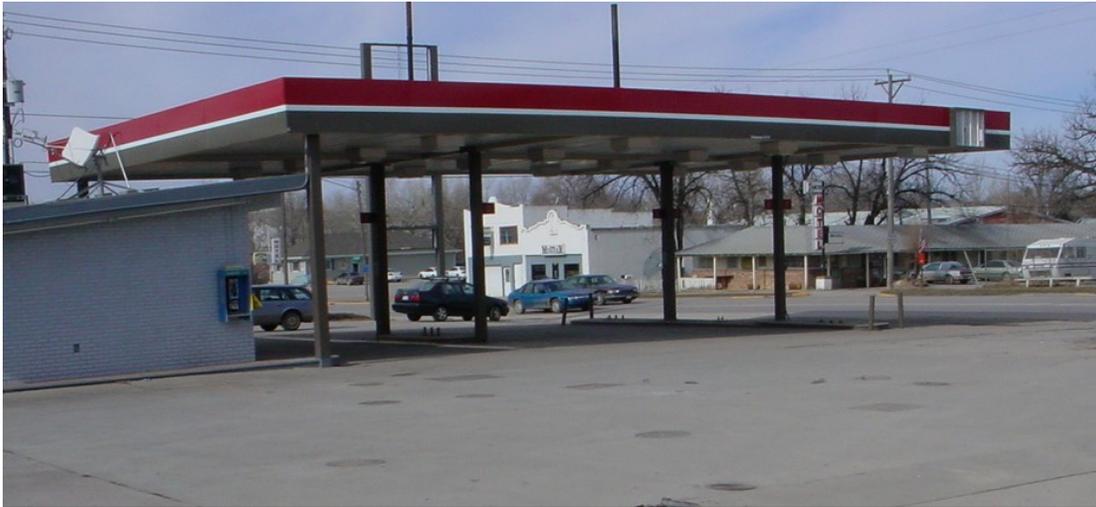
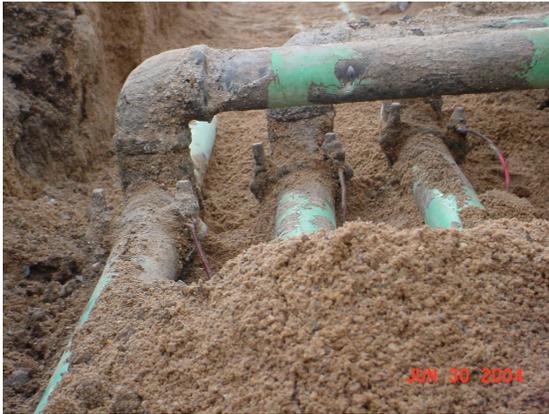
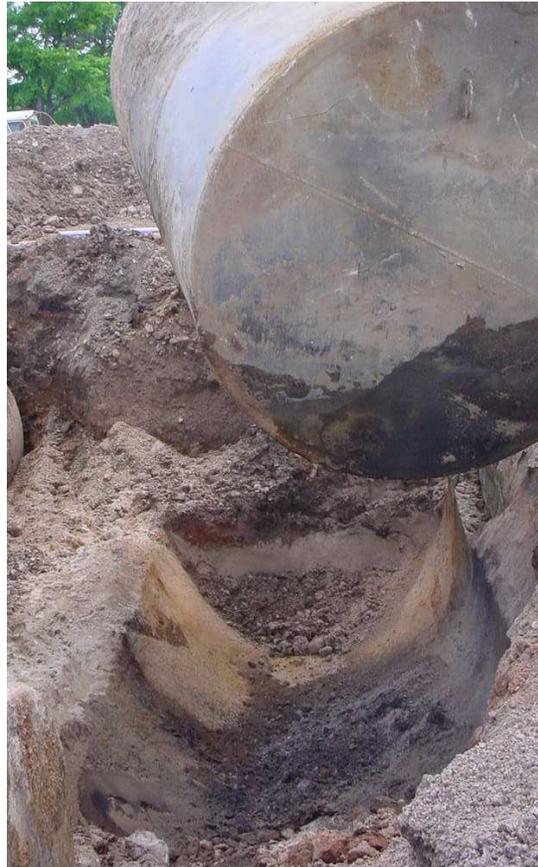
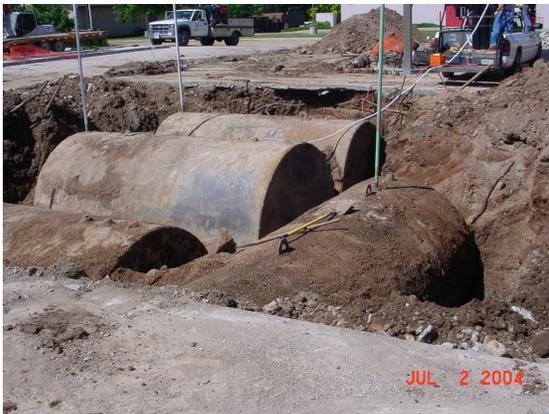
**Project Location #15**  
**Big D Oil**  
**Spearfish, SD**

Release Identified at Site? (Yes/No)	Yes
Source(s) of Release (N/A if no release)	Historic spills / overfills & dispensers
Assessment beyond backfill required? (Yes/No)	Yes
Number of Tanks	4
Type of Tanks	Steel single wall with impressed current protection
Type of Piping	Coated steel
Total Length of Piping	145'
Number of Dispensers	3
Type(s) of Dispensers (Pressure/Suction)	Pressure
Fill pipe Spill Bucket (Yes/No)/Condition	Yes – good condition
Dispenser Sump (Yes/No)/Condition	No
Overfill Protection (Yes/No)/Type	Yes – Flow shut off
Line Pressure Test (Pass/Fail)	Pass
System Documentation Adequate? (Yes/No)	No
Leak Detection Records Adequate? (Yes/No)	Yes

The tank system was installed in 1968. In 1988, new coated steel piping was installed. In 1995 the tanks were lined and a spill / overfill protection system as well as an impressed current system were installed. Upon removal, the tank system appeared to be in generally good condition. No plans or documentation were available for the original installation or for the 1988 & 1995 upgrades. Monthly leak detection records and cathodic and precision test records were provided. The contamination may have been the result of historic spill / overfills or dispenser maintenance/leaks. Contaminated soil has been removed & disposed. DENR has required that site assessment be done to determine if there are any potential pathways and impacted receptors.

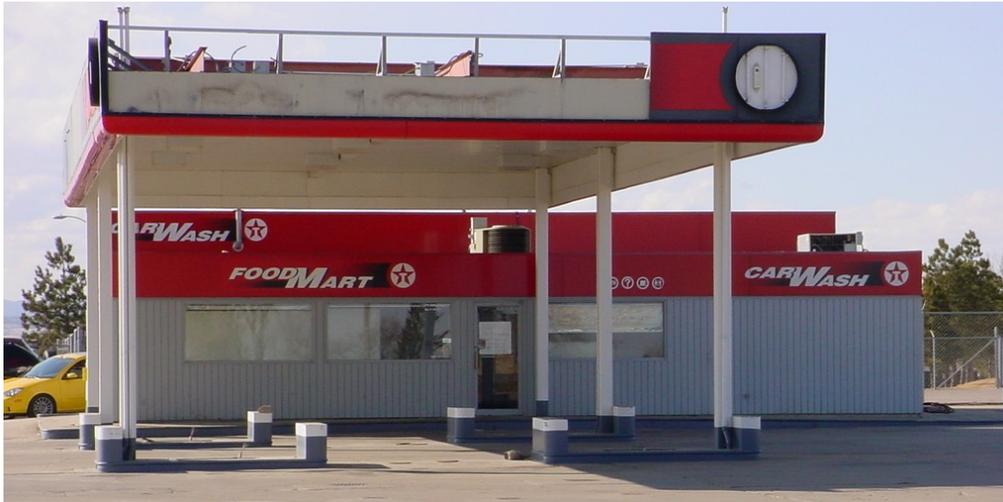
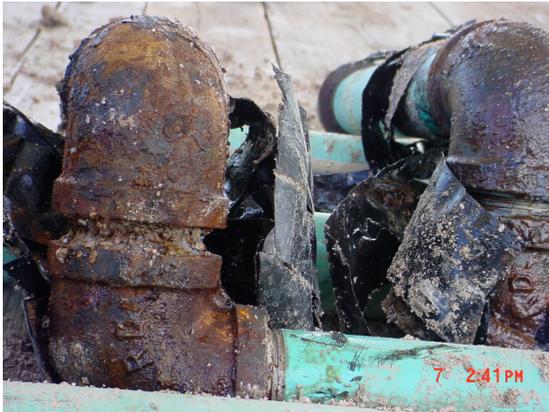
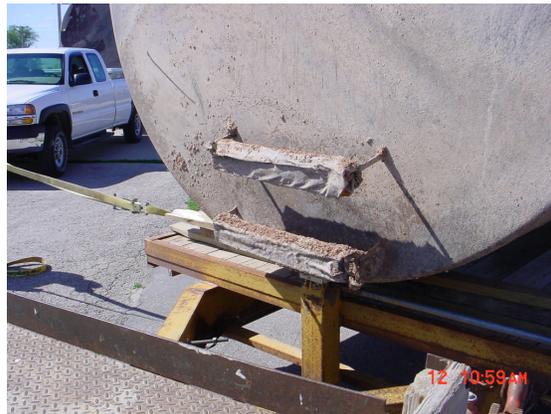
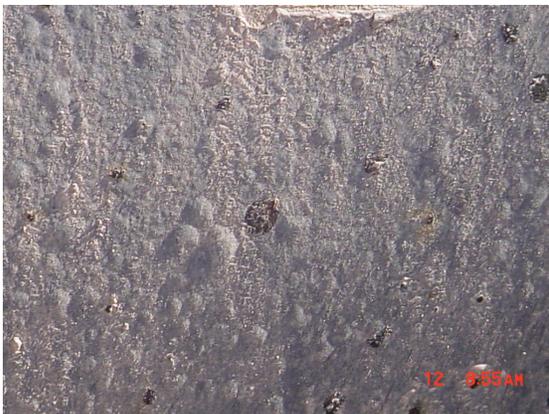
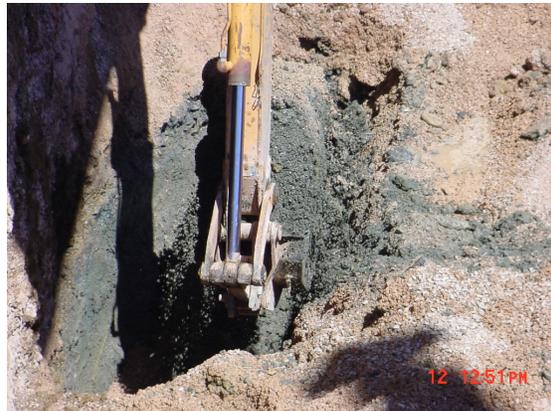
**Project Location #16**  
**Big D Oil**  
**Box Elder, SD**

Release Identified at Site? (Yes/No)	Yes
Source(s) of Release (N/A if no release)	Previous UST systems
Assessment beyond backfill required? (Yes/No)	Yes
Number of Tanks	3
Type of Tanks	StiP3
Type of Piping	Mixture of steel – some cathodically protected, others externally coated
Total Length of Piping	450
Number of Dispensers	4
Type(s) of Dispensers (Pressure/Suction)	Pressure
Fill pipe Spill Bucket (Yes/No)/Condition	Yes / Good
Dispenser Sump (Yes/No)/Condition	No
Overfill Protection (Yes/No)/Type	Yes/Flow shutoff
Line Pressure Test (Pass/Fail)	Pass
System Documentation Adequate? (Yes/No)	No
Leak Detection Records Adequate? (Yes/No)	No

- This location had a second generation, three-product gasoline UST system. The system was installed in 1985.
- Some installation discrepancies were noted. For instance, a few shipping protectors had not been removed from the UST anodes and the protective coating on some piping had been damage by the jaws of a pipe wrench.

- Upon removal of the UST's, it was found that the protective coating had delaminated from the steel. The space behind the coating had been infiltrated by groundwater on the tank ends and by product below the tank fills.

- Product inventory records, leak detection, and inspection records were available but maintenance records were not available for the site.
- As the system was being removed, some of the backfill soils were found to be discolored. This visible contaminated soil, apparently from overfills, was removed. Significant additional contamination, apparently from a previous UST system, was found below the backfill and consequently removed. DENR has required that site assessment be done to determine if there are any potential pathways and impacted receptors.

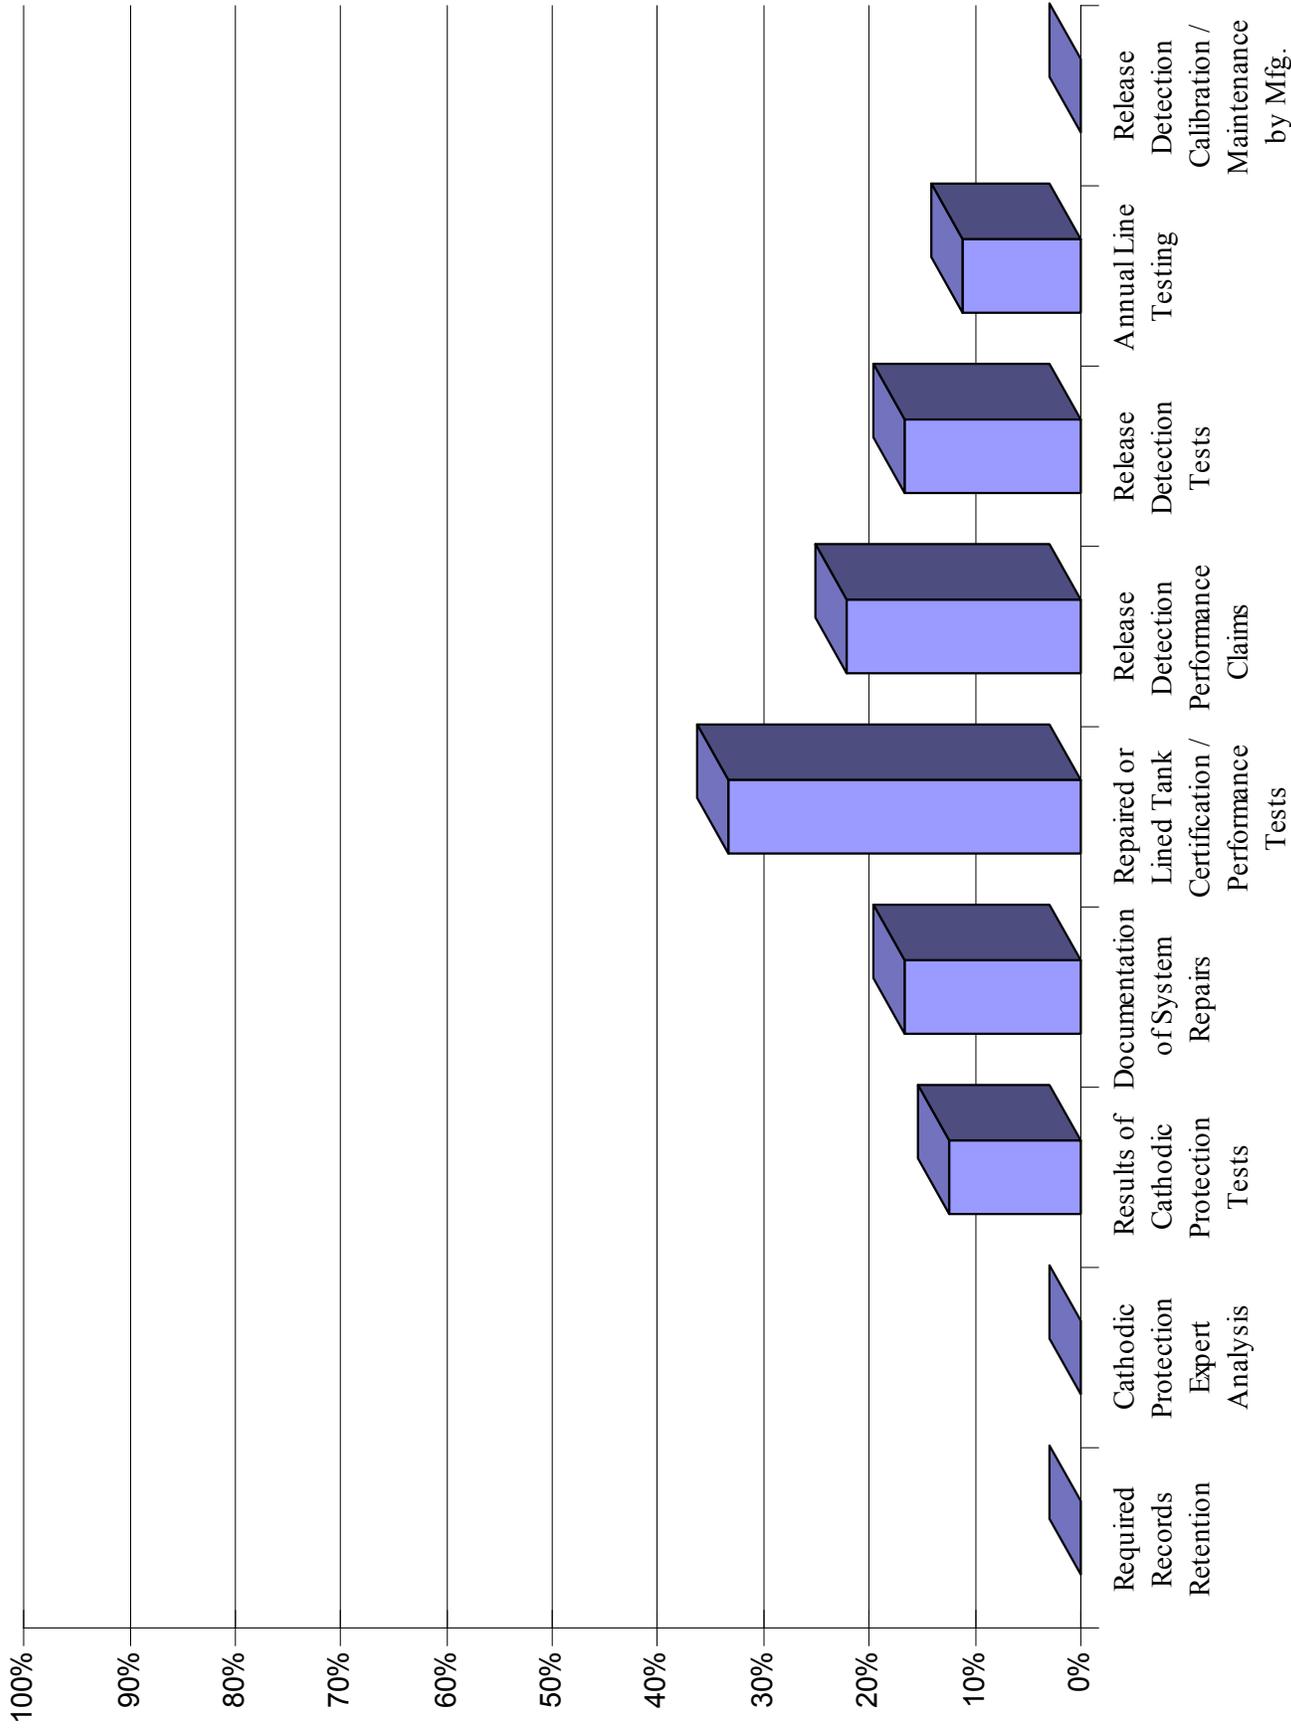
**Figure 1**  
**RECORDS RETENTION**  
**South Dakota PRCF Tank Pathology Study**

Despite State and Federal Regulations regarding records retention, the results of this study conclude that owners and operators at majority of the site evaluated did not retain the required documents to prove that their systems were in compliance with State and Federal rules. Figure 1 summarizes the results associated with records retention. The average records retention compliance rate for the sites included in this study was 11%. Due to the lack of records retention, it cannot be determined if the owners and operators of these properties were conducting required system checks to ensure a release was not or had not occurred.

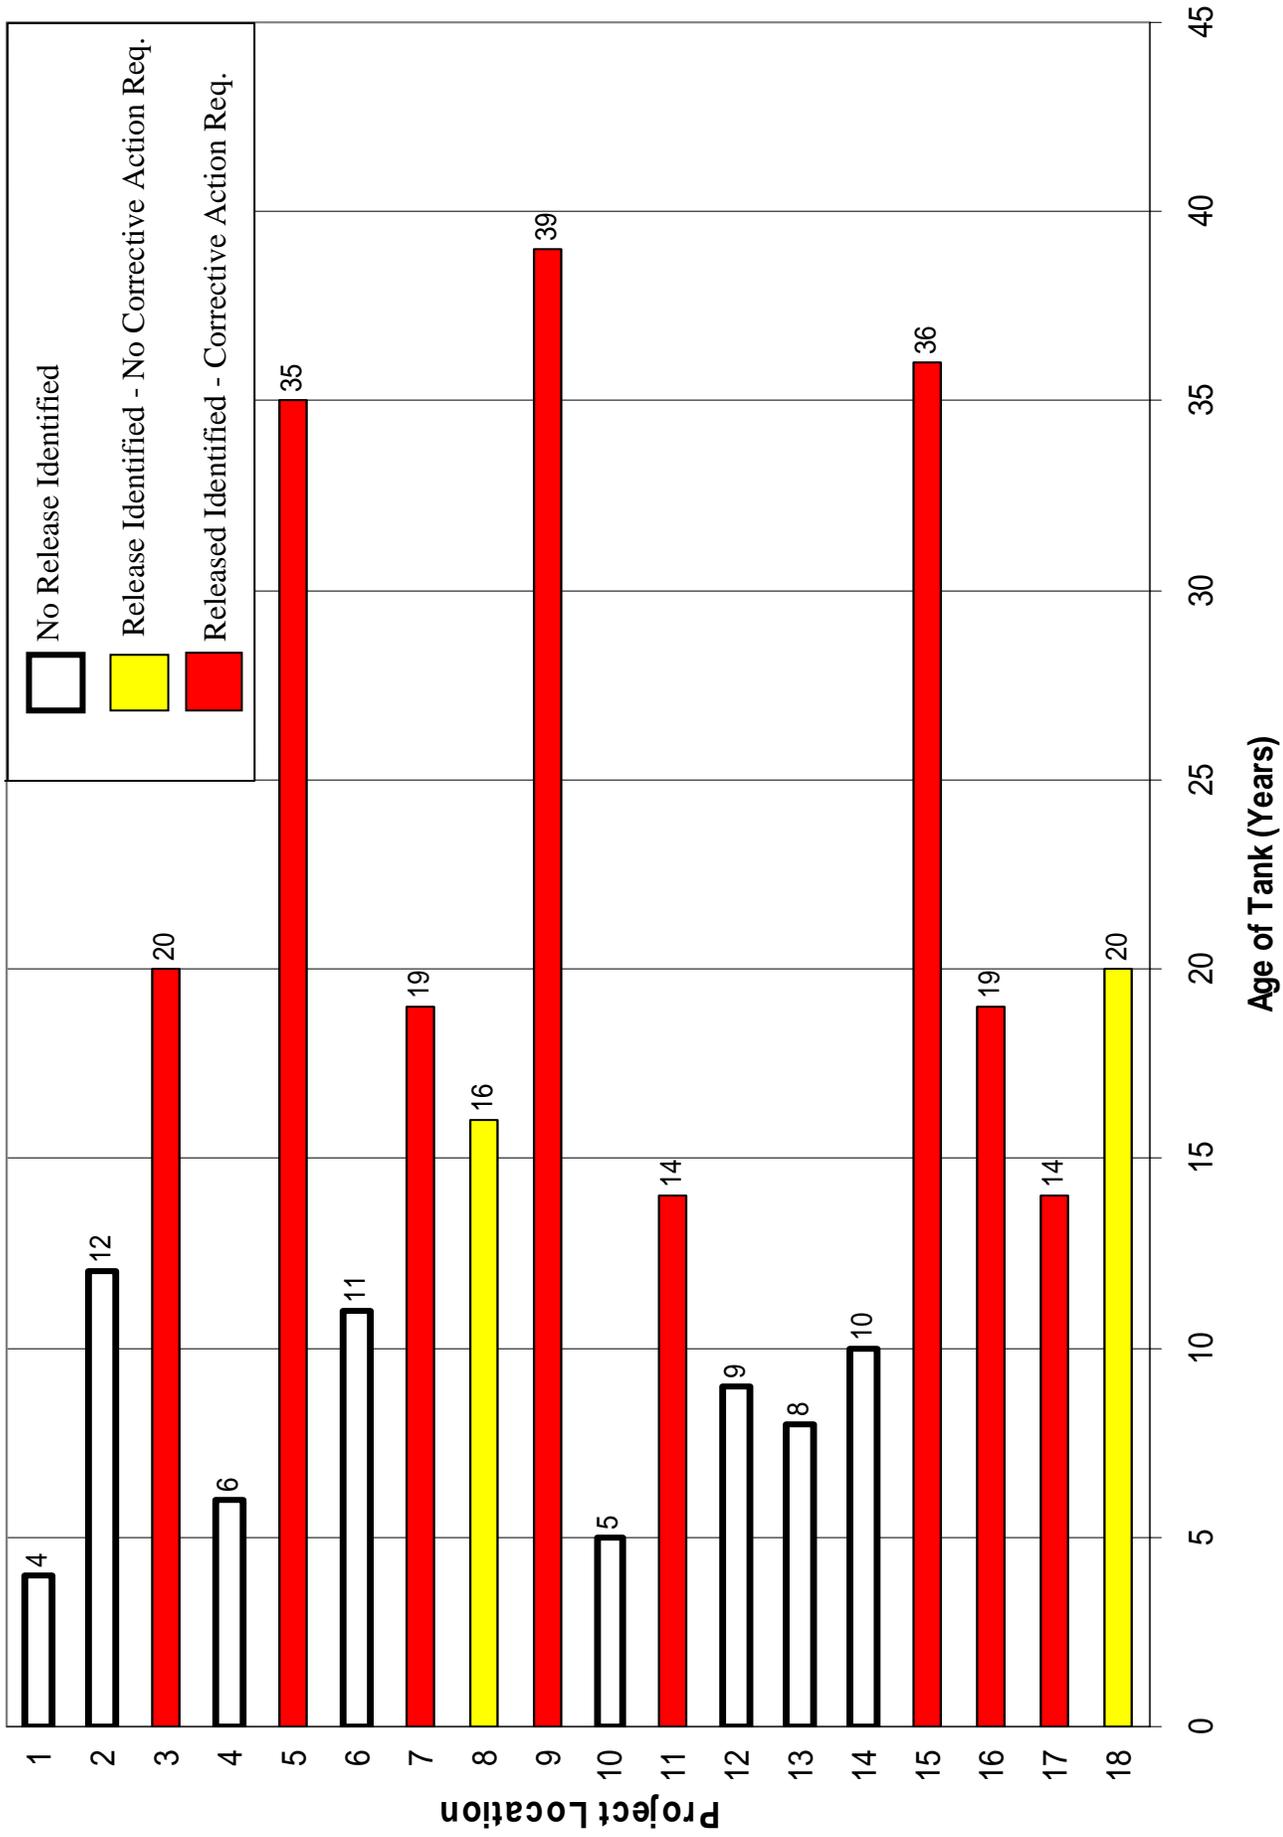
**Figure 5**  
**AGE DISTRIBUTION vs RELEASE DATA**  
 South Dakota PRCF Tank Pathology Study

Figure 2 summarizes the age distribution of the tank systems included in this study. The study included tank systems that were relatively new (less than 5 years), and older systems (>30 years old), with majority of the tank systems averaging about 17 years of age. A release was identified at nearly all tank systems that were 12 years of age or older (8 systems). It was determined that majority of the releases were not the result of the structural integrity of the tanks or lines, but rather the appurtenances, such as the fill pipes. However, the releases at two of those sites are believed to have originated from a previous tank system, and were not the result of a failure in the most recent tank system.
