# SOUTH DAKOTA TANK PATHOLOGY STUDY

## EVALUATING THE INTEGRITY OF TANK SYSTEMS IN SOUTH DAKOTA

South Dakota  
Petroleum Release  
Compensation Fund

**June 15, 2005**

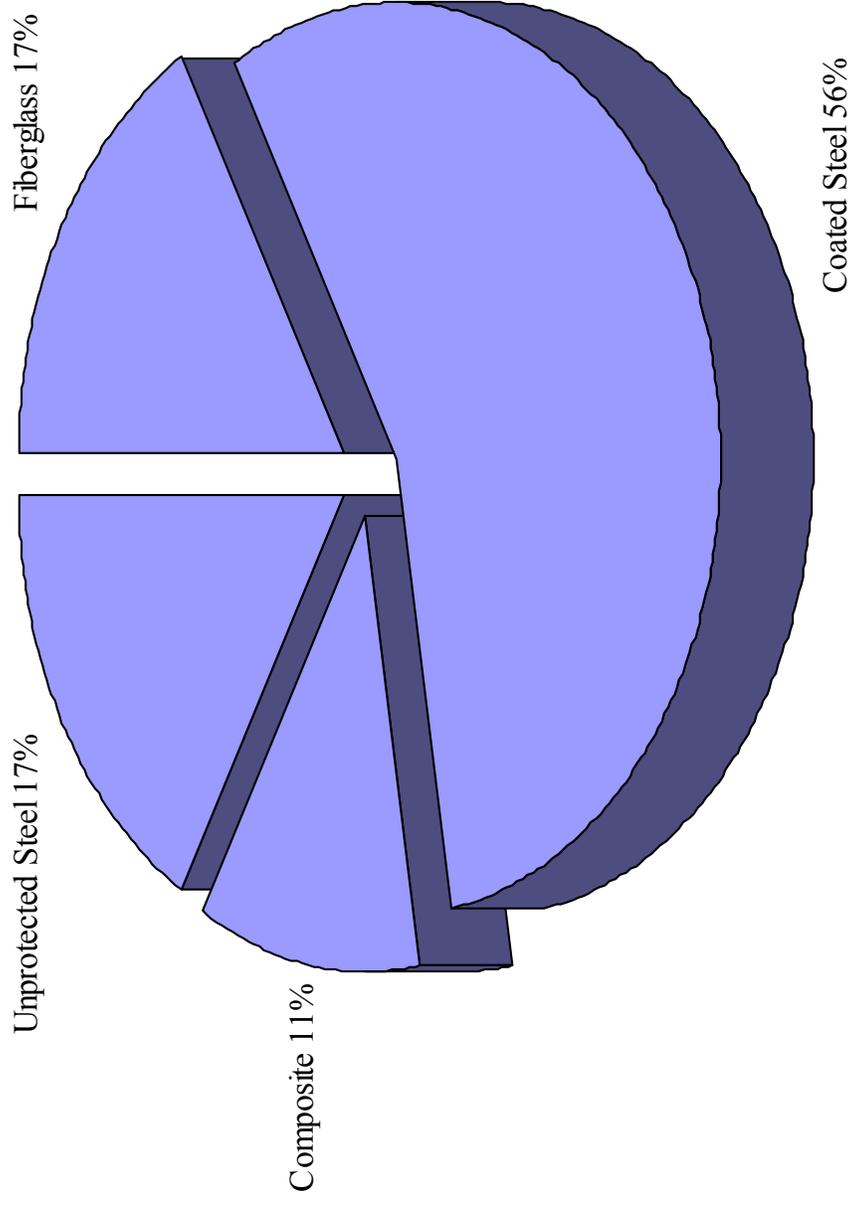
**Figure 2**  
**TANK CONSTRUCTION**  
**South Dakota PRCF Tank Pathology Study**

Of the 17 sites evaluated, the most common type of tank construction found included unprotected steel and steel wrapped with composite materials such as fiberglass. However, there were other steel tanks found that were covered with a protective coating. Majority of the tanks removed appeared to be in fair to excellent condition. Figure 3 depicts the different materials and the frequency of each material encountered.
