**SECTION 319 NONPOINT POLLUTION  
CONTROL PROJECT REPORT**

**WATERSHED PROJECT FINAL REPORT**

**LAKE HANSON/PIERRE CREEK RESTORATION  
PROJECT**

Curt Hart  
Project Coordinator  
Hanson County Conservation District

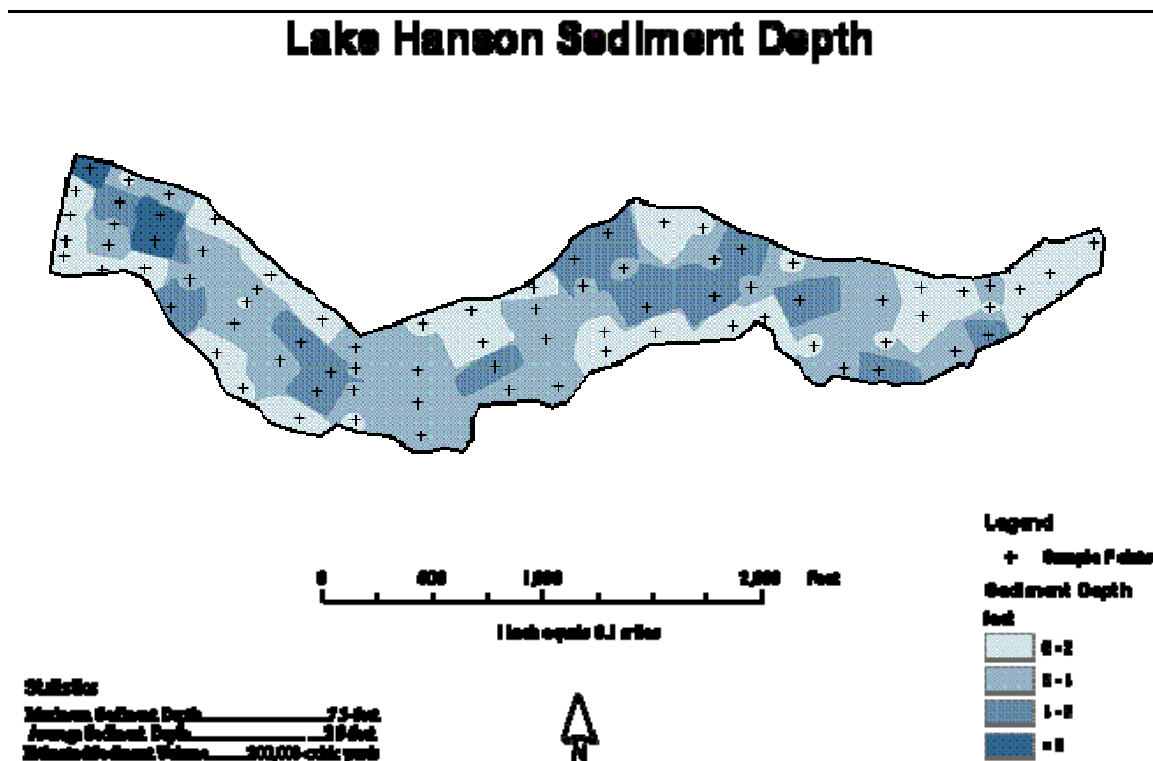
Figure 2: Map of sediment and depth of sediment in Lake Hanson from 2002.

The sediment delivery to Lake Hanson at its inlet was estimated to cause 0.04 inch's of sediment accumulation in Lake Hanson per year. This low rate was attributed to the implementation of conservation practices such as conservation tillage and grazing management over the past 20-30 years. The sediment survey (see Figure 2) measured lake sediment to average 1 meter in depth. The assessment recommends targeting the lower portion of the watershed to obtain the greatest reduction in sediment delivery from current rates, along with treatment of shoreline erosion. Dredging of existing lake sediment is a preferred activity supported by local citizens, and the watershed assessment states *"Dredging the excess sediment from the lake will increase boatable acres in the lake, reduce the potential for excessive plant growth, and remove nutrient-rich sediments that could potentially increase nutrient concentrations in the lake during periods of stratification."*

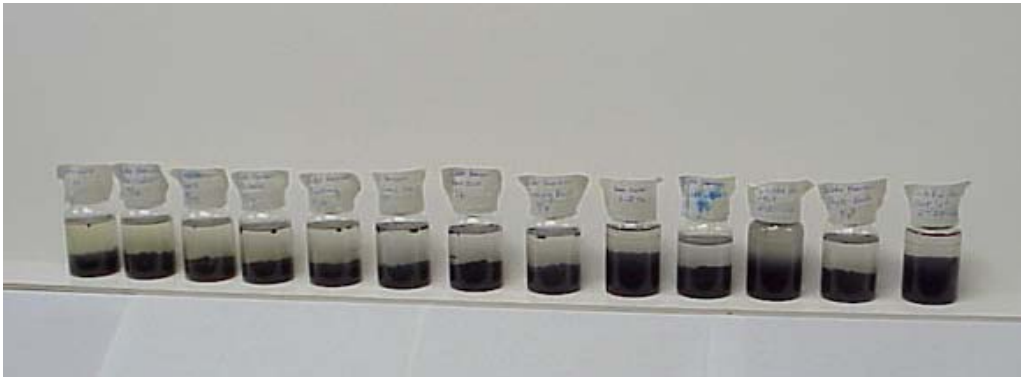
**Figure 3: Results from the cabin septic system test.**

A Septic System dye test was done with 100% compliance to determine if cabin septic systems are contributing pollutants to Lake Hanson. The results from the test show that there is a small amount leaking from the septic tanks into the lake.

A procedure was developed for sampling the septic systems. This procedure can be found in Appendix A of this report. The cabin septic systems were sampled on July 3, 2006 with 100% participation. The results show that there is a small amount leaking from the septic tanks around the lake, but no individual cabins were determined to be failing. The samples that were taken during this test can be seen in Figure 3.

Currently there is some contamination coming from the lake homes around Lake Hanson. Therefore it is recommended that lakeside cabin septic tank testing, similar to the one completed for this project, be completed again. This could show if the septic leakage is getting worse. A feasibility study on options for a sanitary sewer is also recommended. If this is pursued in the future, it may lead to a community system that is monitored more closely than individual septic systems, and would have more safeguards on keeping contamination from the lake homes from getting into the lake.

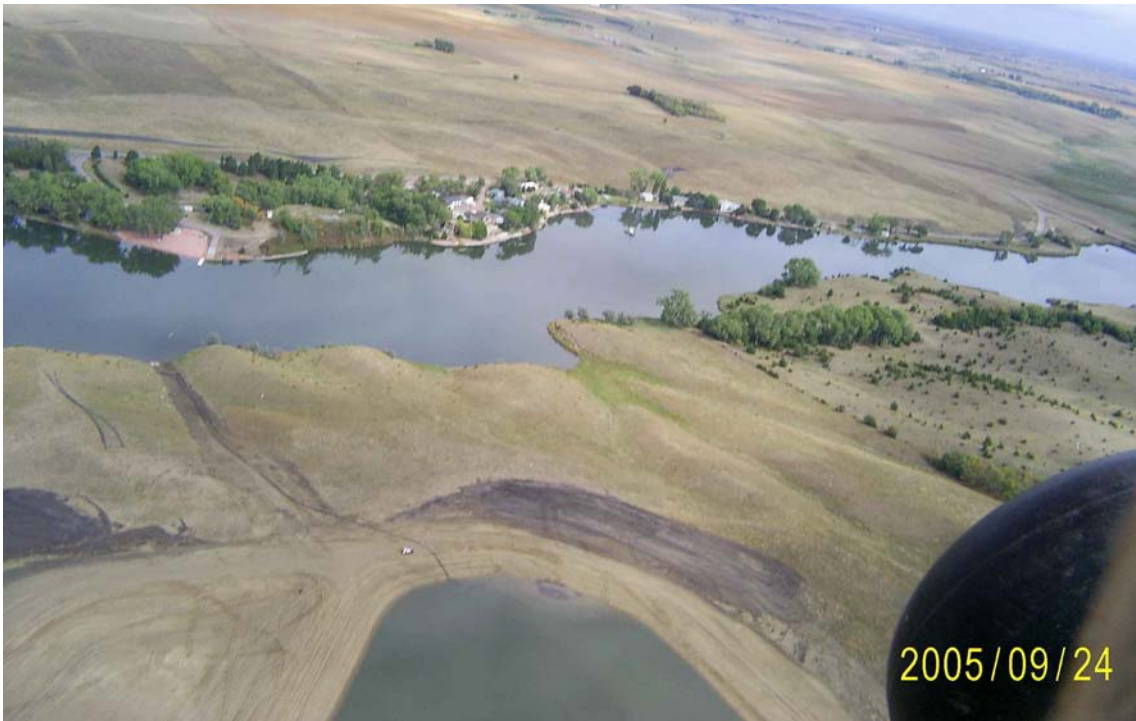
**Figure 4: Start of the dredging project.**

Dredging was started in the fall of 2005 (see Figure 4). Dredging continued through 2006, but was not completed on time because of several minor break downs and one major break down involving the cutter head. Dredging was put on hold during May 2007 when the emergency spillway breached due to excessive rainfall (see Figure 5 & 6). Articles on the breaching of the spillway can be found in Exhibit B of this report.

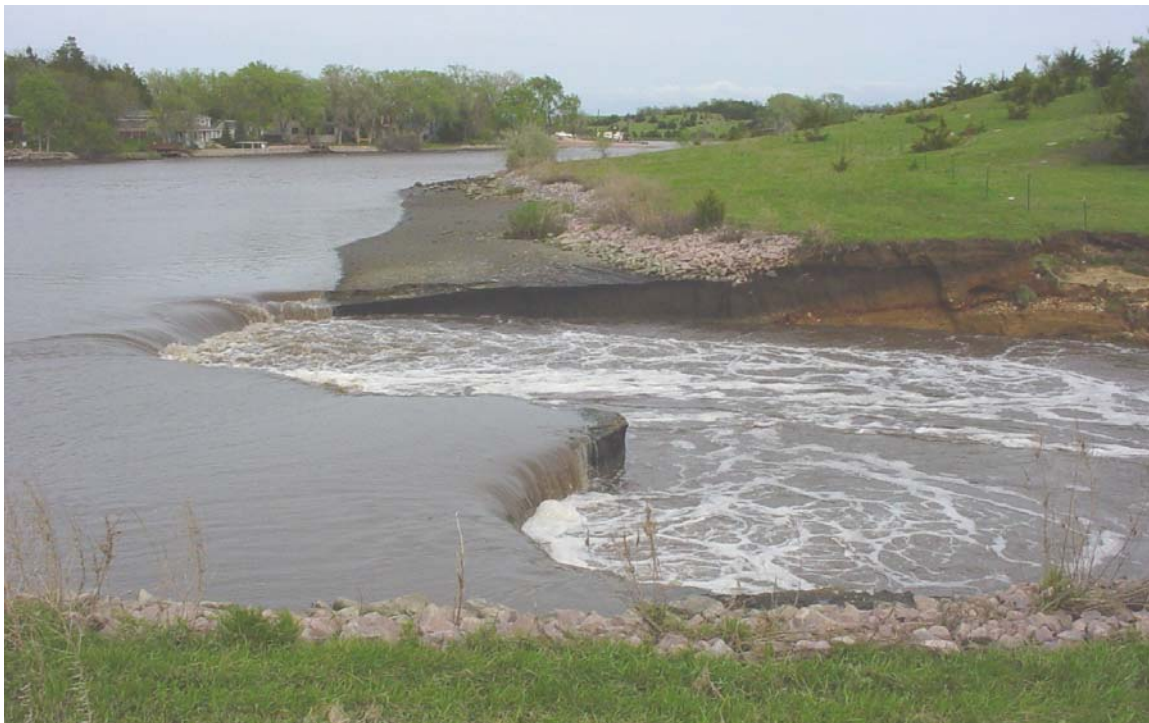
**Figure 5: The emergency spill way after breach, spring 2007.**

In May 2007 storms with rain up to 10 inches caused the breach of the emergency spillway. Dredging was put on hold. Several public meetings were held in the community. Many of the concerned citizens wanted to know the best approach on how to cleanup and fix the emergency spillway. The majority did not want to wait because of health and safety issues. Private money was raised to begin work fixing the break.

As heavy rains hit over the weekend, erosion started at the dam's emergency spillway and worked its way back to the face of the dam, creating a path for the dam's rapid deterioration.

Besides the 70-foot-wide breach, heavy rains also damaged the lake's main spillway, sweeping away rock-filled gabions — rock-filled wire mesh baskets — and eroding banks to within six feet of the Northshore Drive roadway.

Volunteer labor and donations made it possible to repair the breach and the lake. Without this help, the project may have been delayed further.

Hart said 1,000-pound rocks have been added as rip-rap to prevent further erosion at the dam's spillway. The larger rocks will replace the rock-filled gabion baskets at the site and prevent the washout of Northshore Drive.

Using privately donated money and supplies, Hart said 60,000 tons of material was used to repair the 70-foot-wide breach.

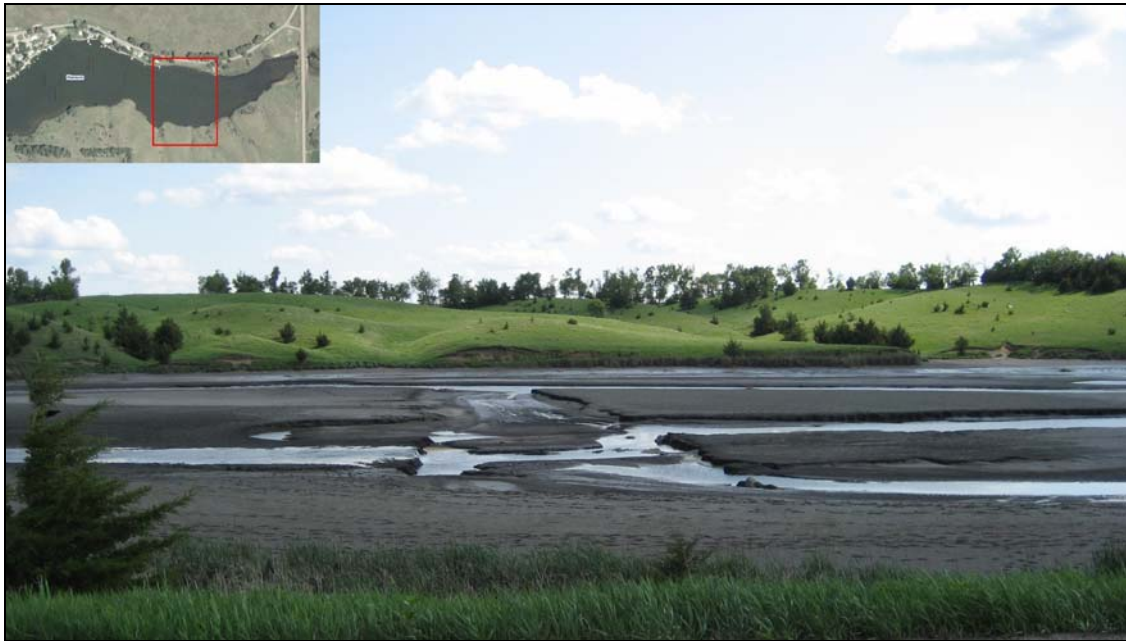
**Figure 6: Area of dredging after spillway breach, and lake drained.**

It was estimated that a total of 121,755 yd<sup>3</sup> were removed from the lake through a combination of dredging and the breaching of the spillway in the spring of 2007. The lake was measured with survey grade GPS after the dam breached and before the lake filled with water again (see Figure 7).

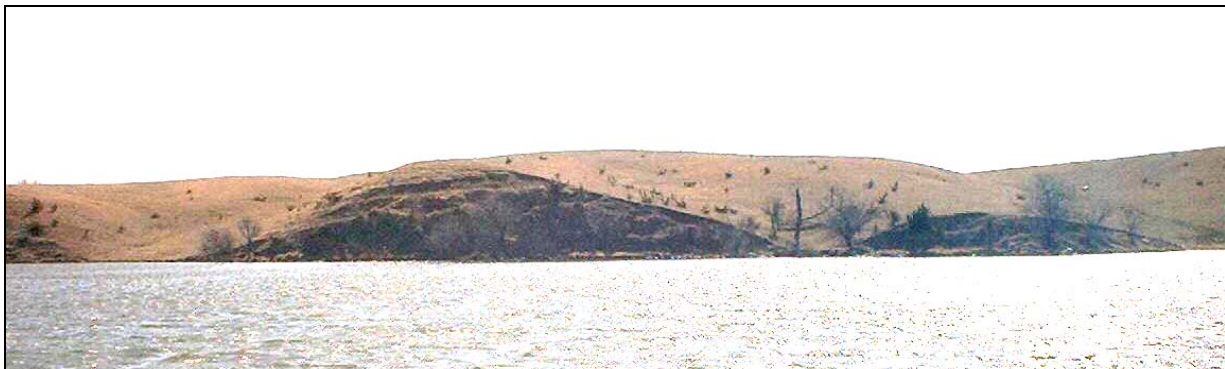
**Figure 8: Area along the south shore of Lake Hanson before stabilization.**

**Task 5: STABILIZATION.** Stabilize 500 LF of shoreline through vegetative/bio restoration and 300 LF of shoreline through (riprap, etc.) to reduce sedimentation from shoreline erosion and improve wildlife habitat (see figure 8 & 9 for a before and after picture of a stabilized area).

Engineering designs were completed by NRCS for 6 areas along the south side of the lake that were in poor condition. These areas total about 1,050 linear feet along the lake, and were completed in the fall of 2008.

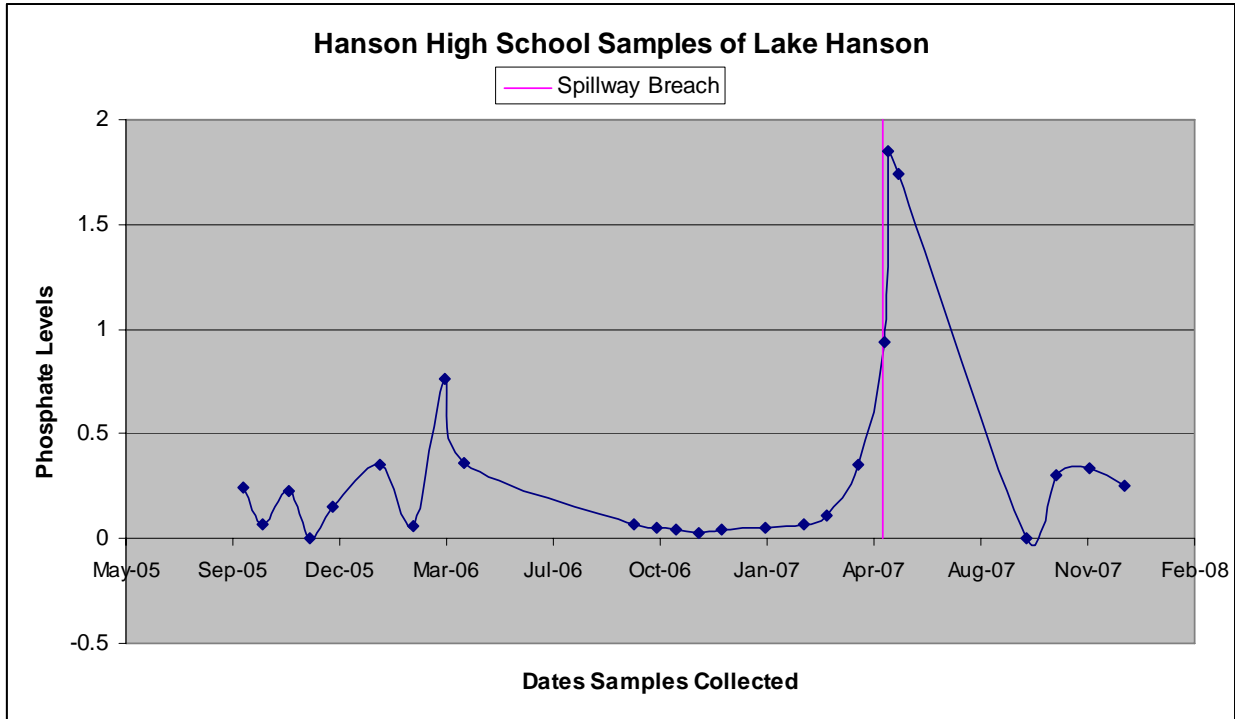
**Figure 10: Hanson High School Samples of Lake Hanson.**

Mr. Posicak from Hanson High School brings his students out to the lake for projects such as monitoring the water quality. The Phosphate levels for the lake during school sampling periods is shown in Figure 10 below. Samples taken shortly after the breaching of the spillway are significantly higher, but are back to normal when sampling in the fall started again. The other parameters sampled by the Hanson High School can be seen in Appendix B attached to this report. They will continue to monitor the water as they have in the past.

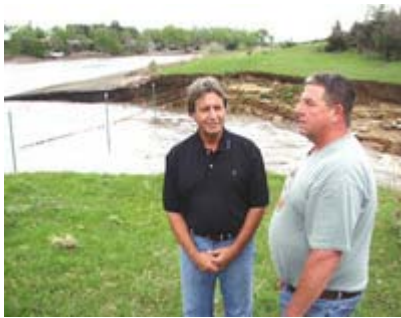
Ross Dolan/Republic Lake Hanson Project Coordinator Curt Hart, left, and Hanson County Commissioner Tom Bell discuss options for the repair of a dam breach at the southwest end of the lake. Heavy rains caused erosion that blew out a section of dam early Sunday morning, washing debris downstream to the James River three miles away.

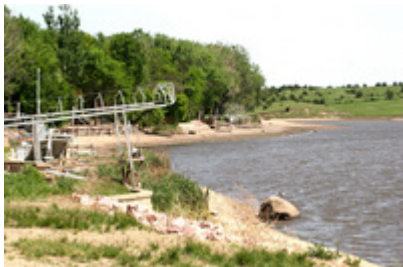
Laura Wehde/Republic - There still is water in Lake Hanson, but it is nowhere near its usual levels. The dam at the lake was breached during a heavy rain earlier this month.
