2004 FIELD AUDIT REPORT

IMPLEMENTATION MONITORING AND EVALUATION OF SOUTH DAKOTA FORESTRY BEST MANAGEMENT PRACTICES

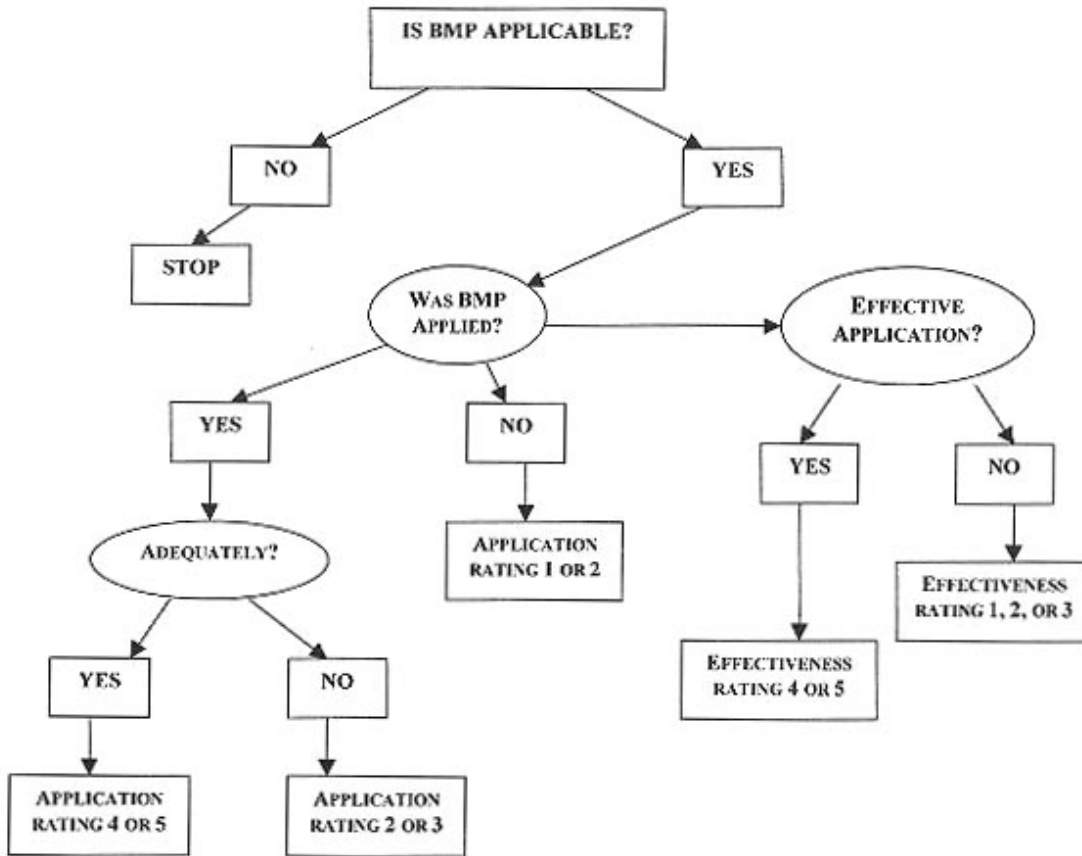
Figure 2. Forestry BMP field audit rating process.

Figure 2 displays the rating procedure used during the field audits. The procedure begins with establishing whether or not a given practice is applicable to the timber sale in question. For example, several BMPs relate to the construction and closure of temporary roads, but not all timber sales involve the use of temporary roads. In an instance where the BMP is determined not applicable, the rating process stops. Where a BMP's applicability is established, the rating process moves on to evaluating the application of the practice, and its effectiveness.
