# 2004 FIELD AUDIT REPORT

## IMPLEMENTATION MONITORING AND EVALUATION OF SOUTH DAKOTA FORESTRY BEST MANAGEMENT PRACTICES

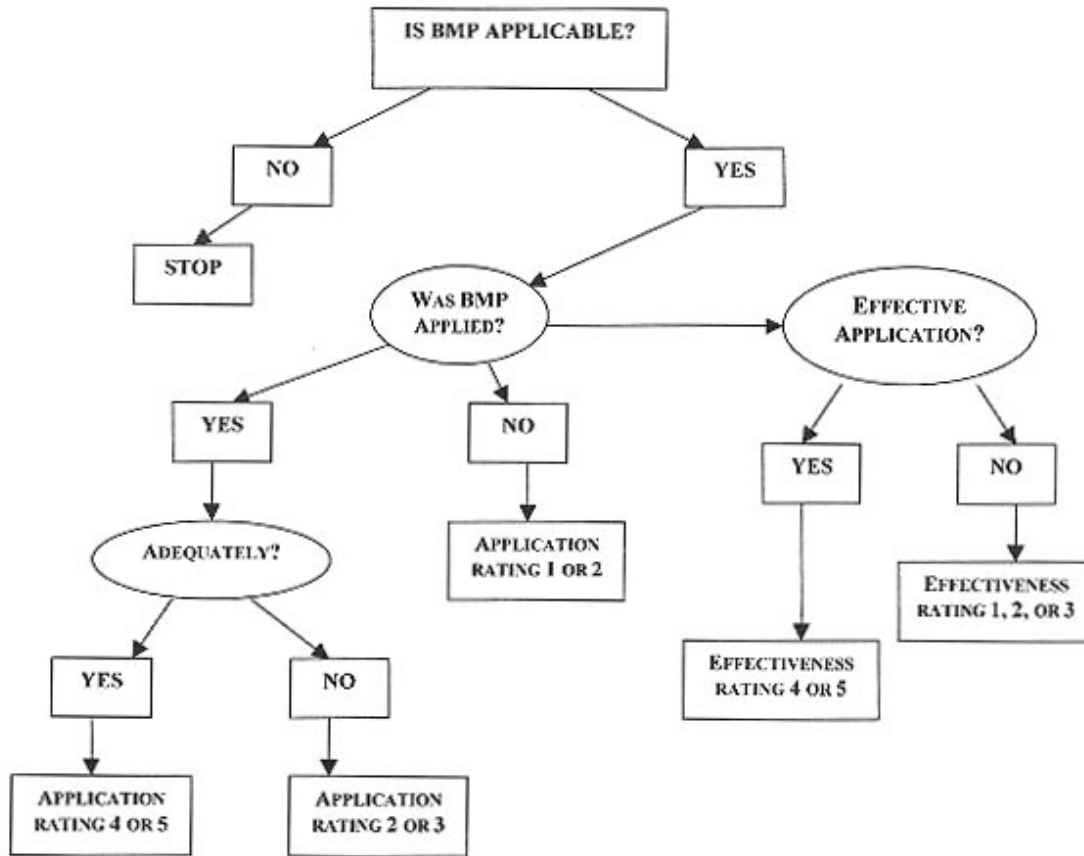
**Figure 2.** Forestry BMP field audit rating process.

Figure 2 displays the rating procedure used during the field audits. The procedure begins with establishing whether or not a given practice is applicable to the timber sale in question. For example, several BMPs relate to the construction and closure of temporary roads, but not all timber sales involve the use of temporary roads. In an instance where the BMP is determined not applicable, the rating process stops. Where a BMP's applicability is established, the rating process moves on to evaluating the application of the practice, and its effectiveness.

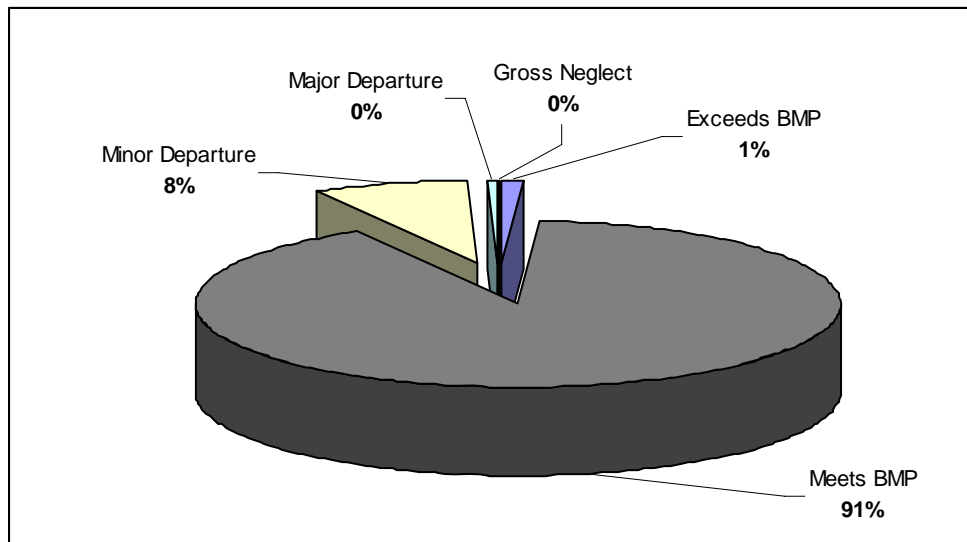
**Figure 3.** 2004 South Dakota Forestry BMP field audit results as aggregate incidence of Application scores relative to total rated items across all land ownerships.

Figures 3 and 4 display the audit results for BMP application and effectiveness, respectively, aggregated across all land ownership categories as a percentage of the total rated items. BMPs were found to have been met or exceeded application standards in 92 percent of the rated instances, and found to provide adequate or improved protection of soil and water

resources in 95 percent of rated instances. Both application and effectiveness ratings exceeded BMP requirements and improved upon pre-project conditions with an incidence rating of one percent. Effectiveness scores for adequate protection are, overall, slightly higher than their corresponding scores for BMP application. Departures from the BMPs made up eight percent of the rated items for application, and five percent of the rated items for effectiveness. Although two major departures were cited in BMP application (Table 3), these account for less than one-half percent of the total rated items. Similarly, one instance of major and prolonged impacts was cited in BMP effectiveness (Table 4), but accounts for less than one-quarter percent of the total rated items.
