# **2009 FIELD AUDIT REPORT**

## **IMPLEMENTATION MONITORING AND EVALUATION OF SOUTH DAKOTA FORESTRY BEST MANAGEMENT PRACTICES**

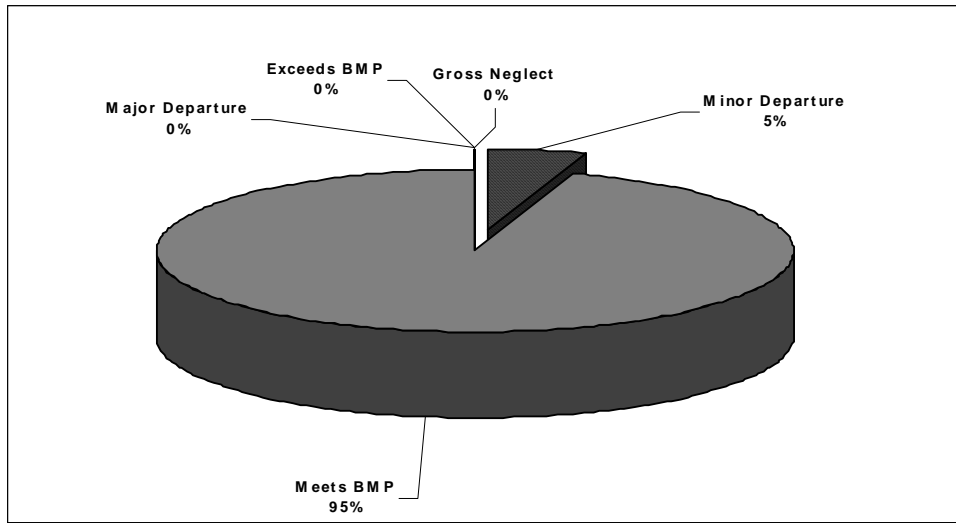
**Figure 3.** 2009 South Dakota Forestry BMP field audit results as aggregate incidence of application scores relative to total rated items across all land ownerships.

Figures 3 and 4 display the audit results for BMP application and effectiveness, respectively, aggregated across all land ownership categories as a percentage of the total rated items. BMPs were found to have met or exceeded application and effectiveness standards in 95 percent of the rated instances. Effectiveness ratings exceeded BMP requirements and improved upon pre-project conditions on both state and federal lands. Departures from the BMPs made up five percent of the rated items for application and four percent of the rated items for effectiveness. Although one major departure was cited in BMP application (Table 3), this accounts for roughly one-quarter percent of the total rated items. Similarly, one instance of major and prolonged impacts was cited and one minor/prolonged was cited in BMP effectiveness. (Table 4) Combining these two impacts account for the one percent given to minor/prolonged impact in Figure 4.

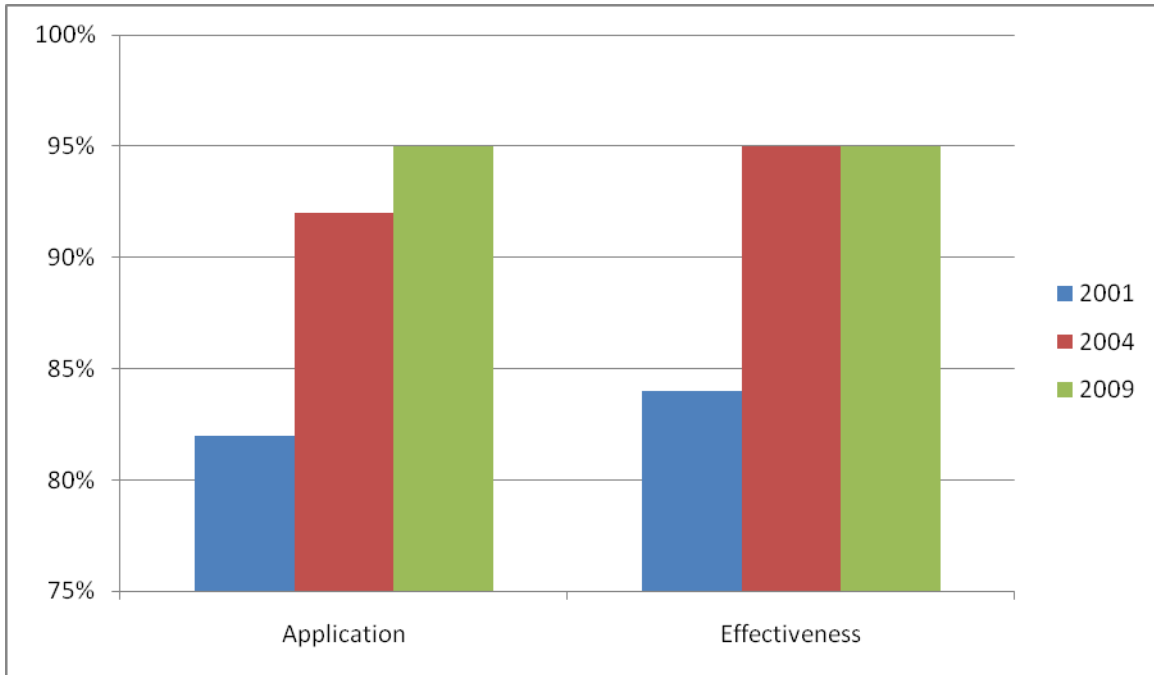
**Figure 5.** Percent of total rated items meeting or exceeding BMP standards for application and effectiveness in 2001, 2004 and 2009.

Application and effectiveness accomplishments meeting or exceeding BMP standards have shown steady improvement since the BMP field audits began in 2001. Figure 5, shown below, illustrates this positive trend and speaks well for BMP training and field work that has been completed by professional loggers and foresters.
